MCPOLIN BARN – STRUCTURAL STUDY

PROJECT #14359

July 1, 2014

PREPARED BY: BHB Consulting Engineers, PC

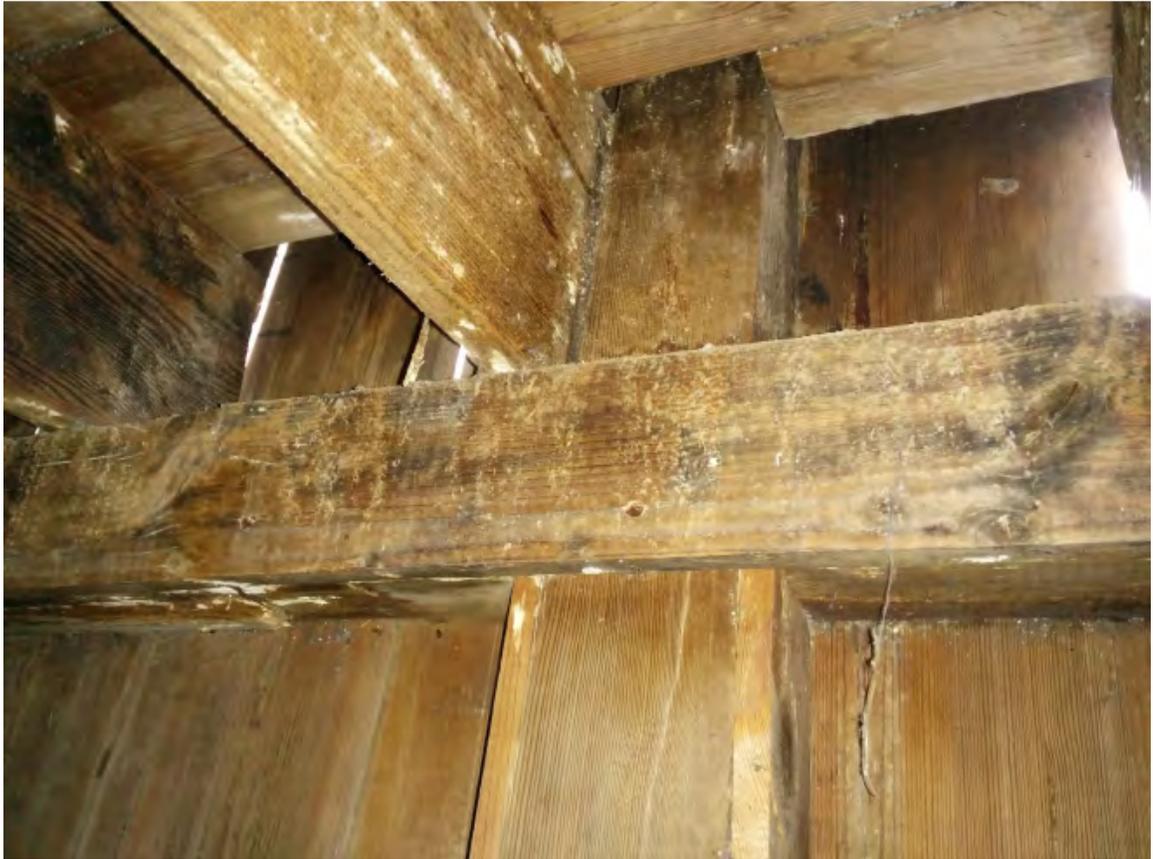
Figure 4. Column to beam connection

1. Gravity Loads
 - a. The beam to column connections at the exterior wall does not have adequate transfer of load from beam to column.

An additional 2 x 6 stud can be added to each side of the timber column and nailed properly. This will give the beam something to physically bear on. Lag screws can be added to create a positive connection. Refer to detail 1 in Appendix.
 - b. There is a column in the south west of the building that has been modified and does not appear to have been replaced properly.

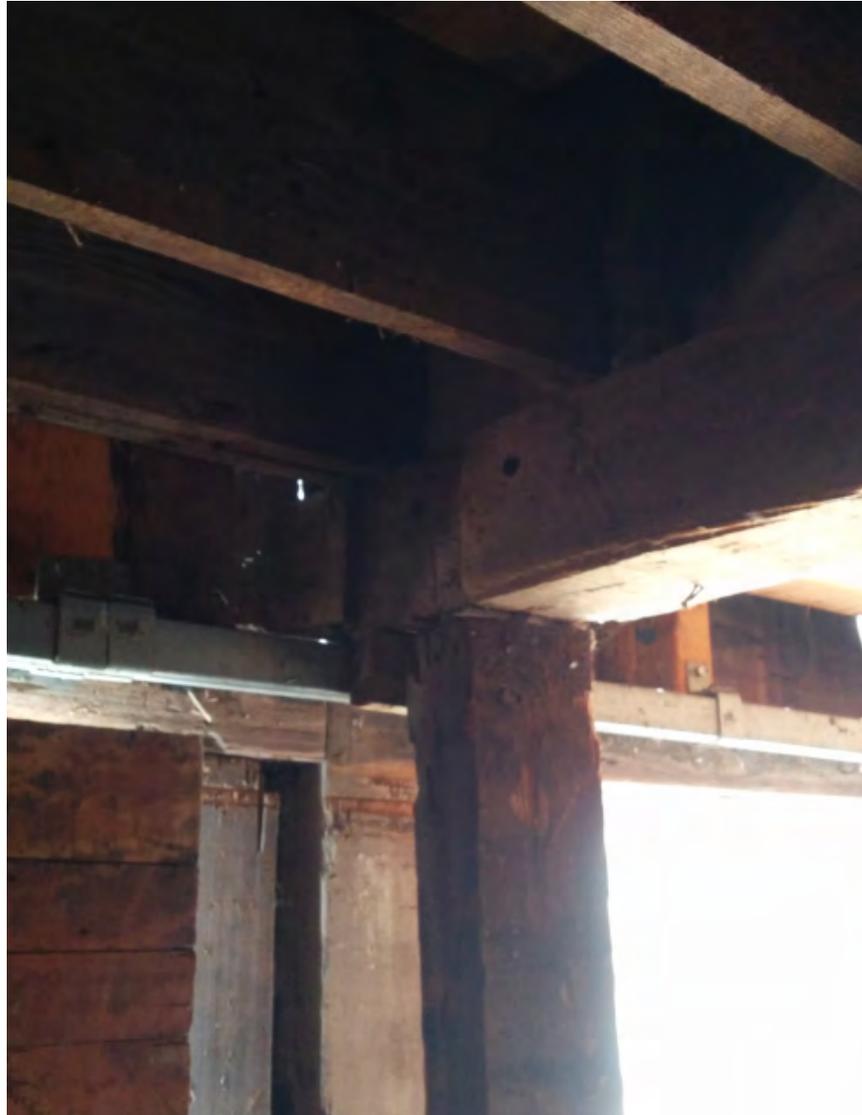
Figure 5. Modified Column

- b. There is a column in the south west of the building that has been modified and does not appear to be installed properly.

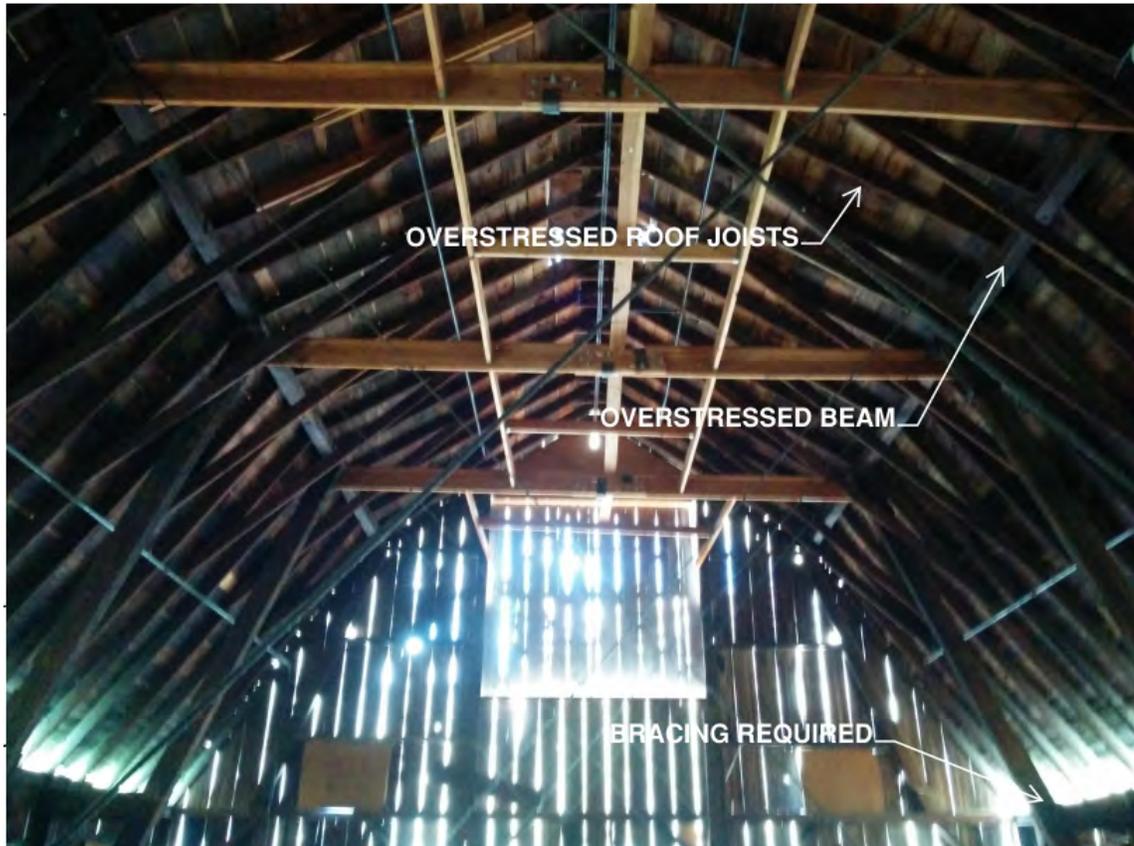
Figure 6. Roof Framing

- a. Roof joists are over stressed between 120% and 500% under design snow loads.
- b. The 6 X 6 roof beam is stressed at 300% under design snow loads.
- c. The diagonal 6 x 10 timber is not braced adequately to withstand design snow loads.
