**SITE MITIGATION 2008 FIELD REPORT  
ALICE LODE  
VOLUNTARY CLEANUP PROGRAM  
ASSISTANCE ID No. C025  
PARK CITY, UTAH**

AMEC Environment & Infrastructure, Inc.  
9865 South 500 West  
Sandy, Utah 84070

June 2013

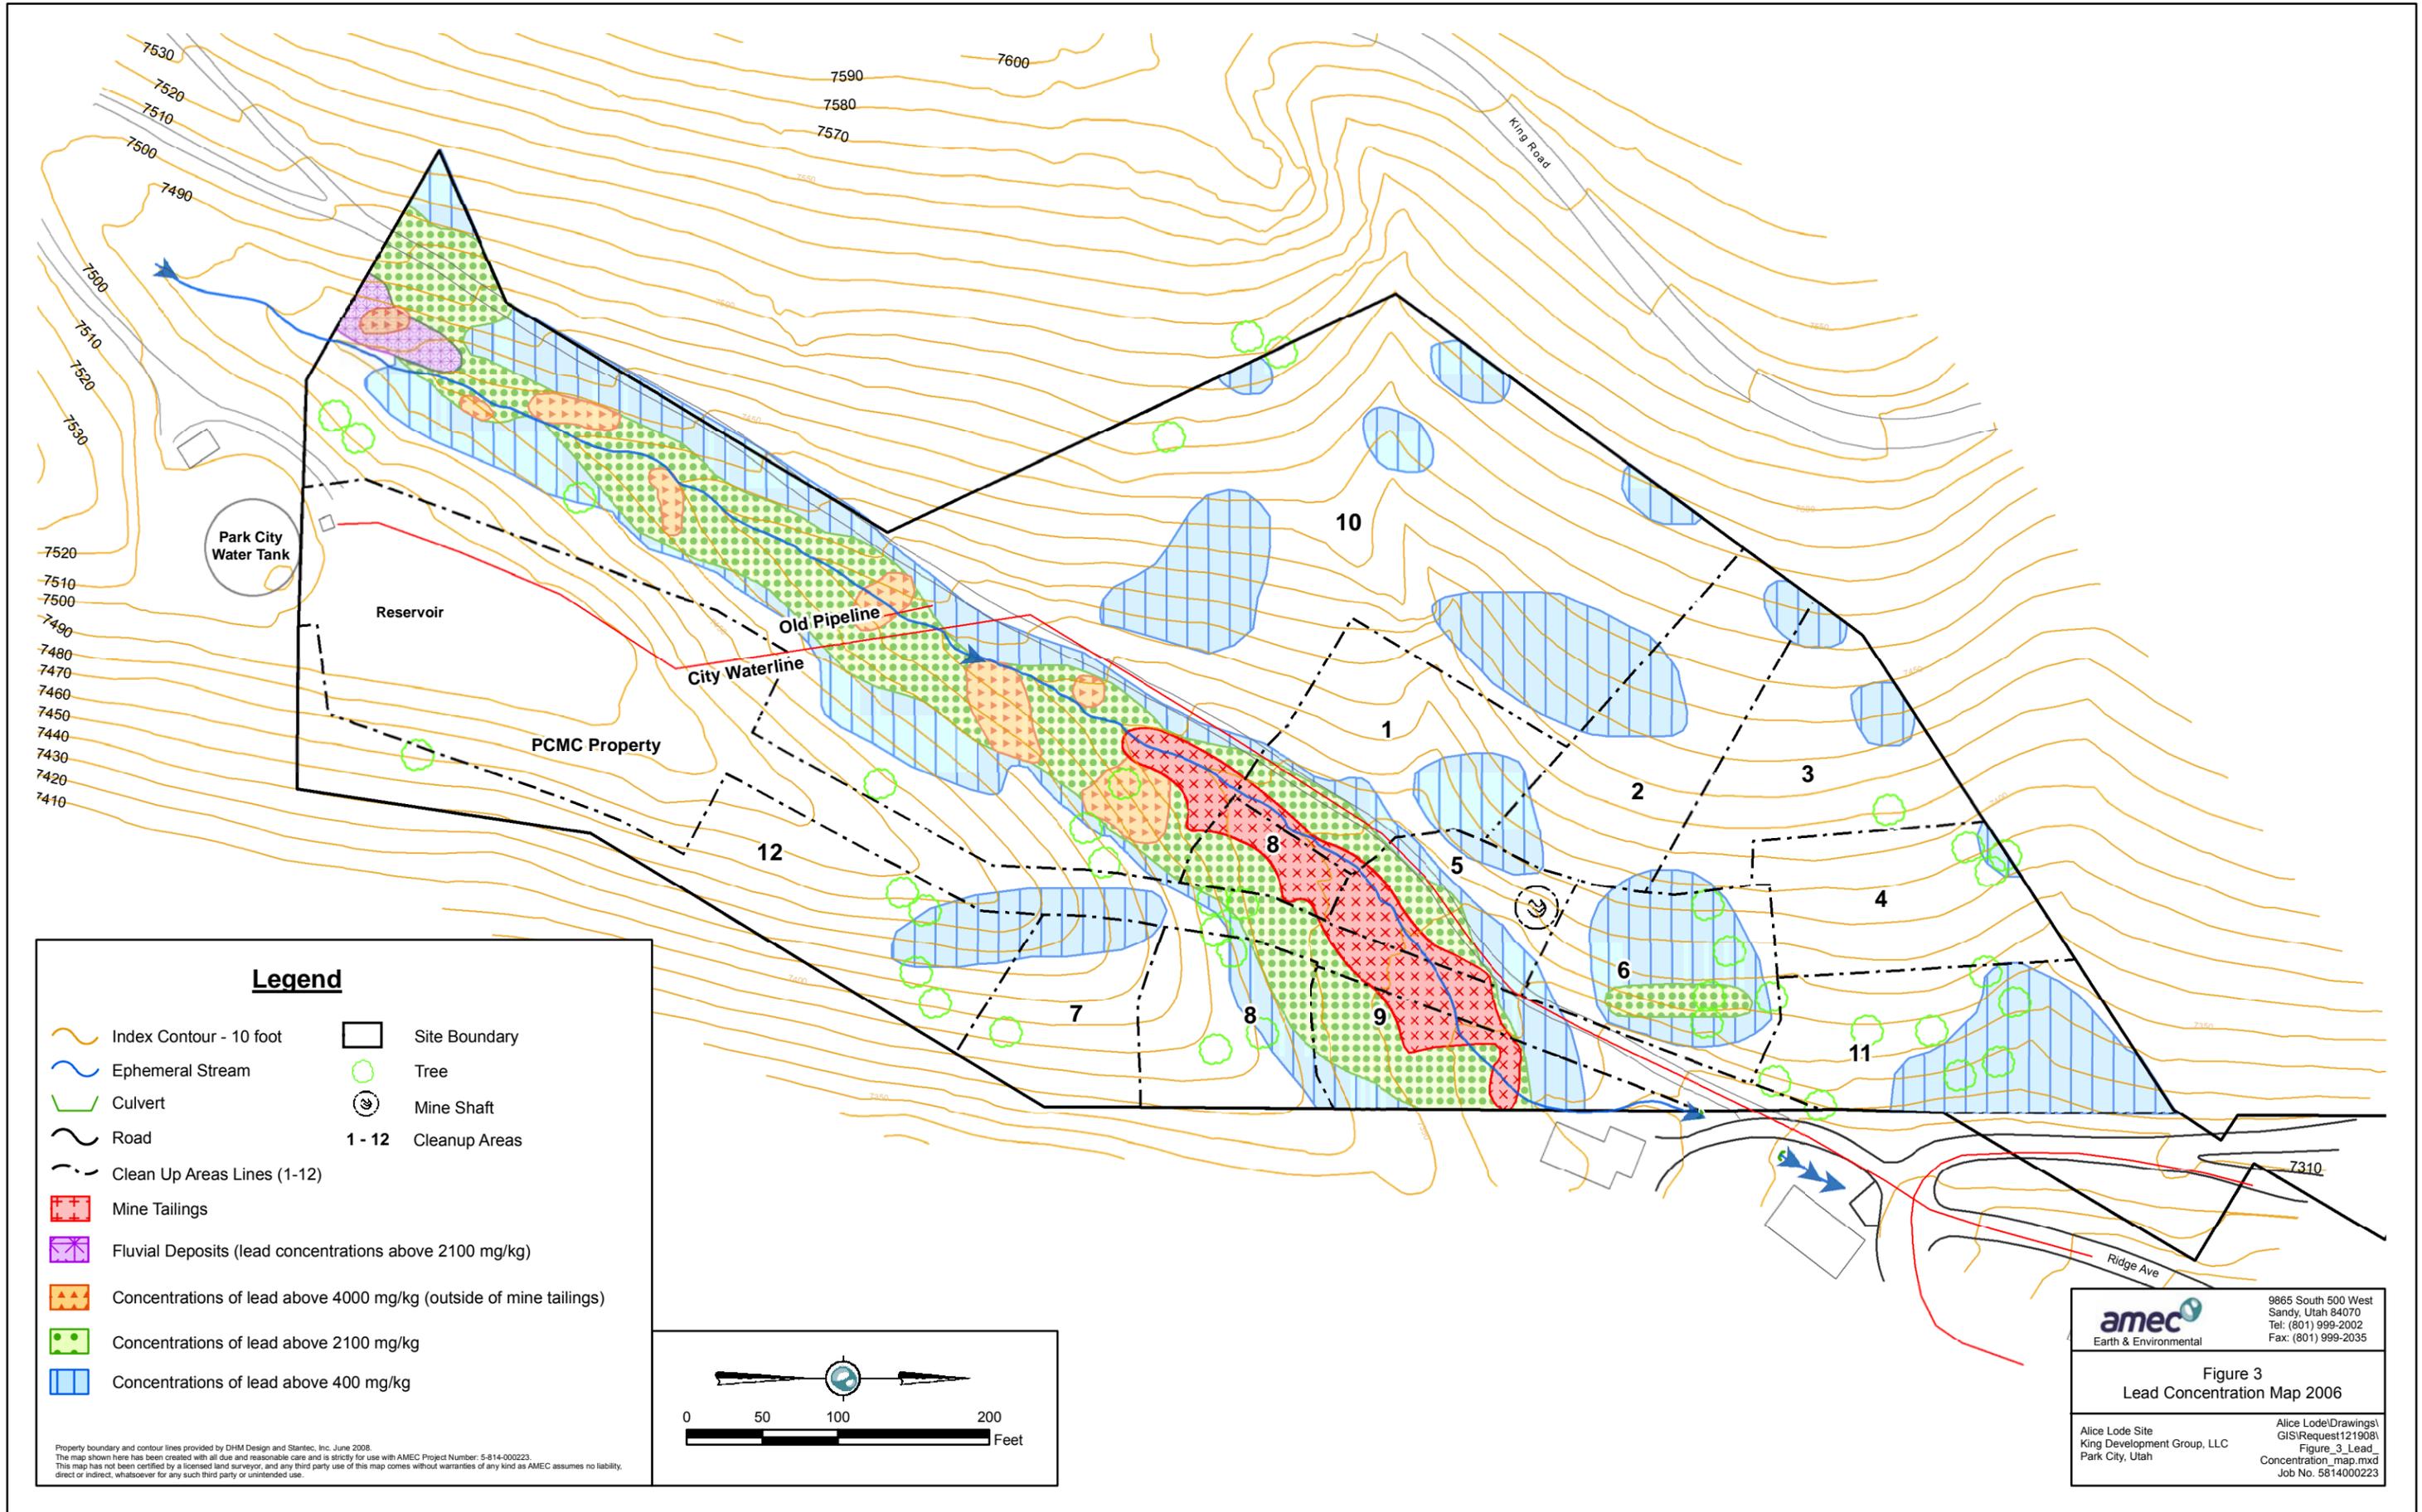
**Figure 3**  
 Lead Concentration Map 2006

**Figure 3** shows lead concentrations prior to mitigation in the surface soils at the Site. Cleanup areas were assigned numbers or areas configured within the future nine lot single family home subdivision as presented in the Site Mitigation Plan.

Flood deposits within the upper stream bed area had lead concentrations greater than 4,000 mg/kg and are shown on **Figure 3**. An access point was cut into the west slope of the stream bed area to access the flood deposits for removal. The impacted soils were removed to approximately two feet bgs totaling approximately 500 cubic yards of export material to Richardson Flats Repository. The streambed area was then capped with 12-inches of clay import material and import natural rock rip rap. The access point and on either side of the streambed was rehabilitated utilizing import material and import natural rock rip rap for reconstruction of the slope, seeded, and covered with erosion control mats.

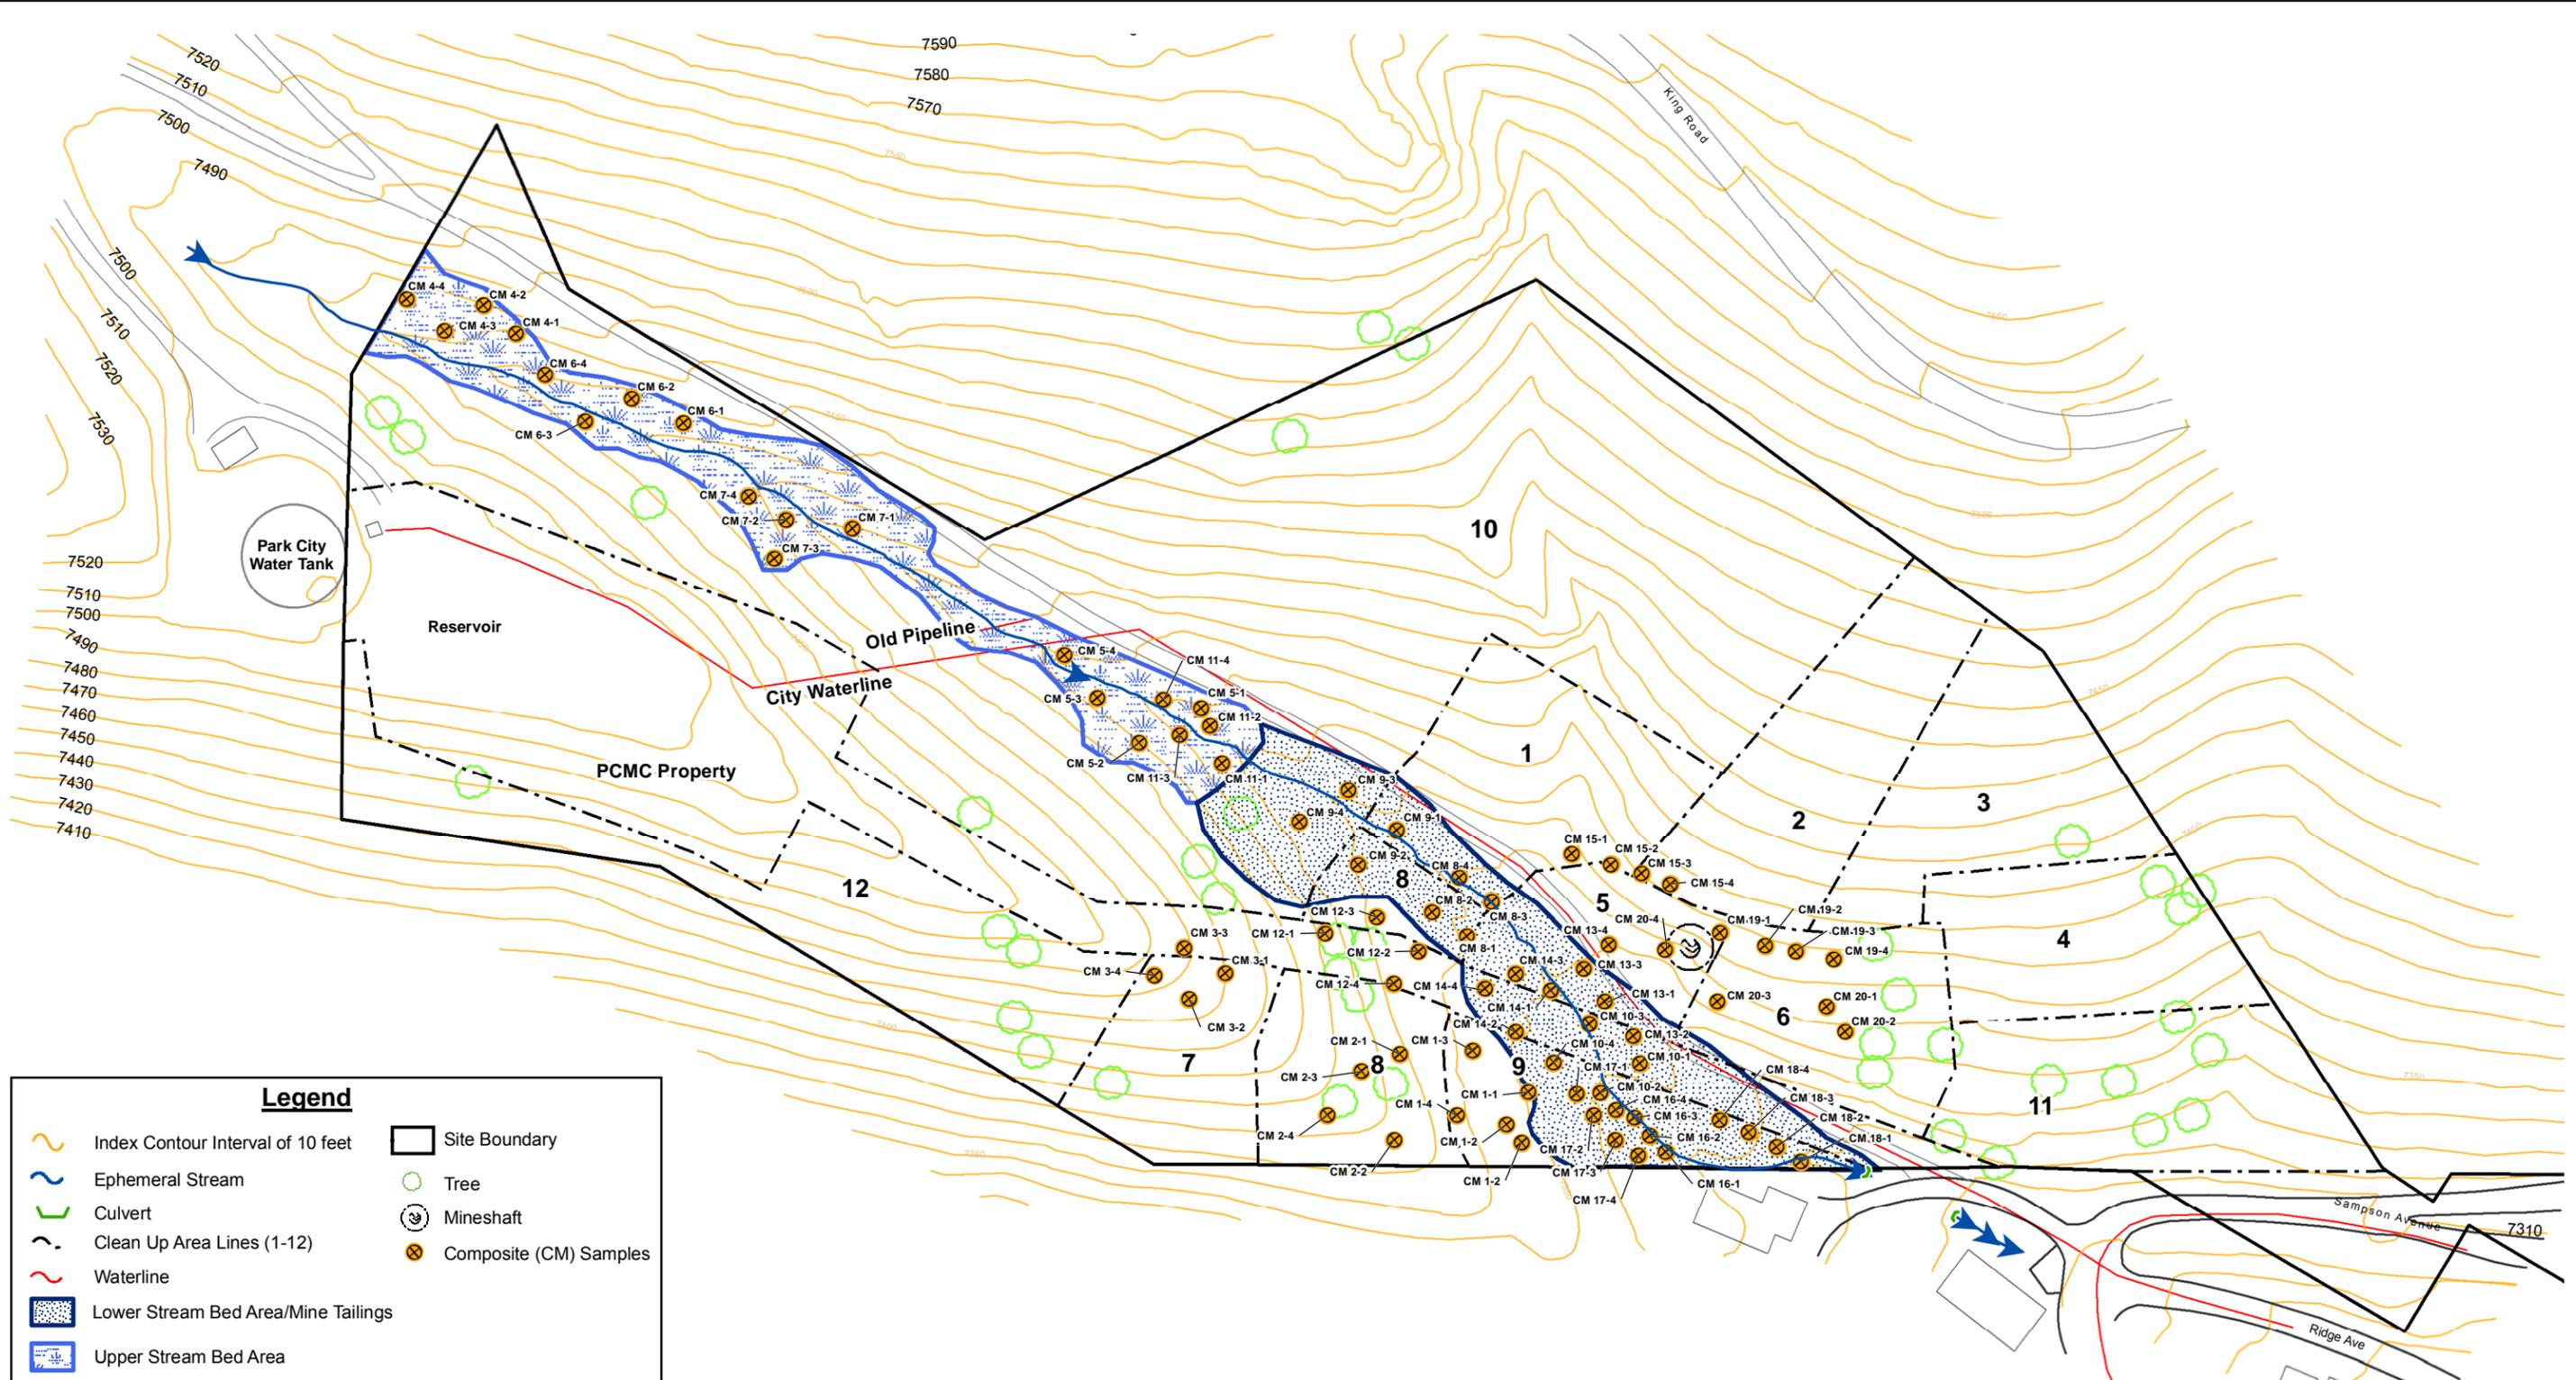
**Figure 4**  
Initial Composite Samples

concentrations left in place. Initial composite soil samples, with corresponding GPS location points, are shown on **Figure 4**.

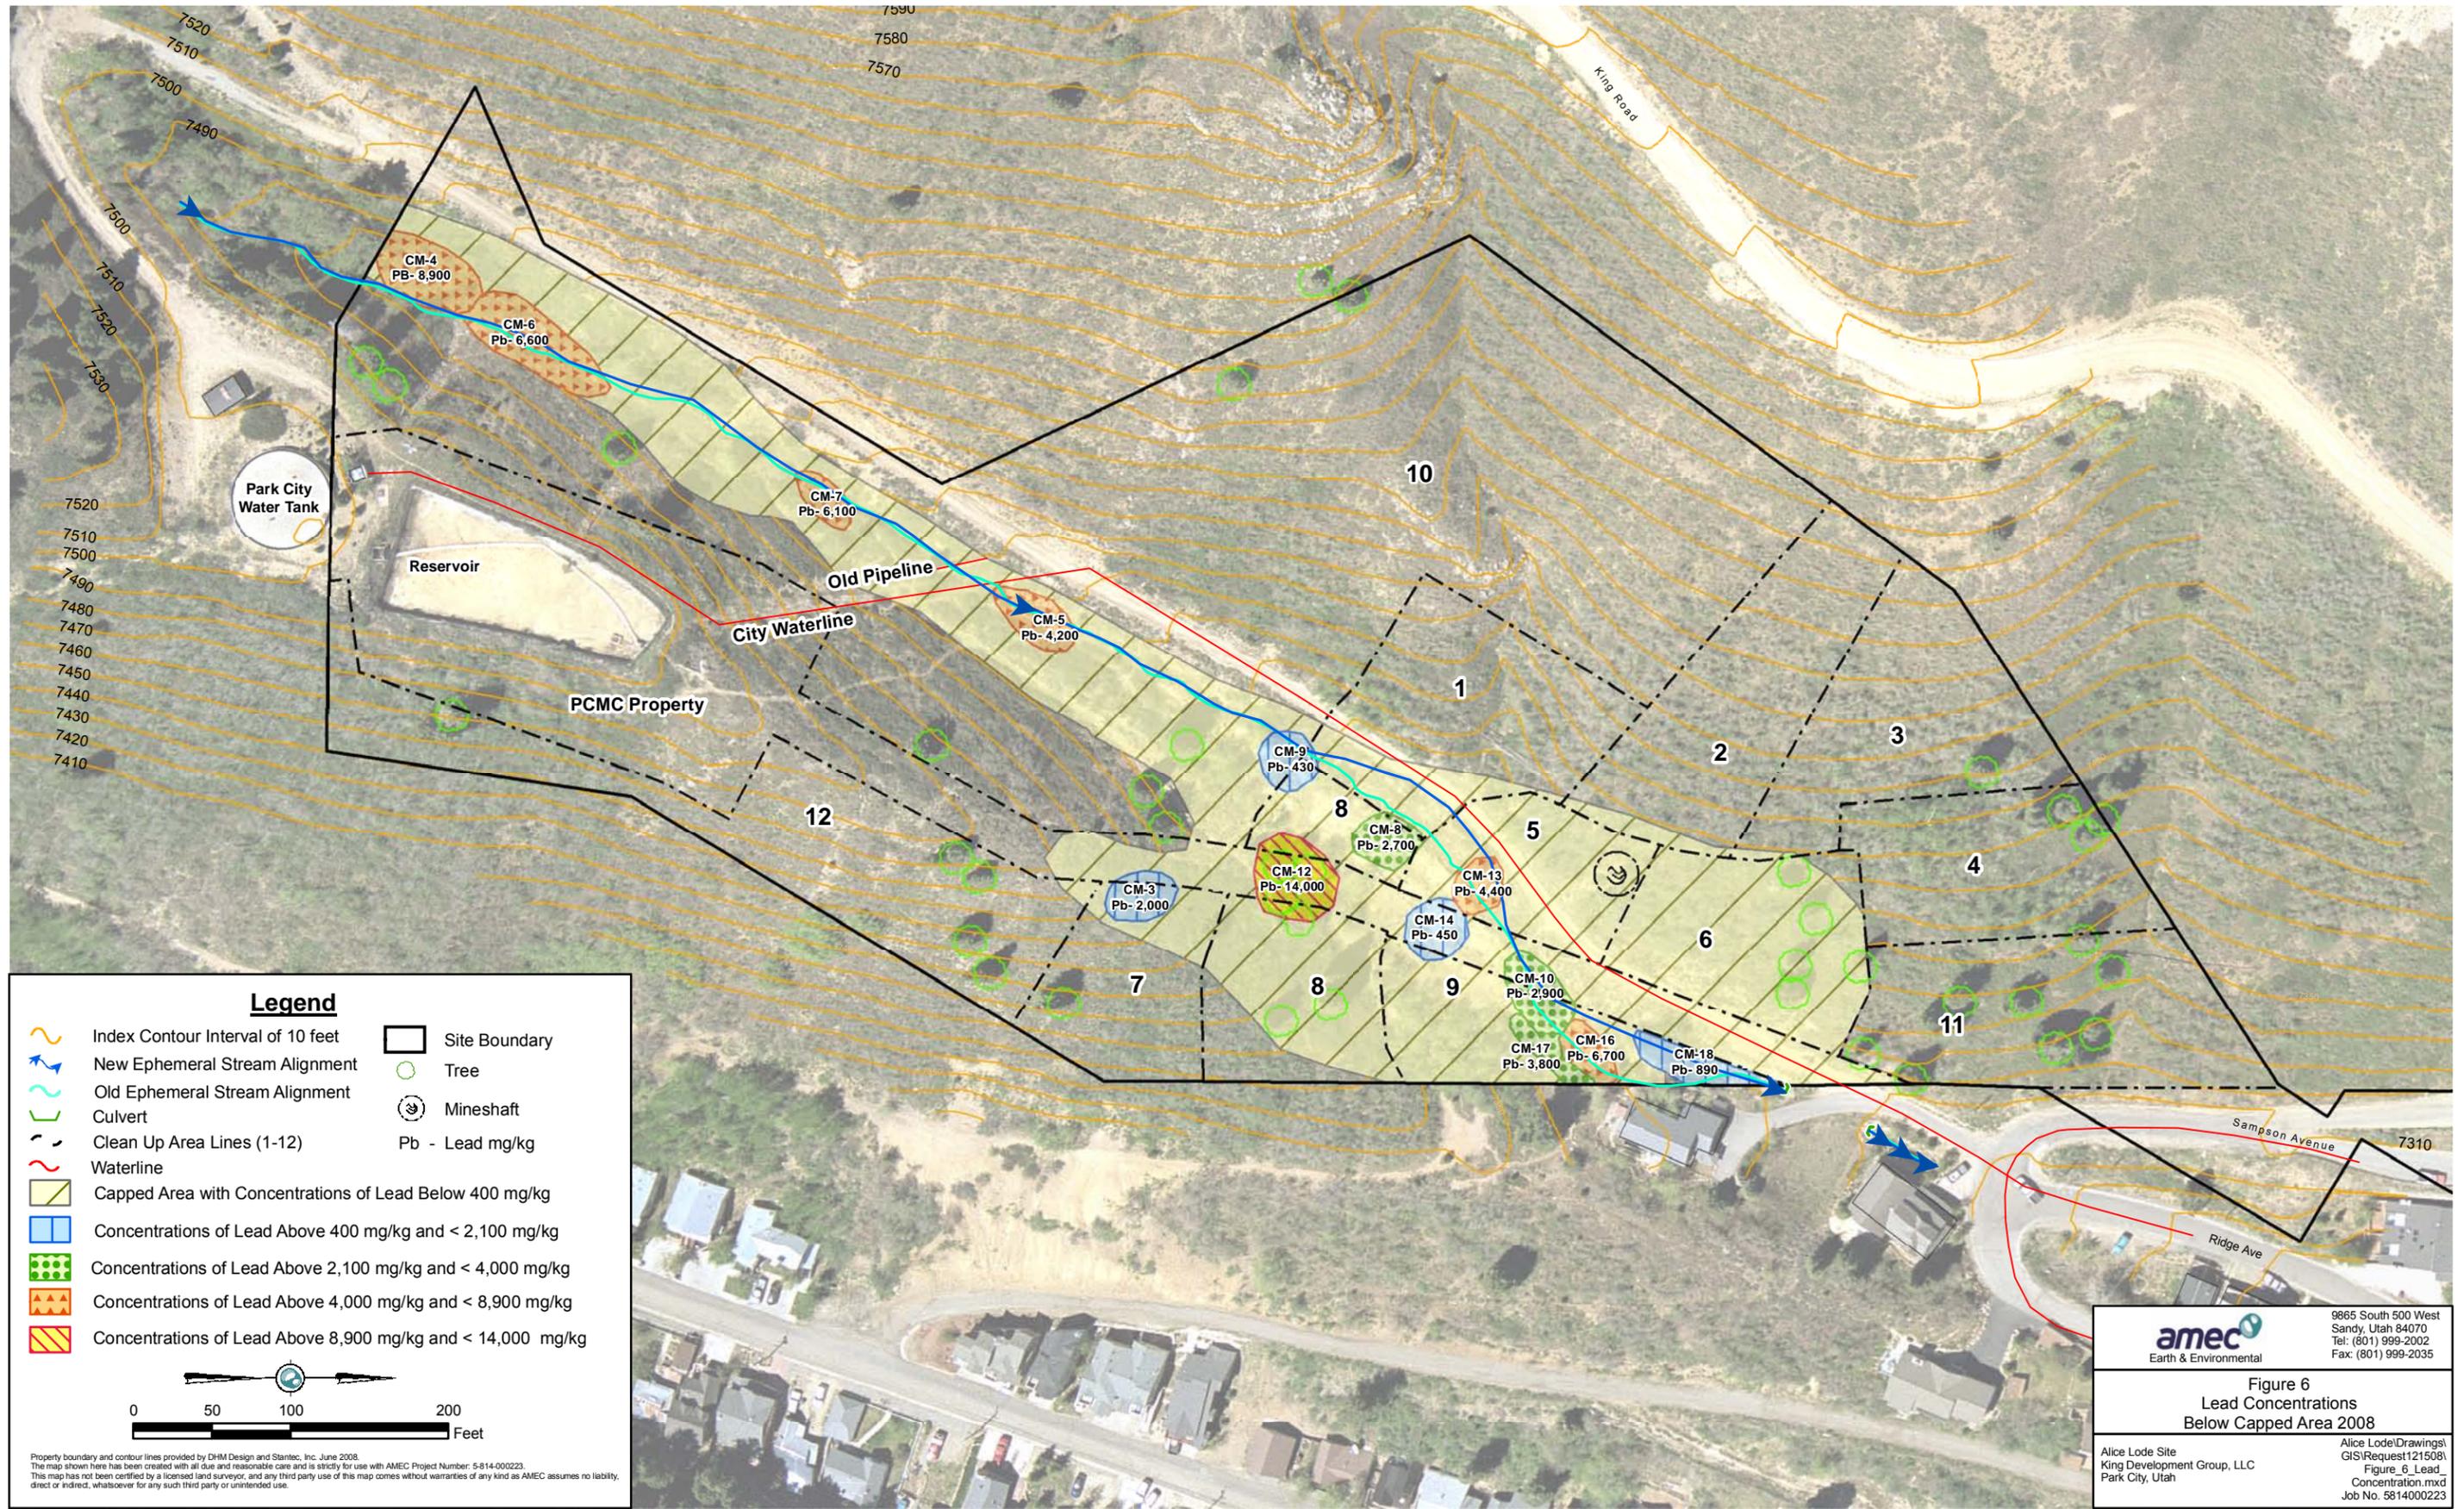
**Figure 6**  
 Lead Concentrations  
 Below Capped Area 2008

**Figure 6** shows soil lead concentrations that are present under the capped areas at the completion of mitigation activities in 2008. Lead concentrations greater than the residential action level of 400 mg/kg are present under the cap along the lower streambed area in PCMC and KDG properties. Samples points CM-10, CM-16, and CM-17 are located along the former streambed alignment where approximately one foot of capping material is present. Sample points CM-8, CM-9, CM-13, and CM-14 are located in the area where 10 feet of fill material was imported. The sample CM-12 is located in the area of spruce trees that topsoil was removed until tree roots were encountered. Additional removal of topsoil would likely kill the trees. The upper streambed has four locations CM-4, CM-5, CM-6, and CM-7 with soil lead concentrations under the cap above 400 mg/kg.

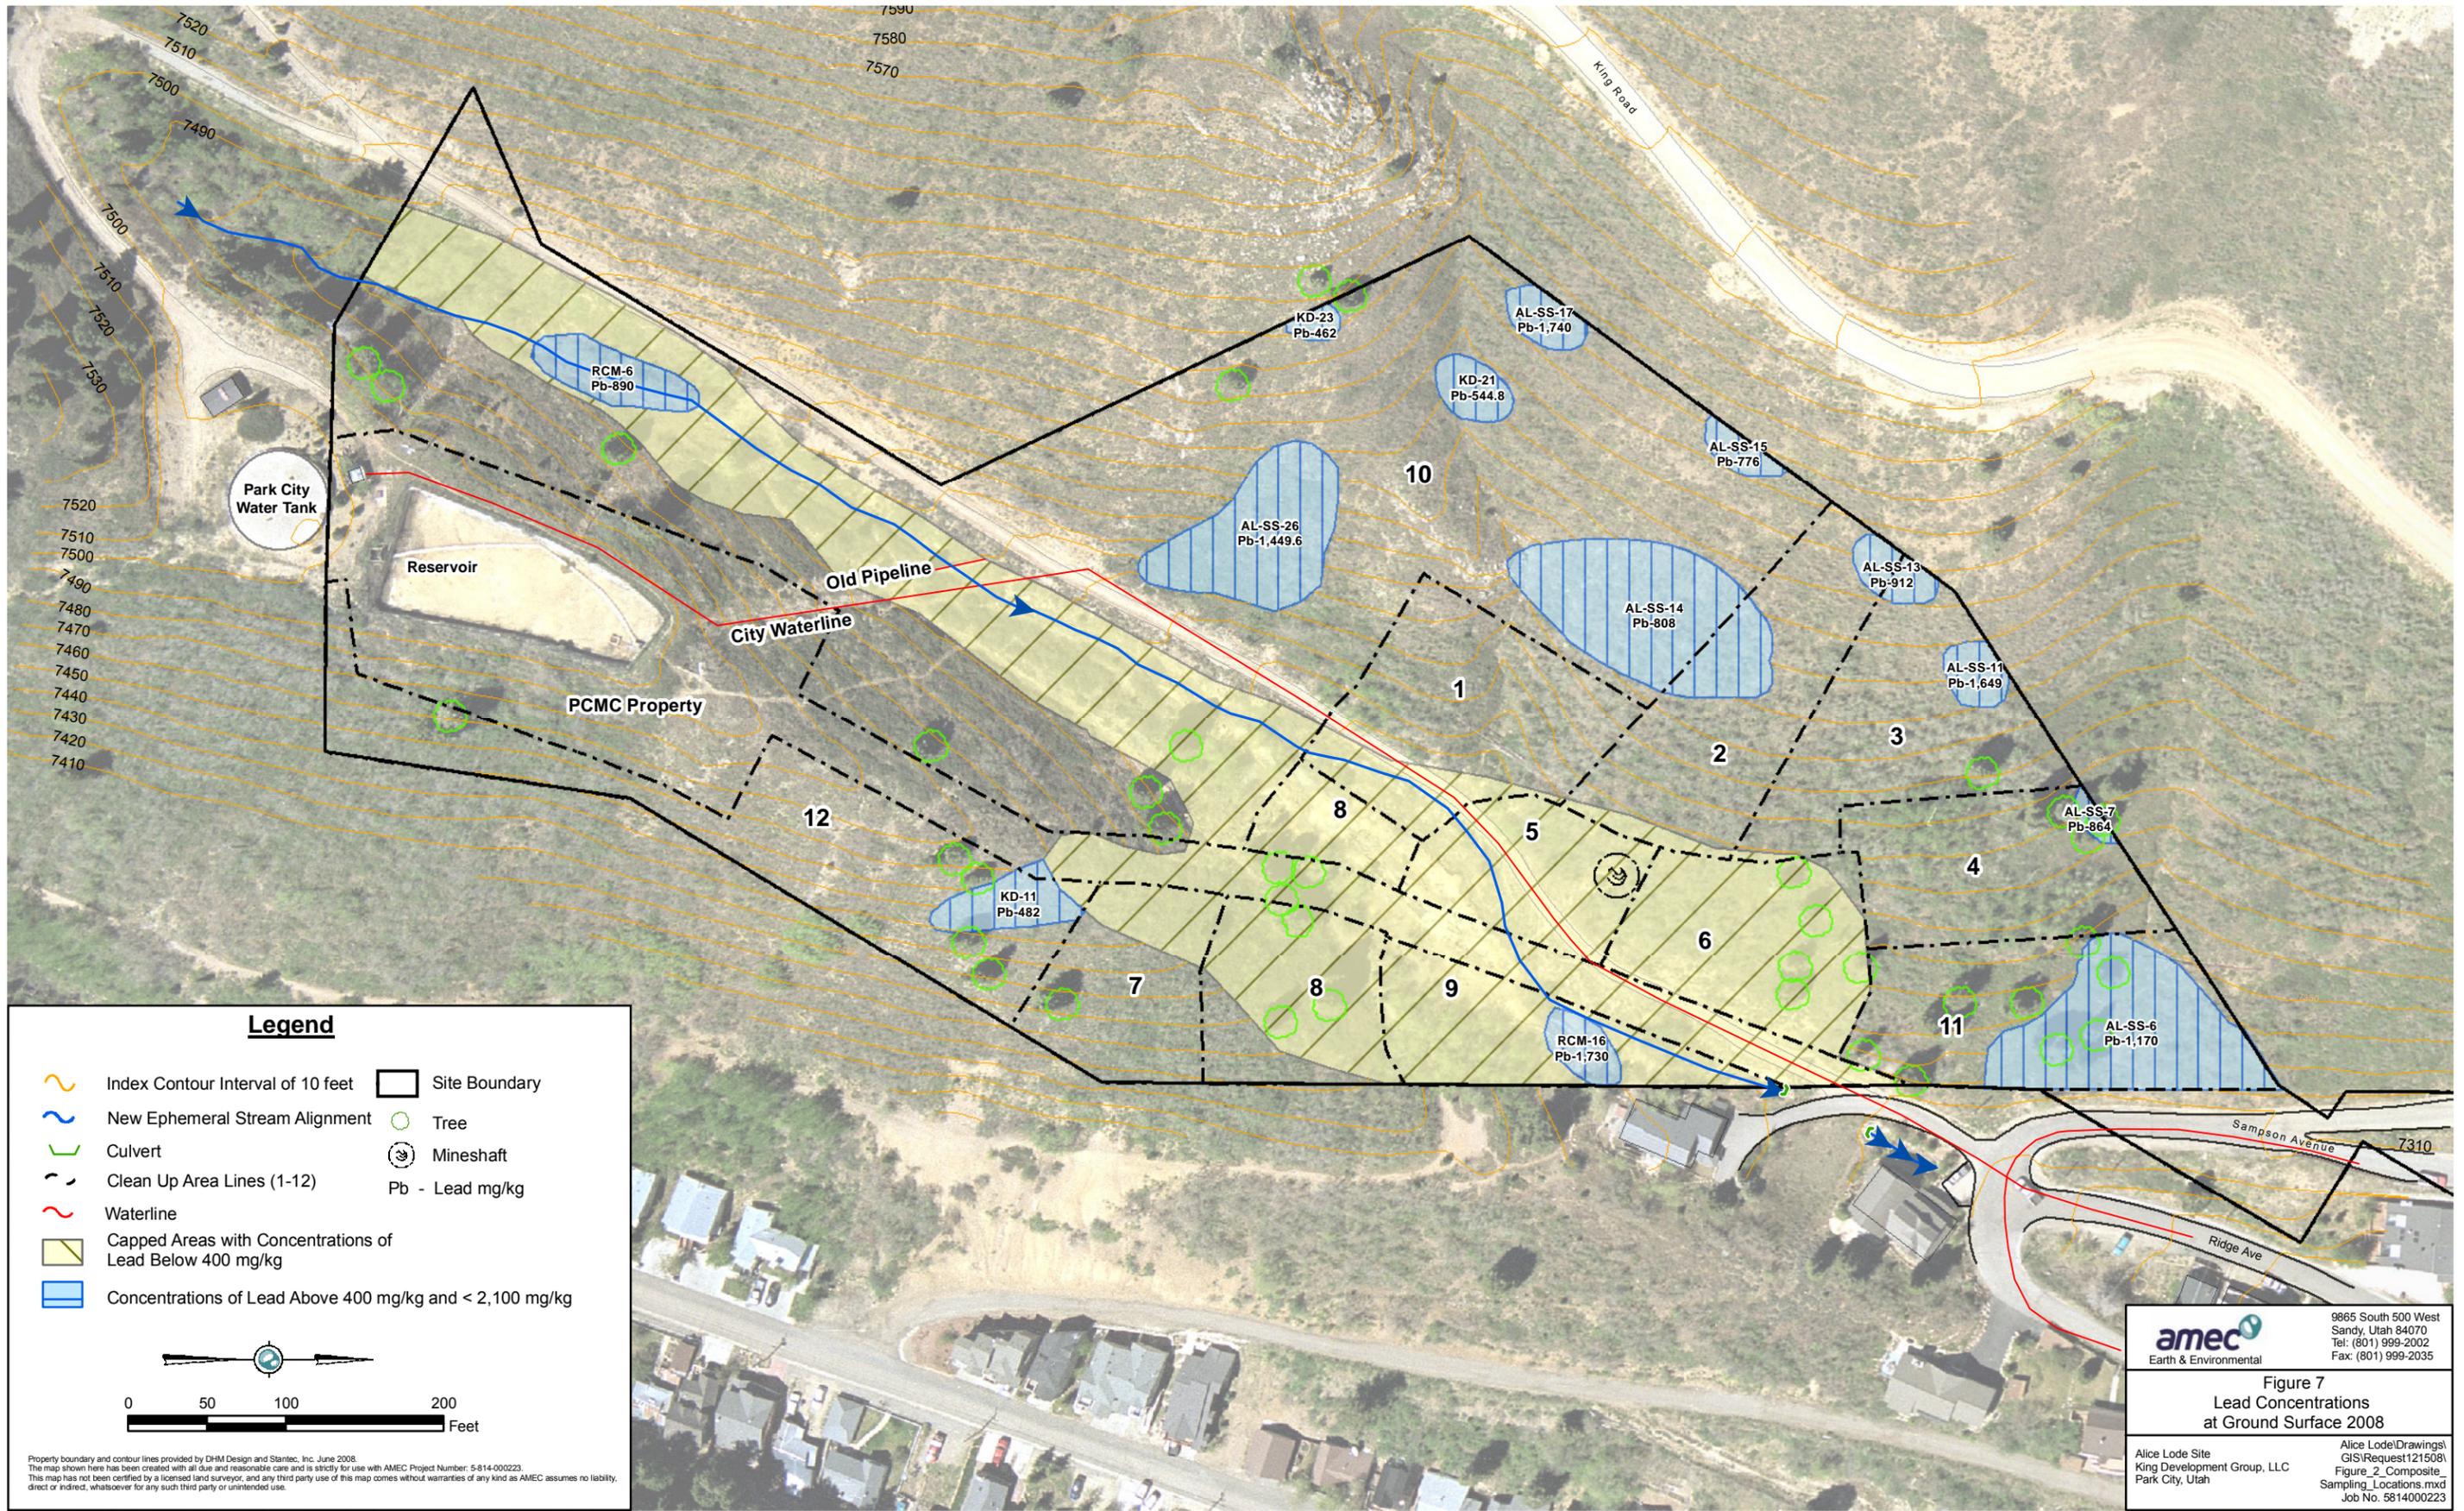
**Figure 7**  
 Lead Concentrations  
 at Ground Surface 2008

**Figure 7** shows soil lead concentrations at the ground surface in areas that have been mitigated and areas that have not been mitigated. Lead concentrations greater than the residential action level of 400 mg/kg in the surface soil cap in Area 9 and upper streambed are present at sample locations RCM-6 and RCM-16. This may be due to possible cross-contamination with underlying material during placement of the cap. Lead concentrations in the surface soil above the residential screening level of 400 mg/kg are present in Areas 2, 3, 4, 10, 11, and 12.
