Potential Impacts of Proposed Development

Prepared for CRH Partners
Park City, Utah

By A. Jason Barto

March 31, 2017

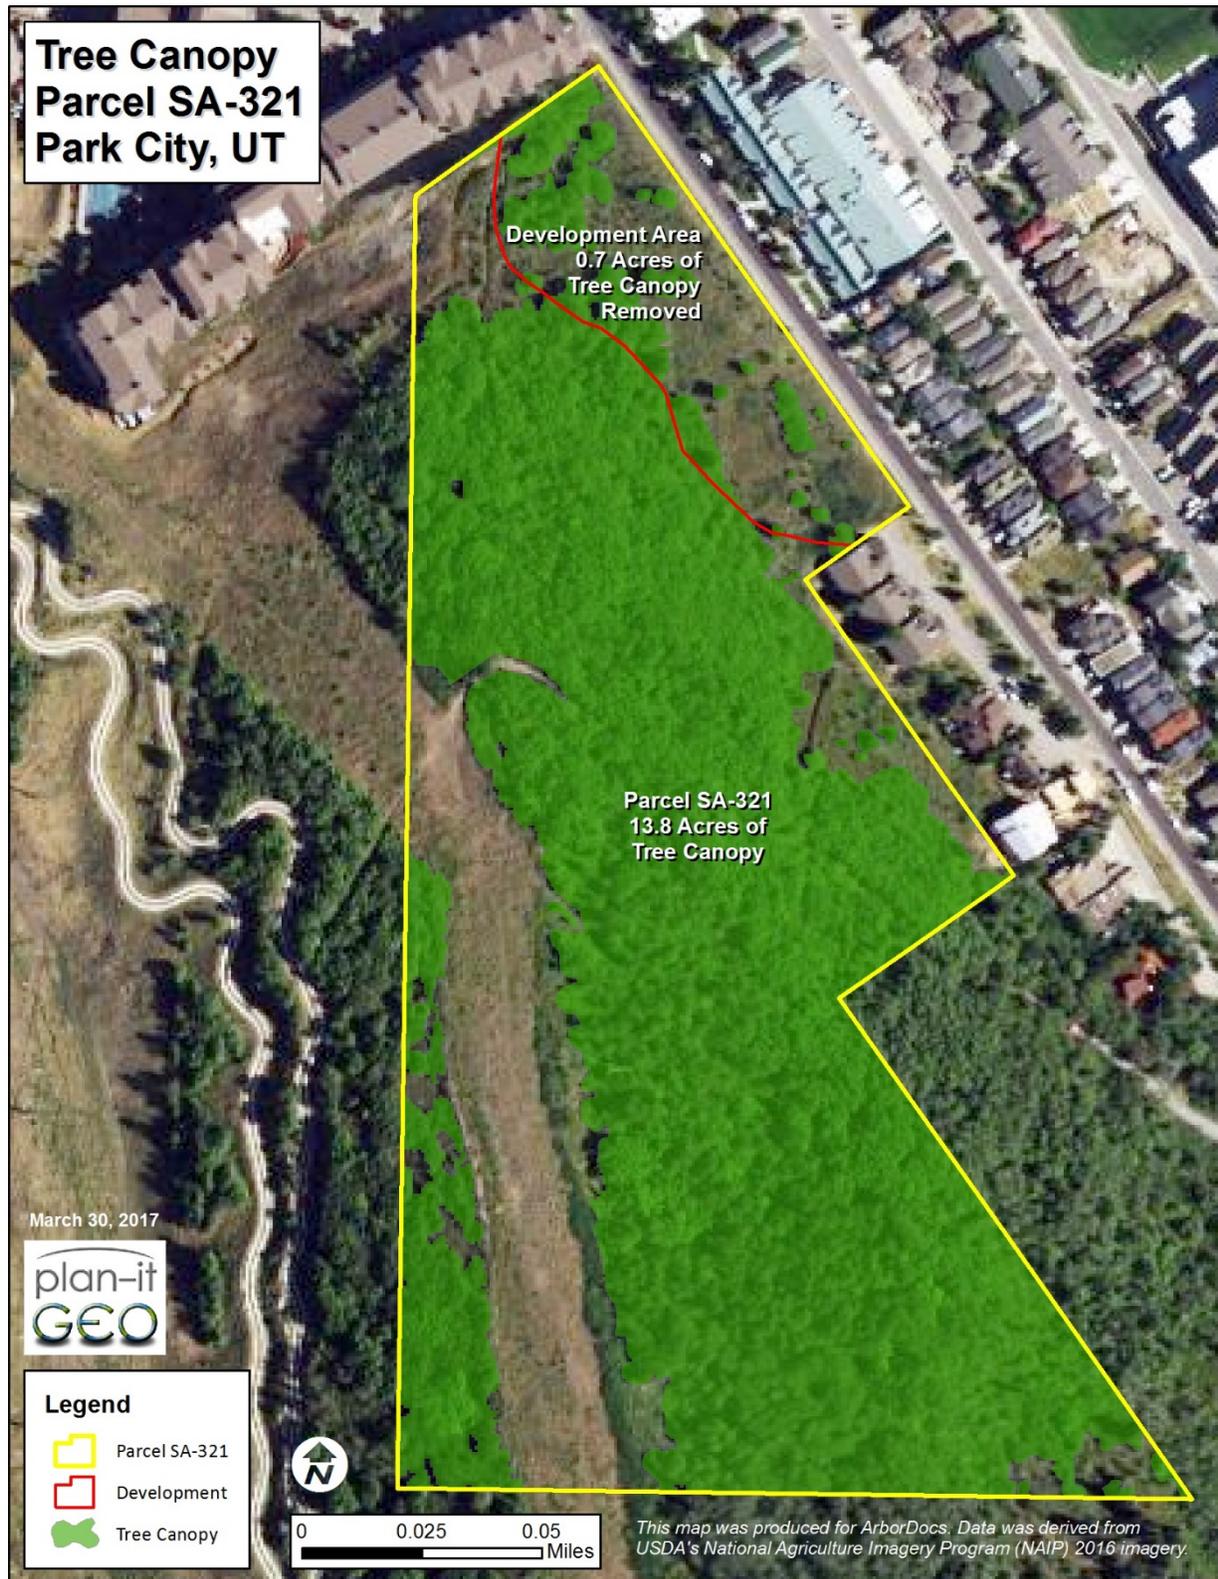
APPENDIX A-SITE PLAN

1. The lot is listed by Summit County as SA-321.
2. The lot is a predominantly East facing aspect.
3. The road frontage is Lowell Avenue 1201-1299
4. The total tree coverage of the entire lot is 13.8 acres. (Appendix A)
5. The area potentially impacted by construction has a canopy cover of 0.7 acres. (Appendix A)

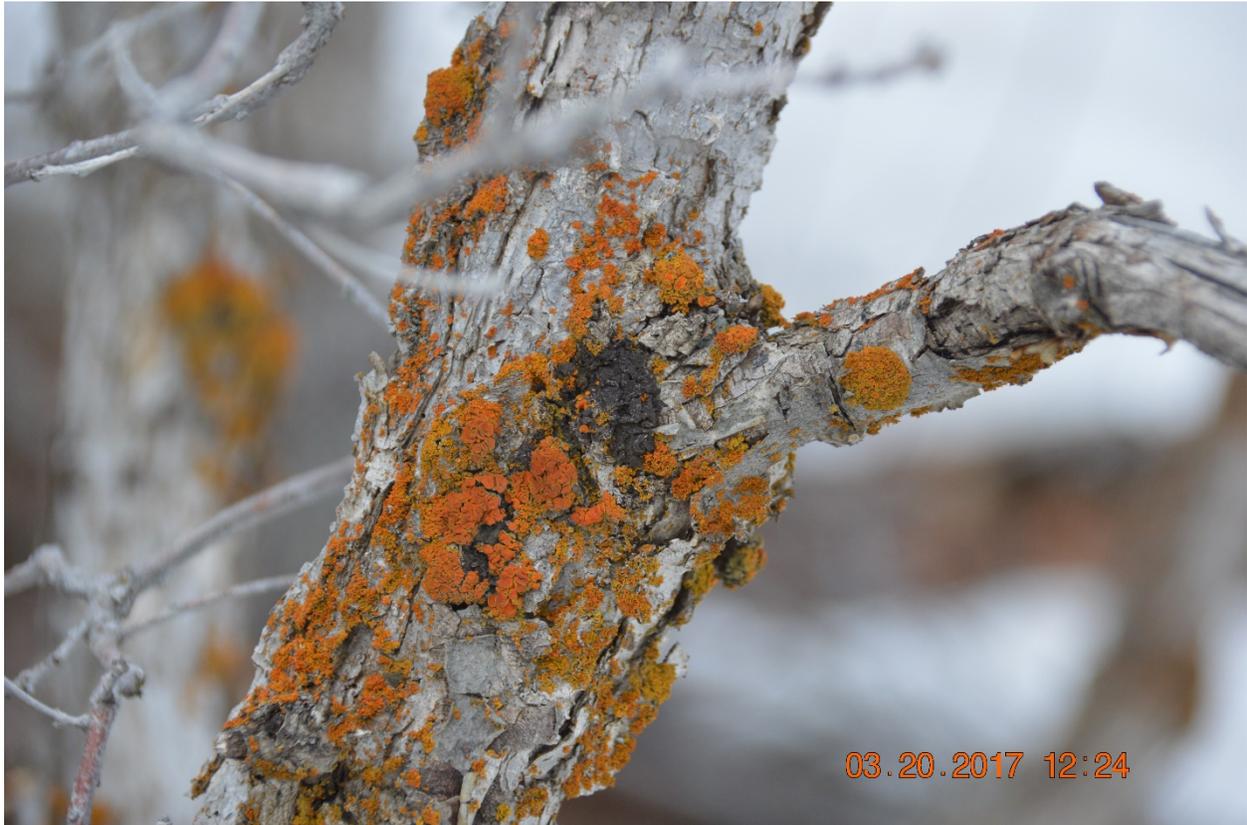
1. Many of the trees appear to be “mature.”
2. Many of the trees have dead and broken limbs.
3. Many of the trees have black and orange lichen growing on the bark and branches. (Photos 13-15)

The appearance of black and orange lichens suggest that tree growth has slowed and that the trees have previously may have had reduced vigor due to environmental conditions such as prior drought. No core samples were taken to pinpoint exact age.

Photo 13- Orange and Black Lichen

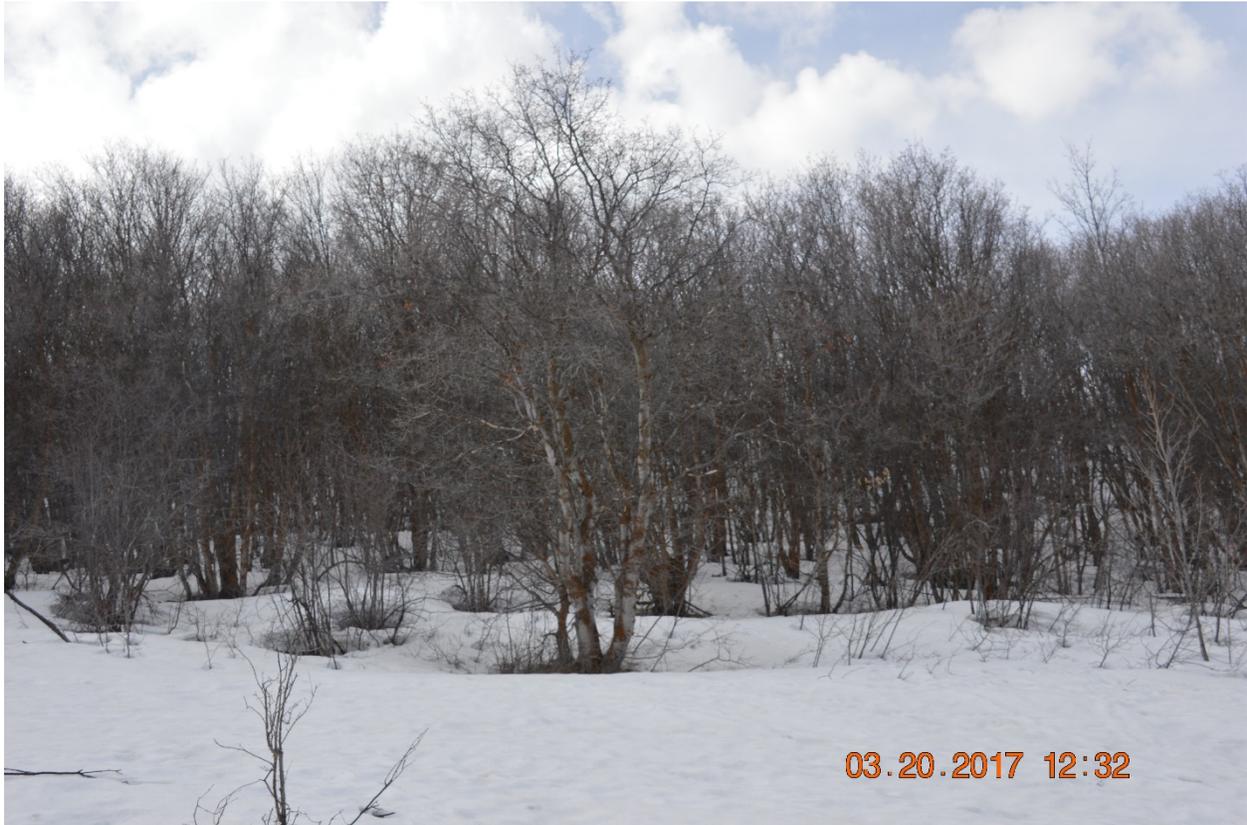
1. The trees are predominantly Bigtooth Maple (*Acer grandidentatum*) with some Gambel Oak (*Quercus gambelii*).
2. Many of the trees have codominant stems. (Photos 14-16)
3. Many of the trees are 15' to 25' tall.
4. The largest "single" trunk measured 13.5" DBH (Photo 16)

Photo 14- Orange Lichen and Codominant trunks

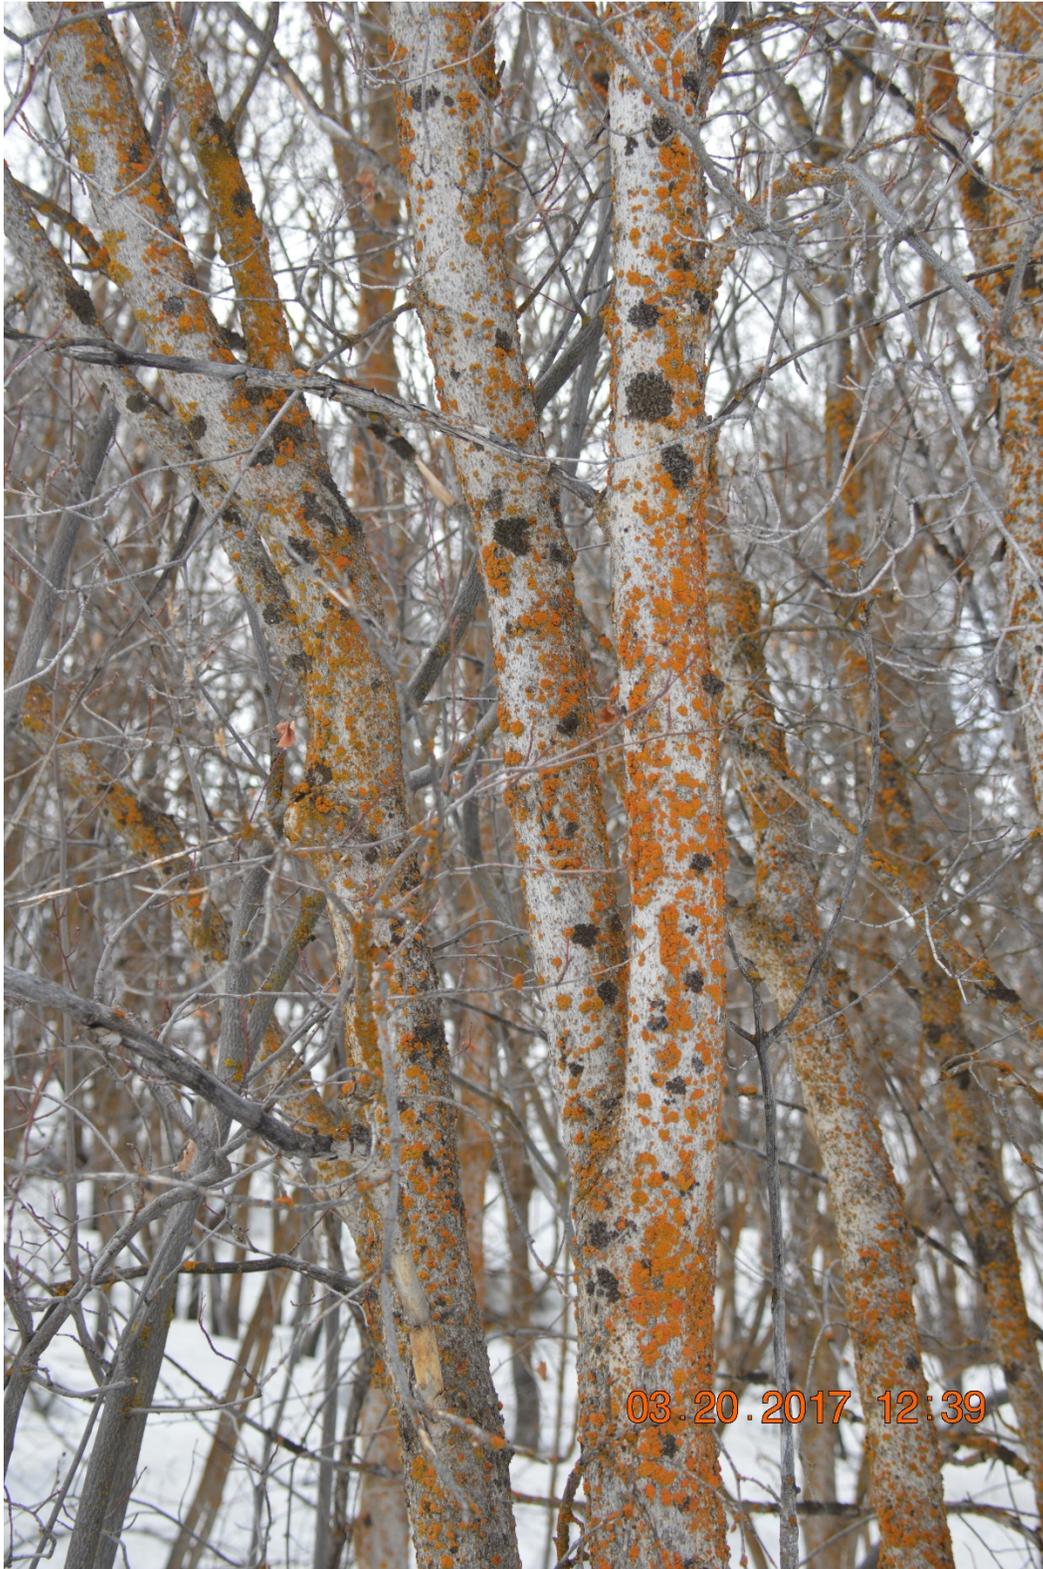
Photo 15- Orange and Black Lichen. Codominant trunks

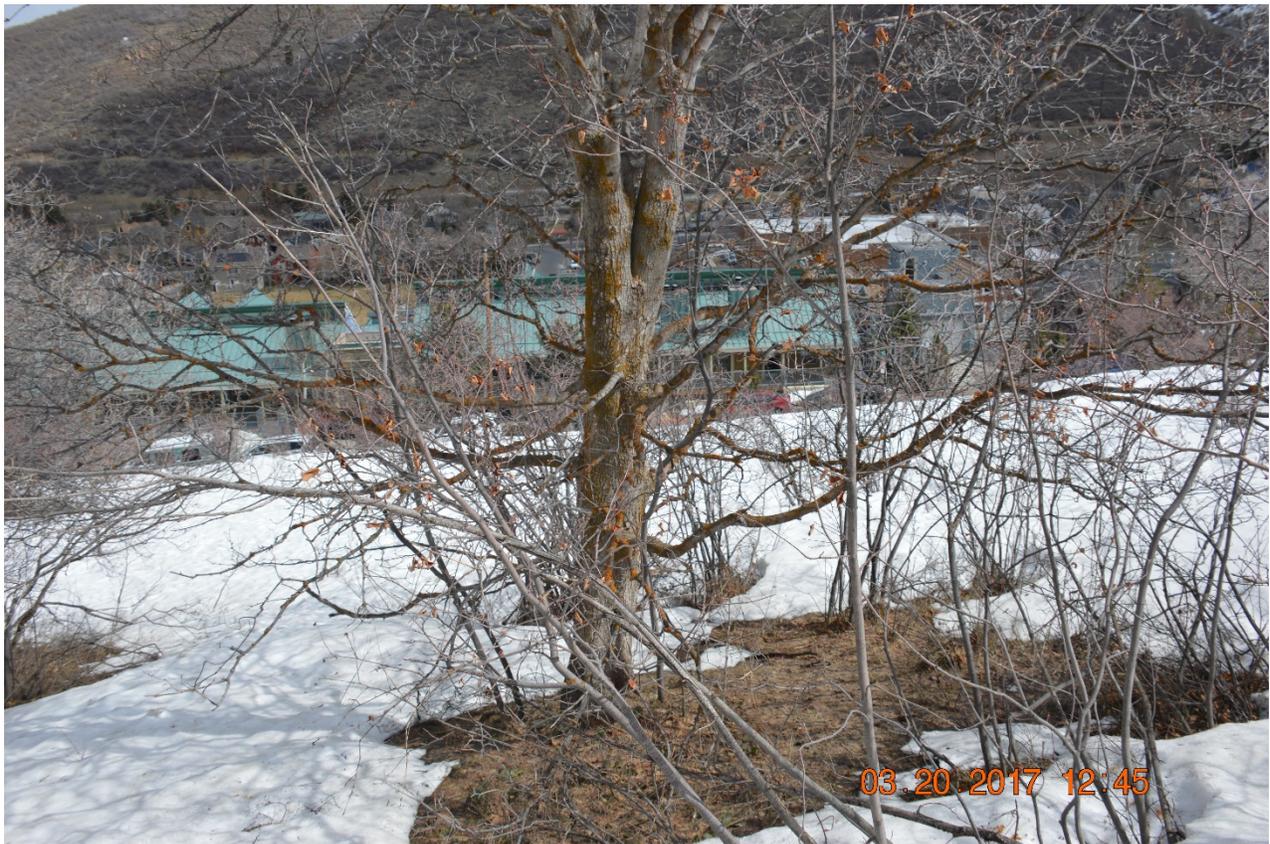
Photo 16- Codominant trunks-13.5" DBH Bigtooth Maple

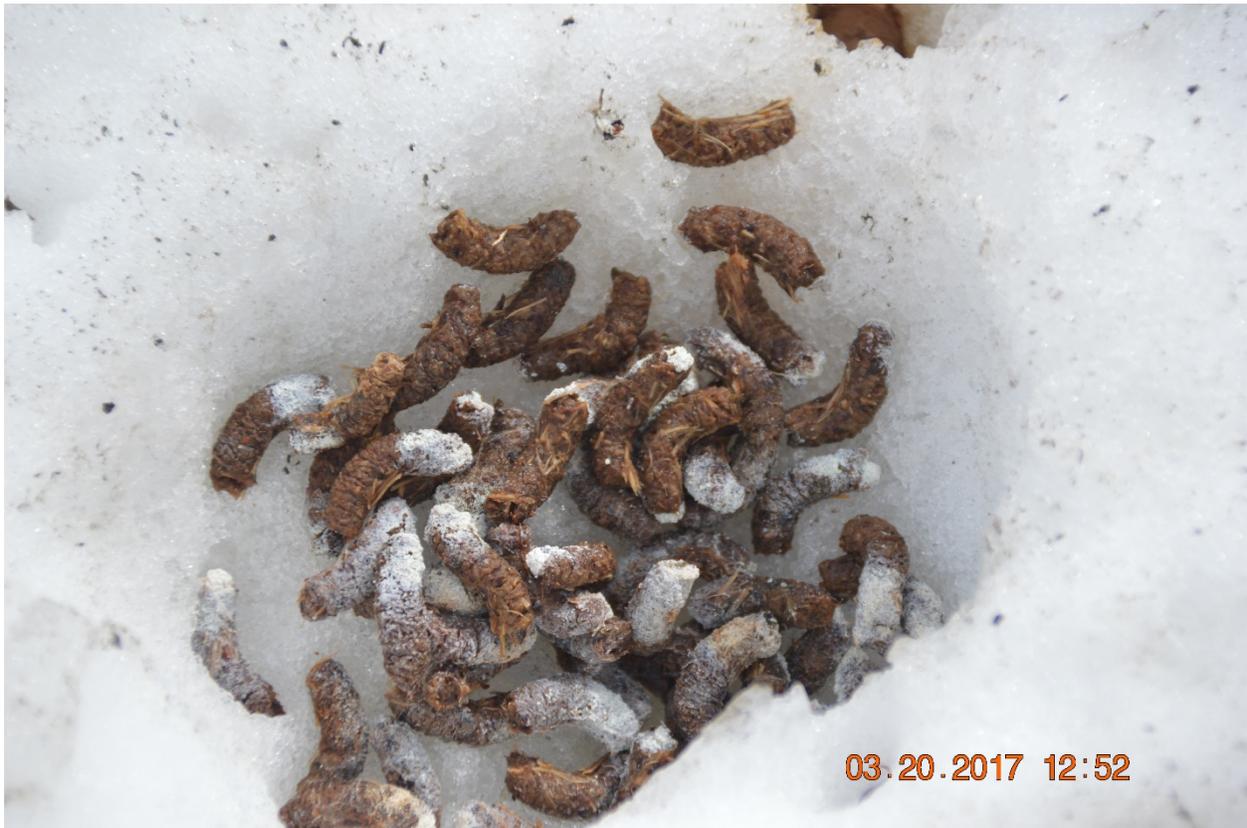
1. No wildlife nor tracks were observed on either site visit.
2. Wildlife scat was observed on the March 20, 2017 visit. (Photos 17 and 18)

Photo 17- Unidentified animal scat

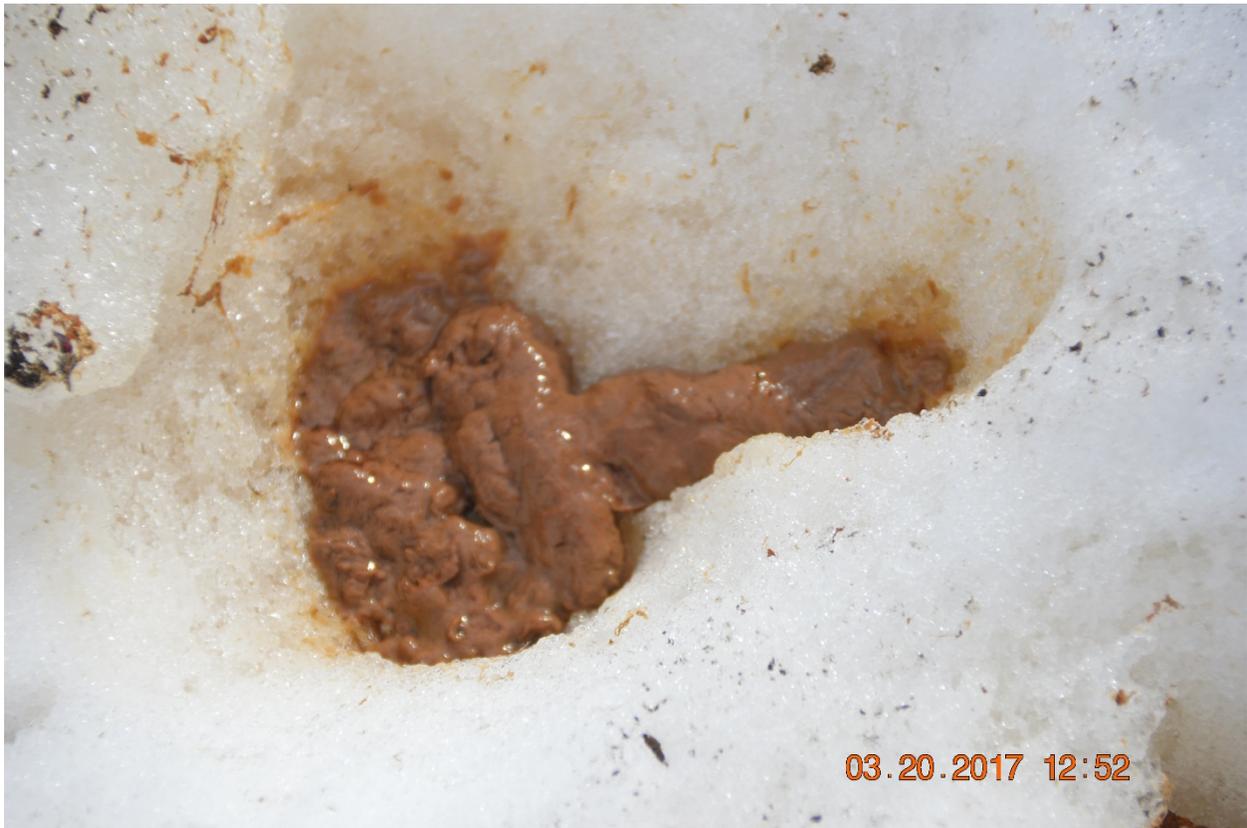
Photo 18- Unidentified animal scat
