**Historic Preservation Board
Staff Report**

Subject: 1063 Norfolk Avenue
Author: Christy Alexander, Planner
Date: September 18, 2013
Type of Item: Historic District Grant
Project Number: PL-13-02051

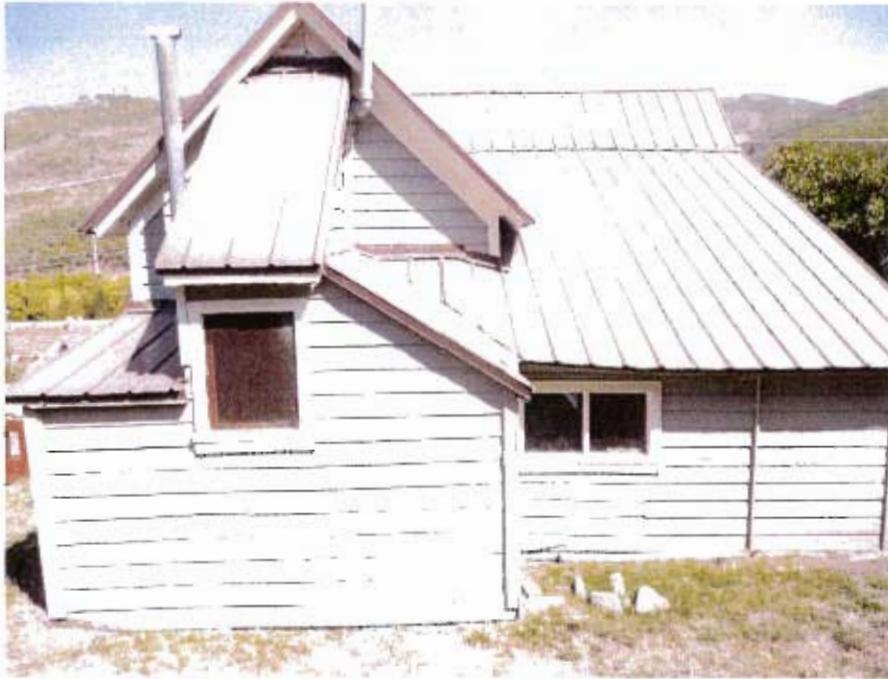
ROOF. Existing Metal Roof viewed from rear.

Roofing. The applicant is proposing to replace the existing roof with new metal roofing. The proposed work includes lifting the existing structure, placing it back on the new foundation, adding structural members from the inside to bolster existing framework to meet current code, and replacing roof decking with metal roofing. The applicant has little information on what the actual costs of reroofing might be. They are requesting that this item be reviewed at a later date and considered for grant assistance when an accurate cost estimate can be obtained.

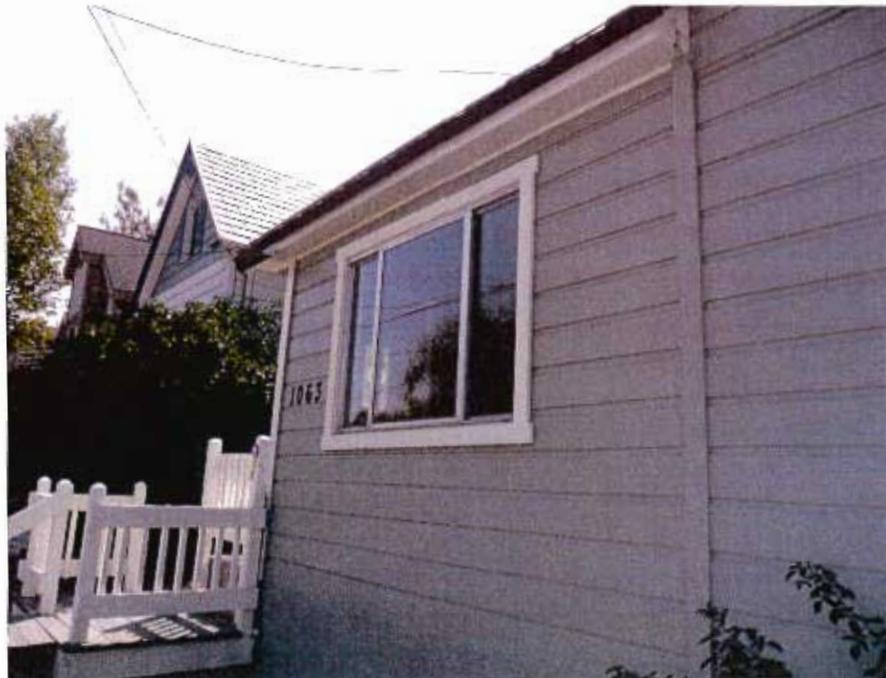
Design. The initial cross-wing frame house had a porch in its L. At some point between C. 1940 and 1995 the porch was enclosed, the roofline extended and the entrance moved to another elevation.

EXTERIOR WALL – PRIMARY FAÇADE. South-east side of house – existing front porch fill-in.

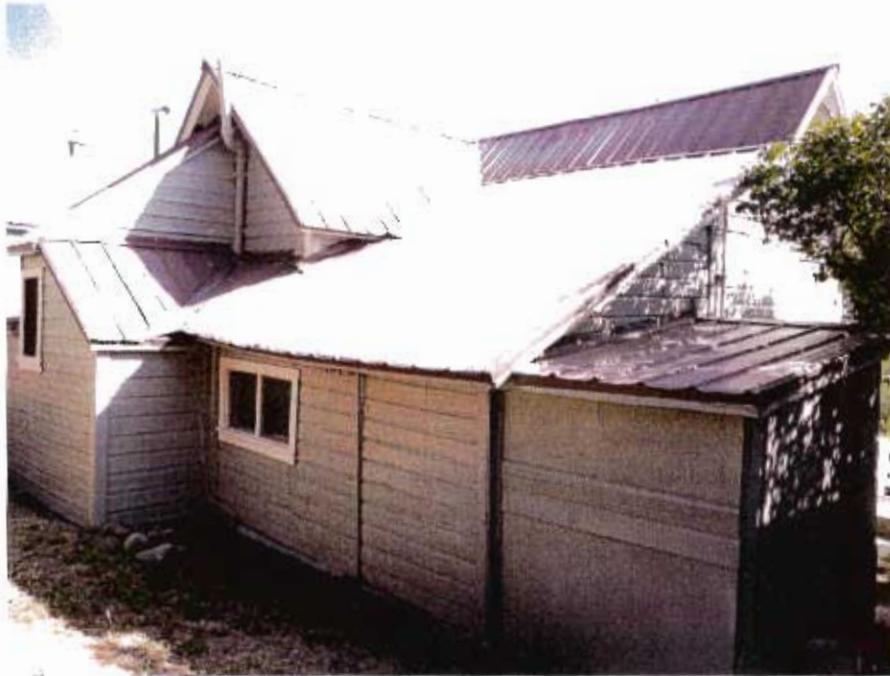
EXTERIOR WALL – REAR FAÇADE. Additions and siding condition.

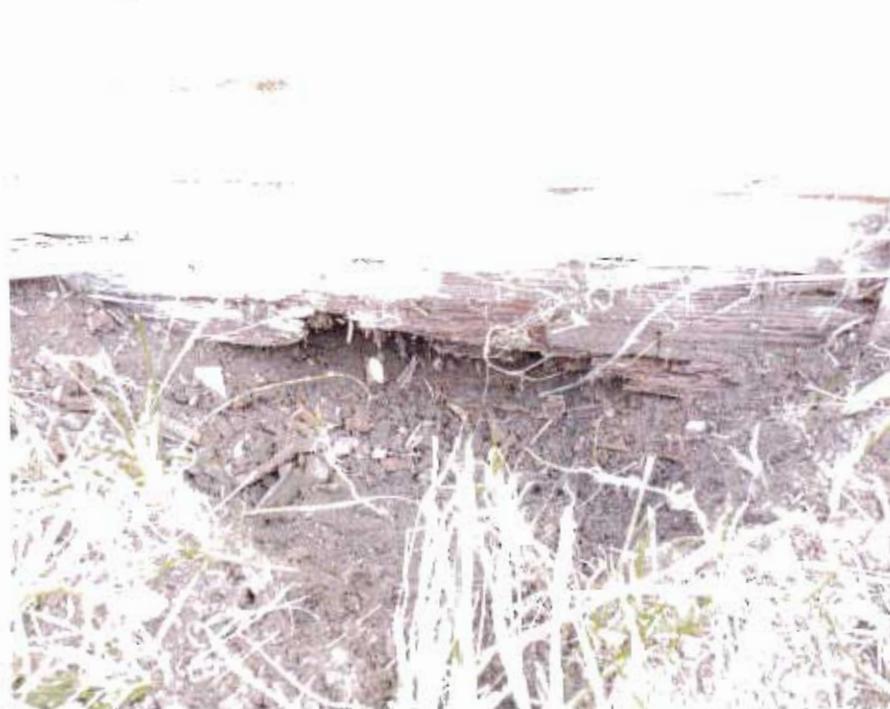
Foundation. The existing home has no foundation or even loose rocks beneath the flooring joists. As a result, significant settlement and rot has occurred at the sill plate level. The applicant proposes to brace and raise the house, dig and pour

FOUNDATION. Rotted sill plate on north side sitting on bare earth (no foundation).

a new basement foundation, repair and add structural flooring members and re-situate the home upon its new foundation. The excavation and foundation estimates relate to the entire project with a basement foundation and a rear addition. In order to estimate just the amount that pertains to grant eligible items (i.e. crawl space excavation and foundation), the contractors have provided the following information:

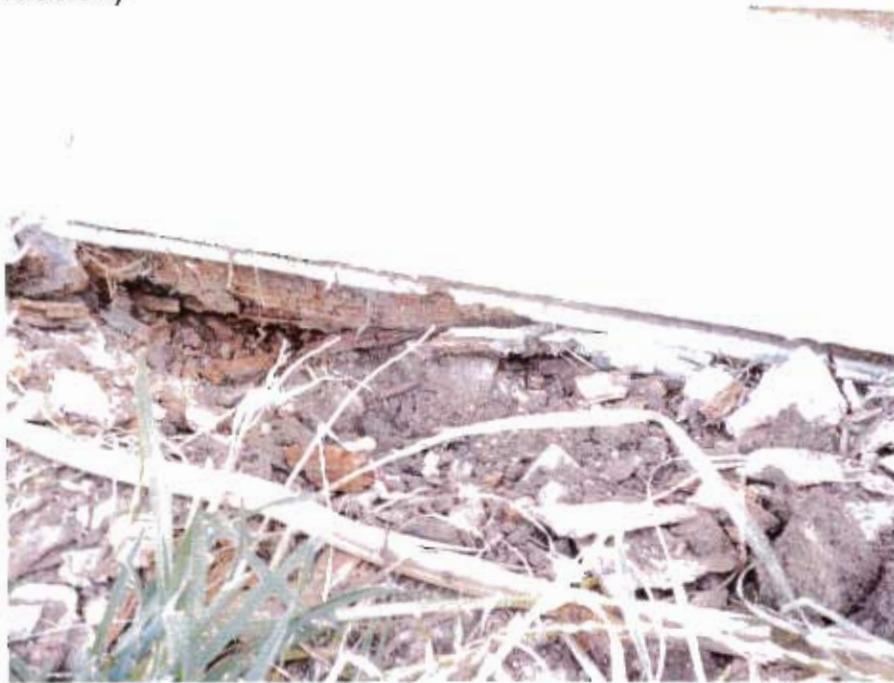
FOUNDATION. Rotted sill plate on south side sitting on bare earth (no foundation).

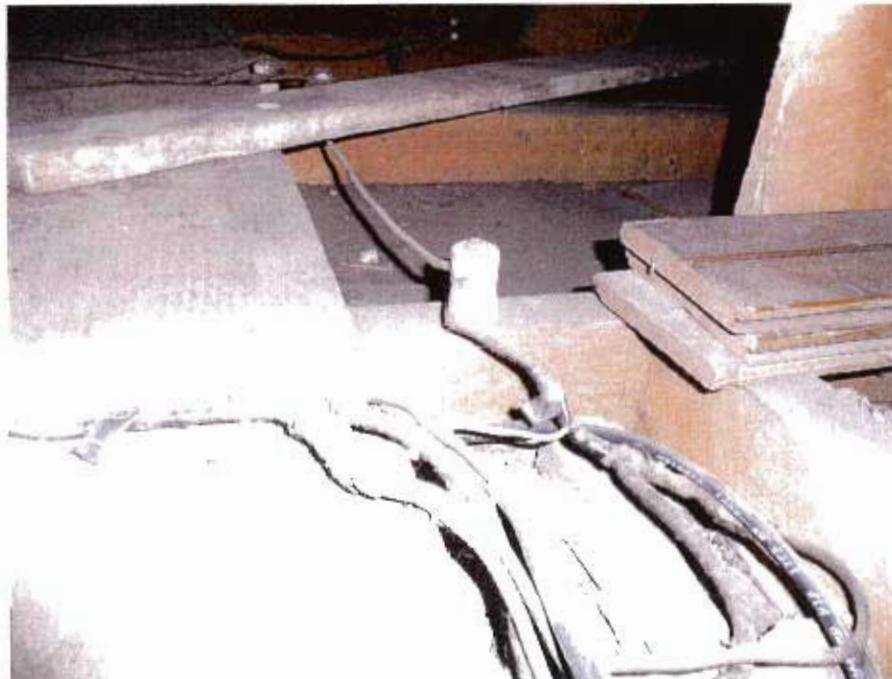
ELECTRICAL SYSTEM. Existing knob and tube wiring in attic.

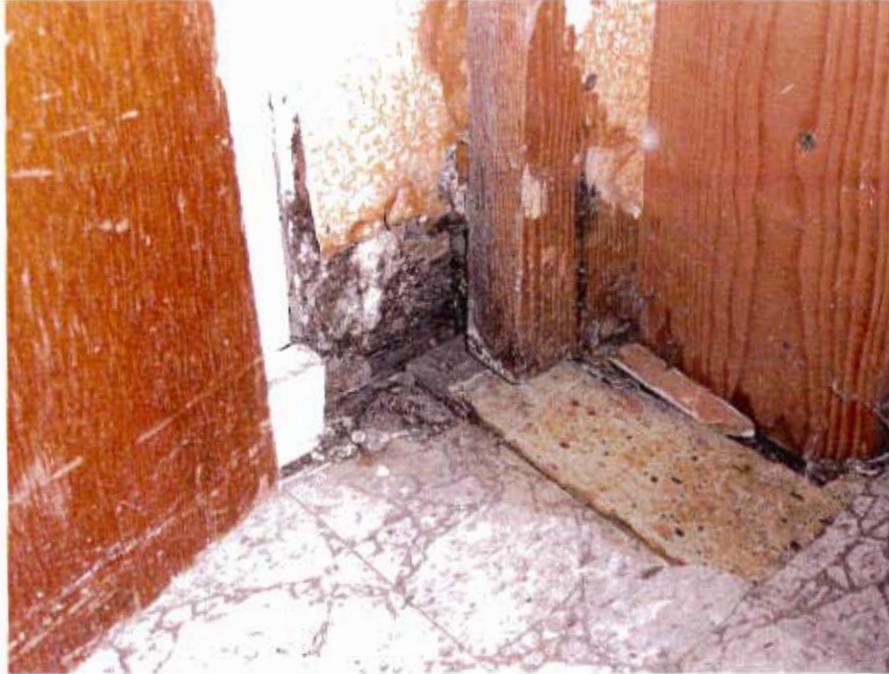
STRUCTURAL SYSTEM. Interior flooring settlement.

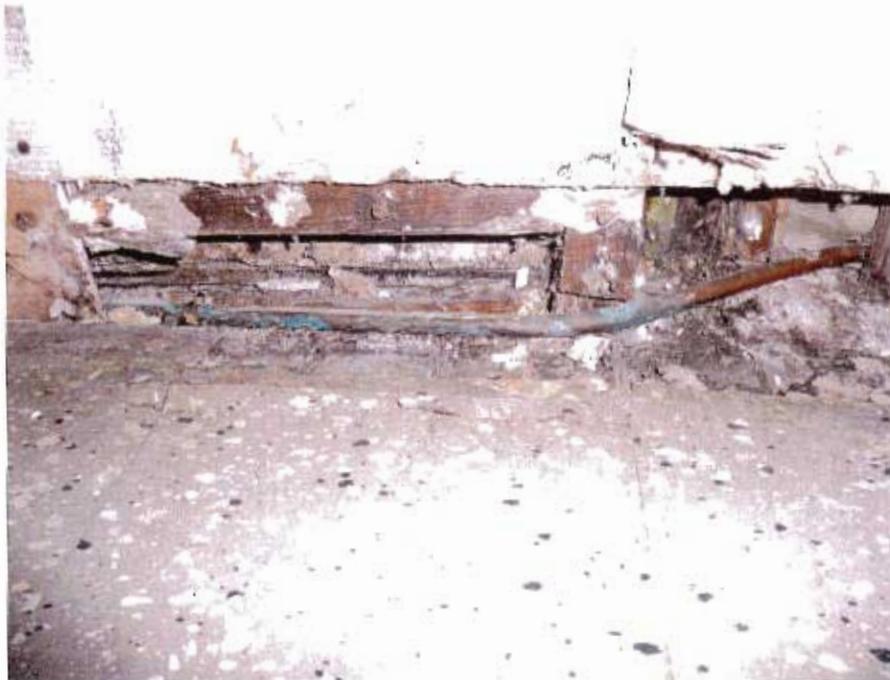
STRUCTURAL SYSTEM. Interior flooring settlement/wood rot.

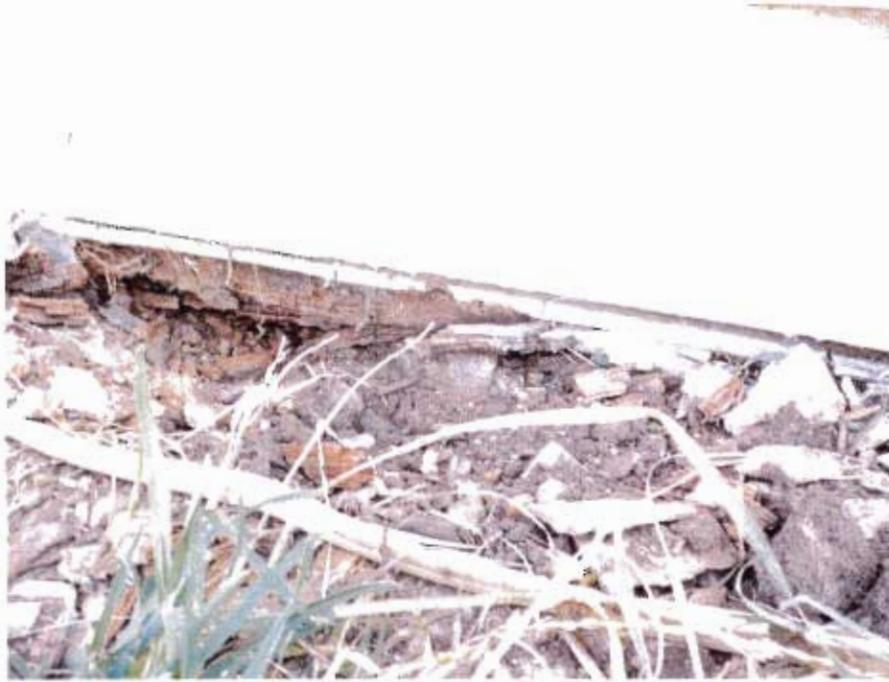
STRUCTURAL SYSTEM. Exterior rotted sill plate.

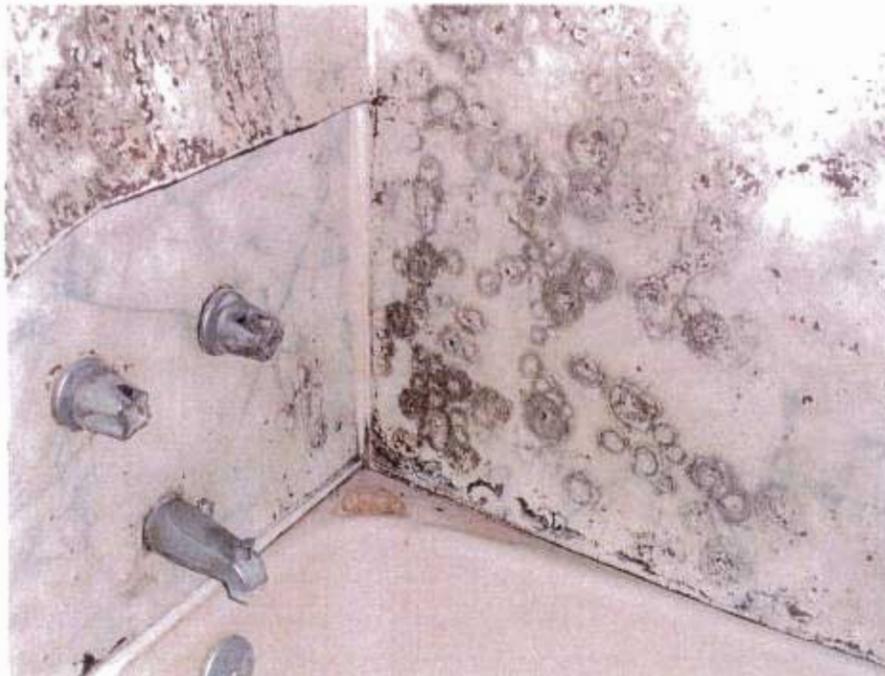
HAZARDOUS MATERIALS. Mold evident in bathroom.

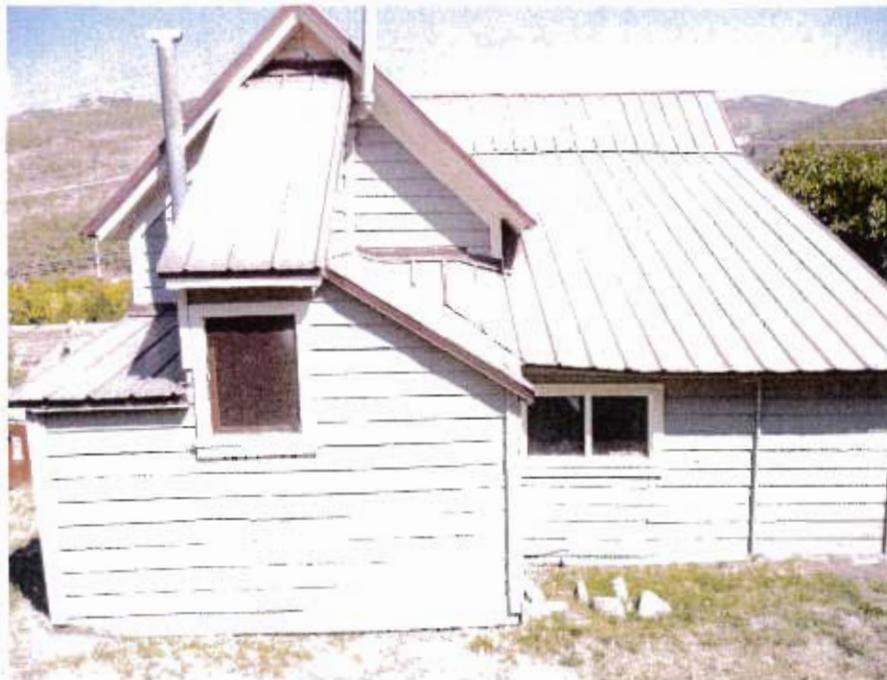
WINDOWS. Rear of house (west side) showing single pane windows.

35. The proposed design complies with Specific Guideline B.5. Windows - There are no remaining historic windows in this home (see historic preservation plan and physical conditions report). They will be replaced with windows known to be used historically new double-hung wood windows that mimic those seen in photographs. The proposed windows in the historical structure will be revised to one-over-one as proposed. Windows on the new addition will differentiate from the historic. The intent of the proposed addition is to compliment and contrast with the historic structure rather than mimic as the addition will appear to be constructed out of period to the house, rather than compete with it.

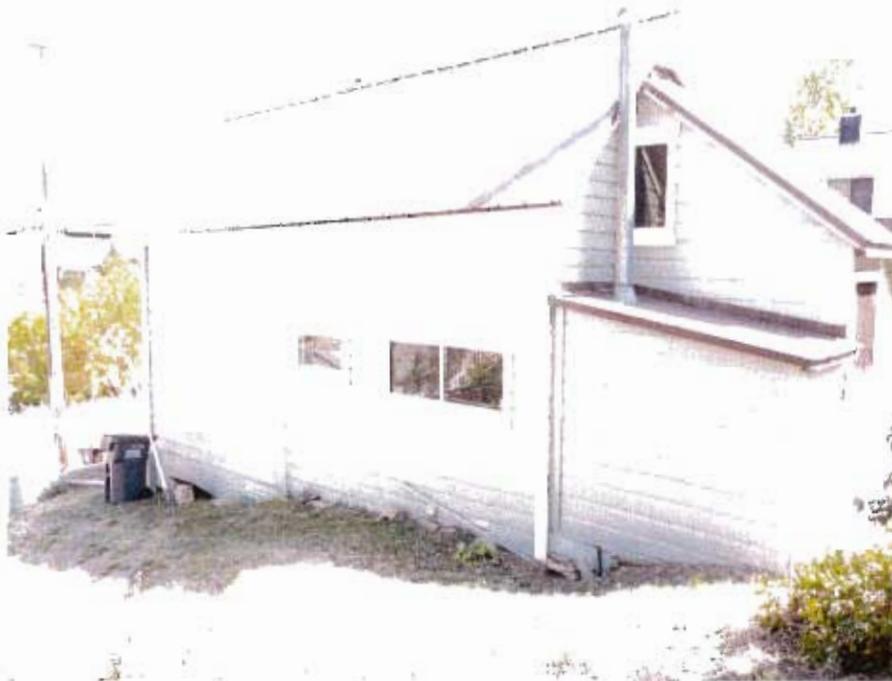
WINDOWS. North side of house showing single pane windows.

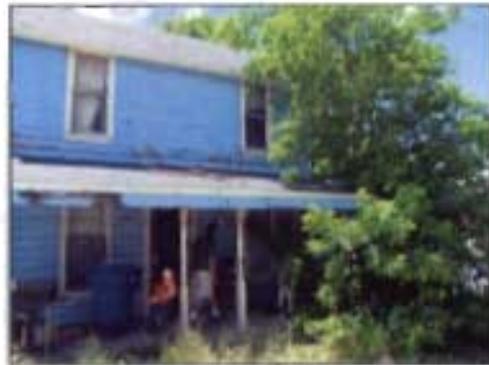
In the front yard (east) of the house, a tree has been allowed to grow to approx. 22' on the NE corner of the original house. Overall, weeds, dirt, debris, and the aforementioned tree are all that exist as landscaping. The driveway and adjacent and parallel raised curb on the NE is overgrown. The front porch is concrete. A worn path to the porch exists though in photos from 2006 there was a concrete path from the sidewalk to the front porch. The path is not immediately evident and may be overgrown by weeds and grass or may have been removed.

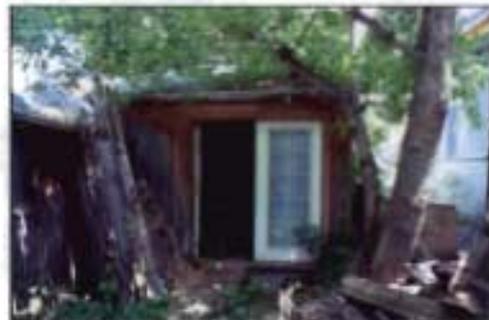
In the rear yard trees at the southwest corner of addition 1 have been allowed to grow too close to the house. A large tree in the north-rear side yard has also been allowed to grow and overhang the rear additions. Other than plentiful weeds, grass, and vines, the remaining rear yard landscaping is made up of piles of building materials, garbage, stoves, boats, trailers, garbage, tires, and other manmade debris. The large piles of fill and debris in the NW corner of the property have fostered growth of weeds and grass.

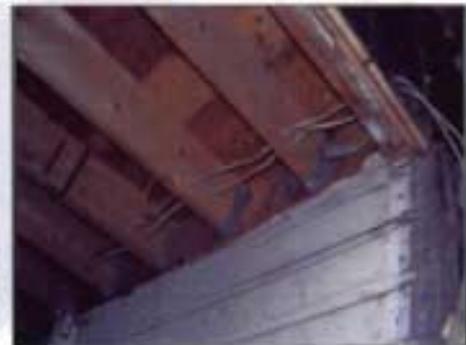
Garage addition: A flat roof with undetermined roofing materials. This roof was inaccessible due to the condition of the structure and the site. The garage roof structure, visible from the interior, is 2"x8" rafters attached to a ledger board using undersized joist hangers.

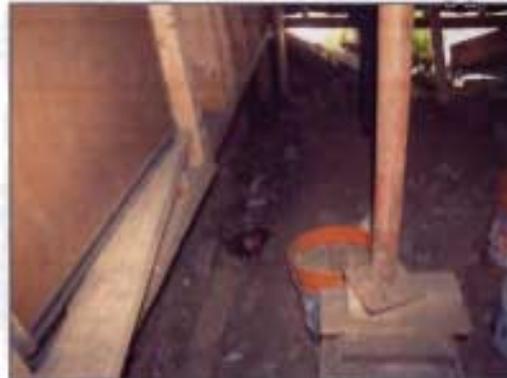
The original hall-parlor house has no foundation. County tax assessor building cards suggest that the structure had wooden sills on dirt or rubble foundation as late as 1968, but all material that once supported the perimeter walls has been removed. All that exists is the trenched perimeter

where the original footing and/or foundation material was removed. The front and south sides of the building are suspended above the bottom of the trench by a series of 4 to 5 pipe jacks located haphazardly on the interior dirt where the floor joists and decking have been removed.

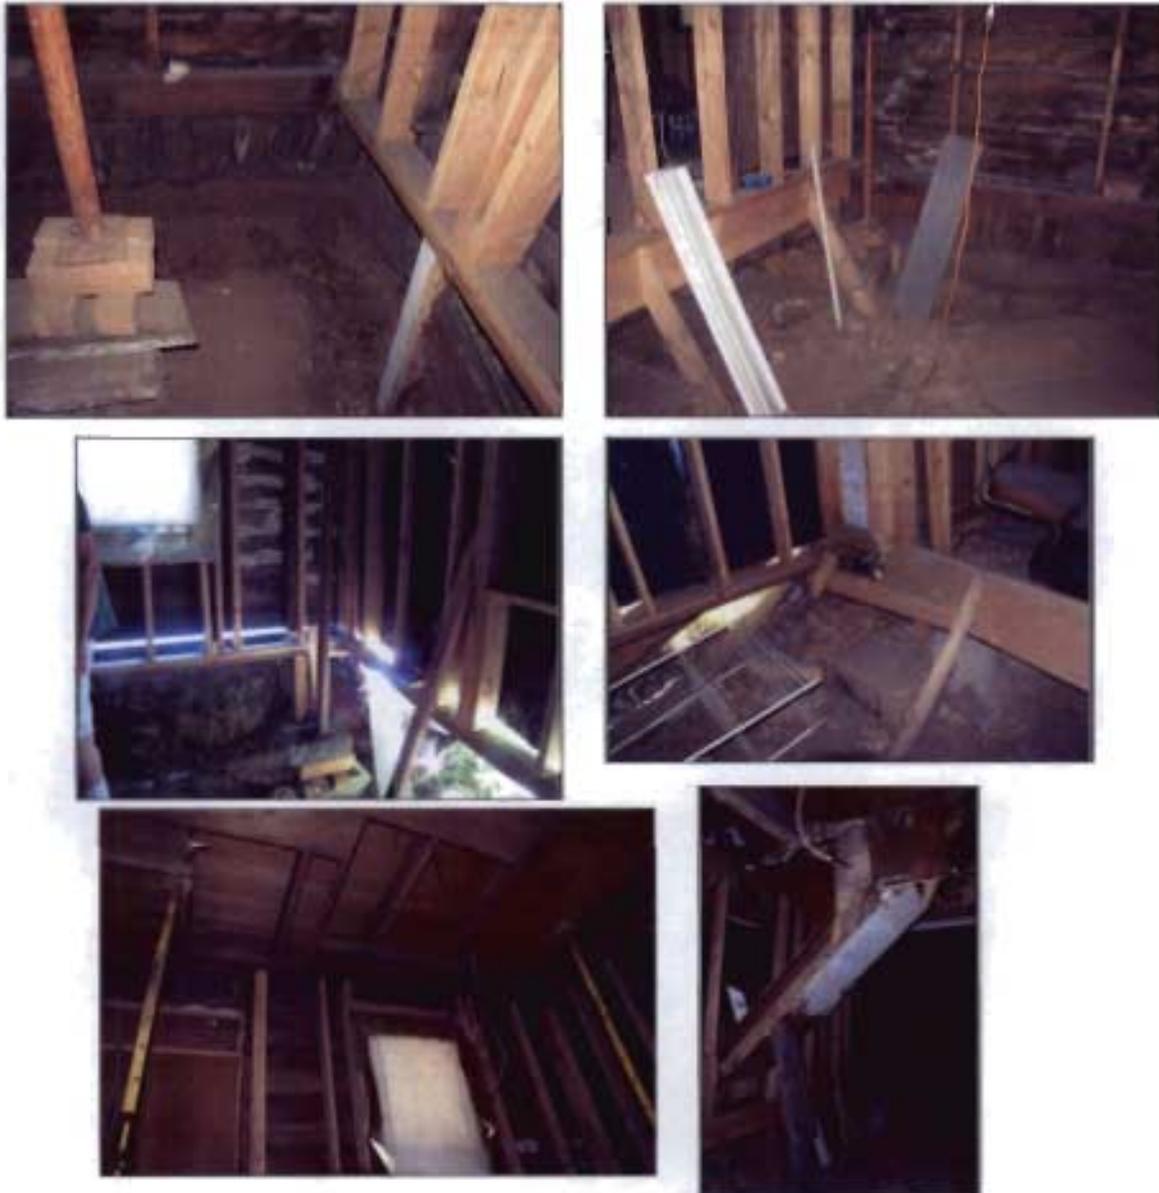
The original studs in the walls have been removed and replaced with dimensional lumber in some areas. Spot footings have been poured in a few locations but the beam spanning those has warped, waned, and failed. Attempts at bracing it further are unsophisticated at best and negligent at worst. The roof trusses of the shed roof addition are failing and in most cases fall short of the bearing wall. The 4'x8' beam that was meant to carry half of the trusses is salvaged lumber and fails to have permanent trimmer or king stud support. The stairs to the upper level are supported only by a broken piece of 2'x12' board hanging from above and a short salvaged section of wall resting in the dirt. We did not attempt to use the stairs, nor should anyone else. There is no cohesive structural system.
