SOILS STUDIES & OPINION REPORTS

PRELIMINARY ENGINEERING GEOLOGIC REPORT TO PARK CITY ON
THE PROPOSED QUITTIN TIME DEVELOPMENT

by
William Lund, Geologist

Done at the request of the Park City planner.
May 1979

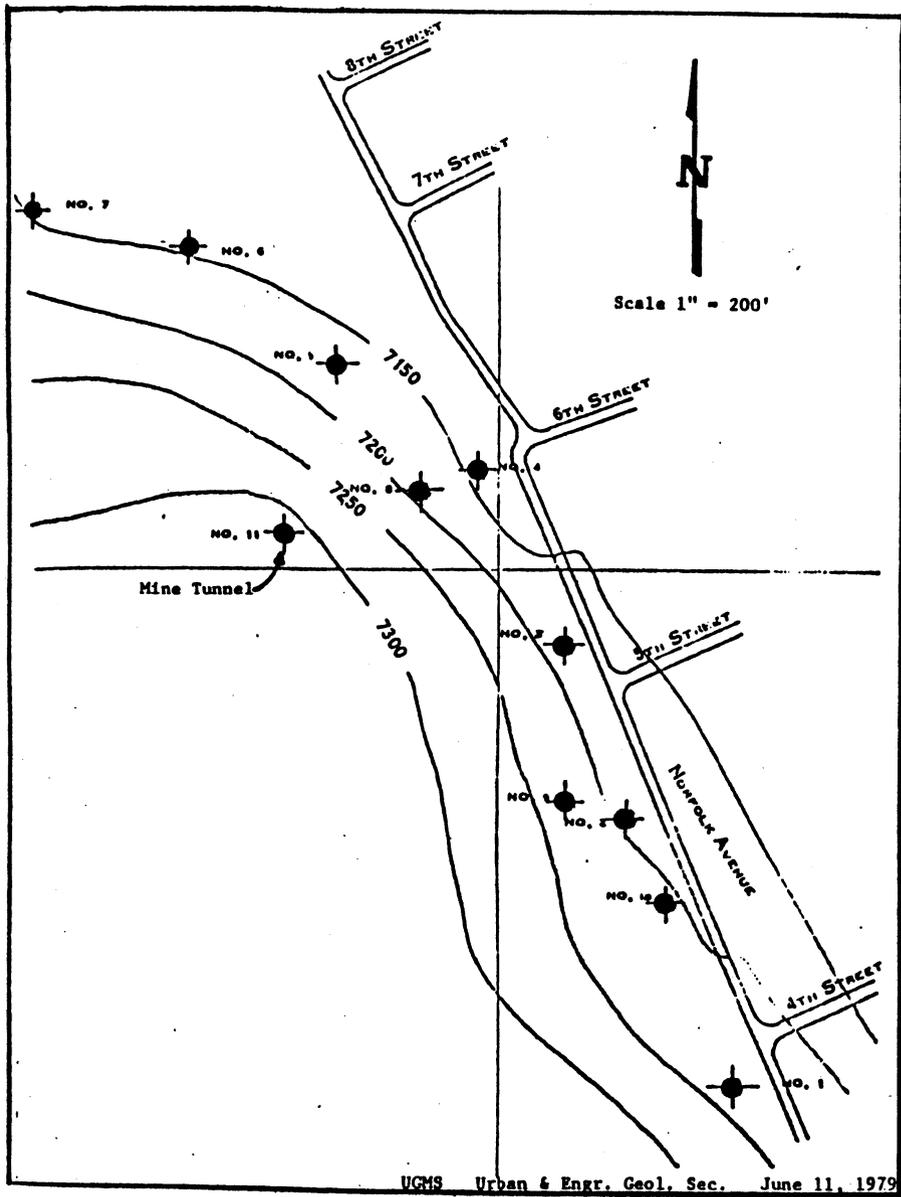
Figure 2 Location of Test Holes (Modified from consultants report)

During this investigation nine of ten backhoe pits excavated by a private consulting firm which had previously prepared a report on this property were examined (Figure 2). Prior to the field reconnaissance, four of these test holes were cleaned out by the Park City backhoe. The five remaining holes were not cleaned, either because they were inaccessible due to installation of a new municipal waterline across the site, or because they could not be located by the equipment operator. The four test holes which were cleaned, nos. 1, 4, 5, and 10 of the consultant's

report, were all reported to have reached bedrock at depths ranging from seven to nine feet below the ground surface. Groundwater was encountered at a depth of eight feet in test hole no.10, and this prevented the excavation from being adequately cleaned. As a result no determination could be made regarding the presence of bedrock. Test holes 1 and 4 were both cleaned to their original depths, but an inspection showed that neither of the two had reached solid, in place rock. Instead, both excavations stopped at a dense, closely packed layer of quartzite cobbles and boulders in a clay matrix. This material appears to be sufficiently compact to resist excavation by all but the largest of backhoes, and may represent the zone of broken and weathered material that commonly mantles in place bedrock. However, since the excavations did not penetrate this horizon, its true thickness and relationship to the underlying bedrock is not known. Test Hole No. 5 was excavated one foot below original grade and bedrock was not encountered. The walls of the five remaining test holes had all sluffed to some degree, consequently, bedrock could be positively identified only in test hole no. 6. The tenth test hole, no. 3 of the consultant's report, had been backfilled and could not be located.

The soils exposed in the test holes generally conform to the descriptions provided in the consultant's report (Appendix A). The only significant difference concerns the description of the Zone 2 soils. This soil horizon is described in the consultant's report as a granular zone composed of angular fragments in a silt matrix, and is classified in their logs in accordance with the

United Soil Classification System as a silty gravel. Such a description implies that the material is non- to only slightly-cohesive and possesses no or only very low plasticity. The soils which correspond to Zone No. 2 observed in the test holes were found to contain a considerable amount of clay and as a group are probably better classified as a clayey gravel and in some localities even a gravelly clay.
