**PARK CITY MUNICIPAL CORPORATION
HISTORIC PRESERVATION BOARD
COUNCIL CHAMBERS, CITY HALL
MAY 29, 2012 - 5:30 PM**

Historic Preservation Board Staff Report

Subject: 335 Woodside Avenue
Author: Francisco Astorga
Date: May 29, 2012
Type of Item: Quasi-Judicial – Appeal of Staff’s Determination of Compliance with the Design Guidelines for Historic Districts and Historic Sites

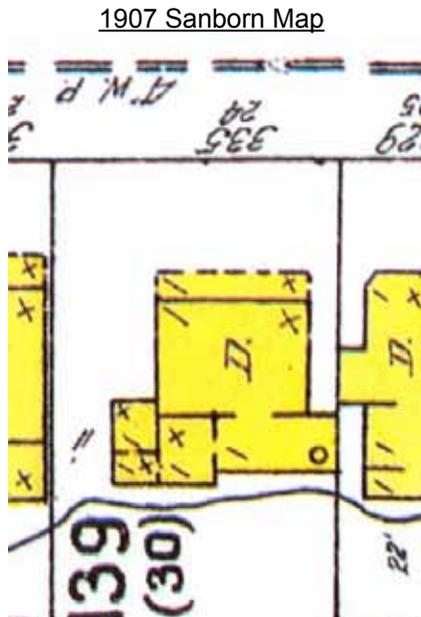
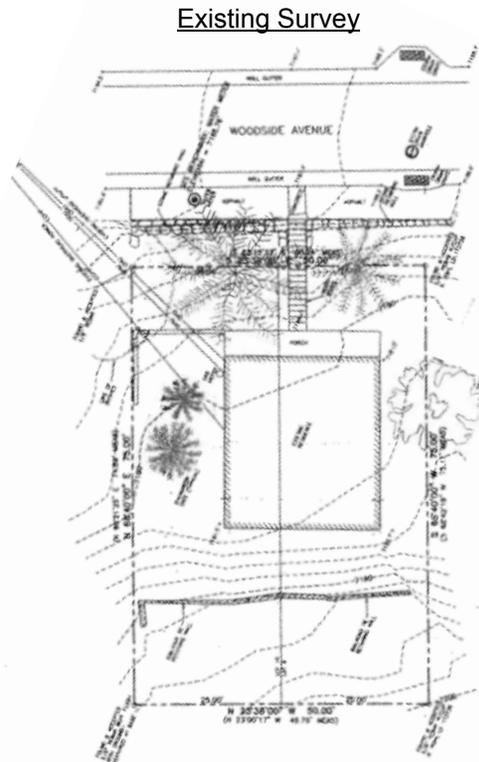
The rear wall was scheduled to be removed because it has been determined to be part of a non-contributory footprint/addition. The Sanborn maps of 1900, 1907, 1929, 1940, and 1958¹ indicate the same exterior configuration, see Exhibit C, also illustrated in the 1907 Sanborn map shown below to the left. This configuration shows the footprint of the front half to remain unchanged in its square form with the porch covering the entire length of the front façade. However the rear half of the structure is completely different from what exists today. See existing survey map shown below to the right, also found on Exhibit B – approved plans. The illustrations below are not to scale as the purpose of the illustrations is to show the difference in footprint.

As shown on the historic and existing footprints above, one can clearly identify that the rear façade is completely different as the historic footprint has a small change in the rear wall plane. In addition, the historic footprint shows that the rear portions of both sides have respective bump-out features extending past the side façades which were removed after 1958.

There is clear evidence that the rear façade and the rear portion of the side façades have been reconfigured from the original footprint. The existing rear addition, though

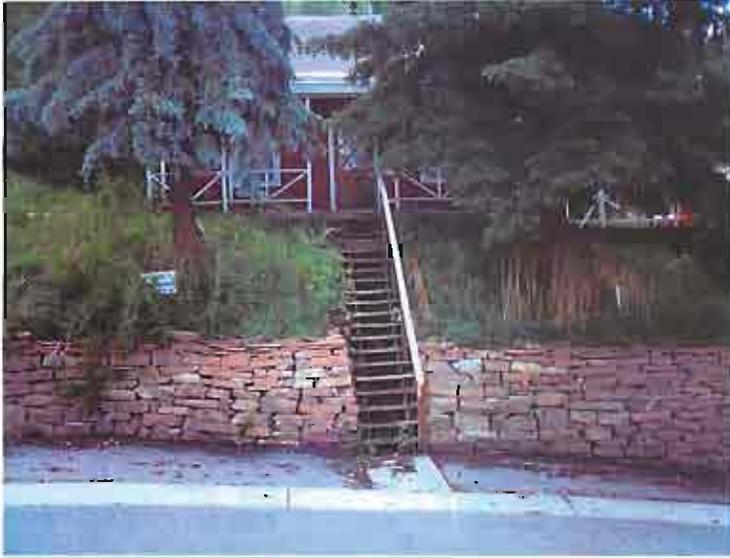
Street View

Across the front of the property, as described in the Topography section, there exists a very nice hand stacked stone retaining wall (2' to 6' in height). The wall is in very good condition. Another retaining wall exists, also described in the Topography section, high upon the site to the rear. It is built of railroad ties and is in poor condition.

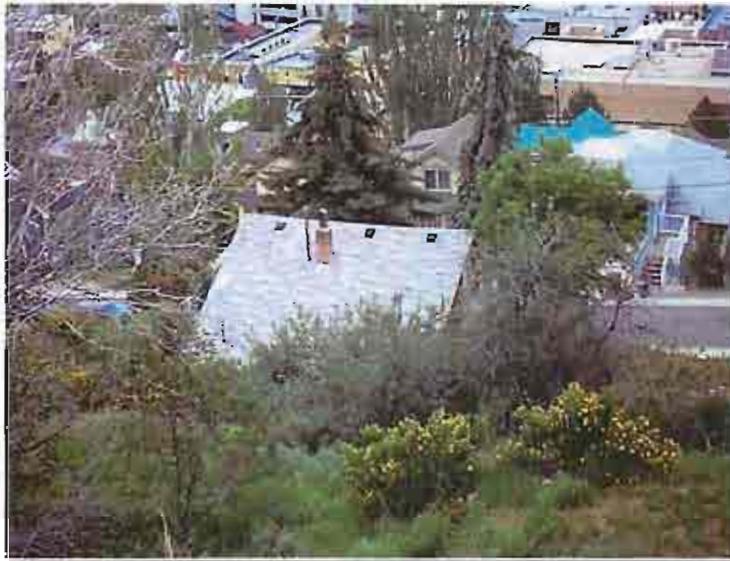
Rear View

This façade is the same exterior materials as the other facades. It is in very poor condition because a steep bank of earth comes right down to it. Its proximity to the earth and many winters or deep snow against it has rotted much of the material. This wall is scheduled to be removed because it has been judged to be part of a non-contributory addition.

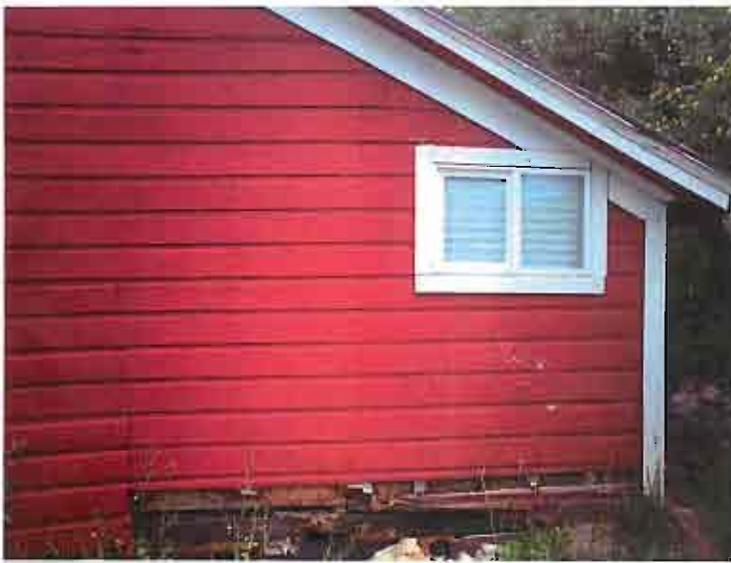
Northwest Corner

The North and South facades are also of 1"x7" pine drop siding. The trim around the windows are of the same 1"x4" pine as the front façade. There is a trim board just below the soffit along the rake of the roof. This trim consists of 1"x8" pine with a 3" crown mold. The soffits are 9" wide and are 1" pine painted and recessed ½". The condition of the material is fair. The wall structure is the same as described in Primary Façade 1.

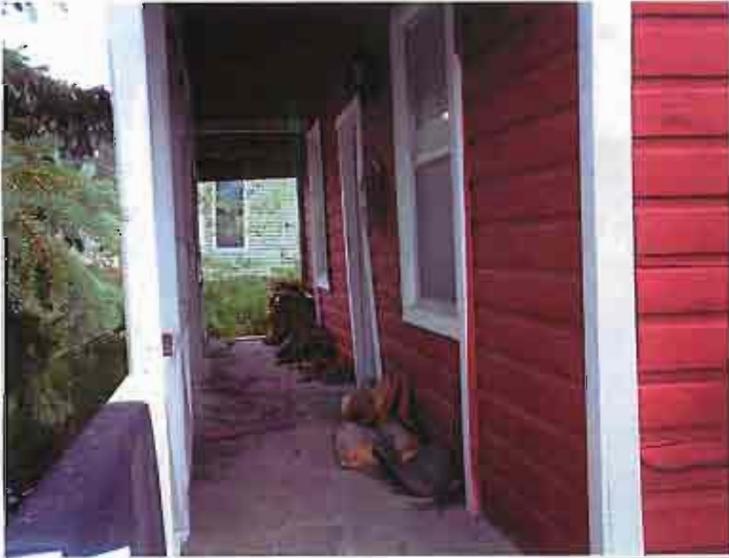
Northeast Corner Showing Porch, Front Door Window Trims

This façade is wood siding. It is 1"x7" pine drop siding. The trim at the building corners and around the windows and front door is 1"x4" pine. The fascia at the roof is 1"x7" pine with a 3" pine crown molding. The condition of the material is fair. I think a good portion of it can be re-habilitated and re-used. The wall structure is of the typical historic construction seen in Park City. It consists of two layers of 1"x12" pine boards. The layers run perpendicular to each other.

All of the exterior trim around the doors and windows and the building corners are very simple 1"x4" pine and void of any ornamentation. Everything is square cut and painted. There are no window sills. All original windows have been replaced with aluminum and one vinyl.

All trim is judged to be in fair condition, possible for rehabilitation and reuse.

Trim- Much of the door and window trim on the existing house can be reused. The trim is very simple flat square-cut pieces. If any of the pieces need to be replaced, it will be a very simple match. See details provided of the window and door trim and the porch and stair railing.

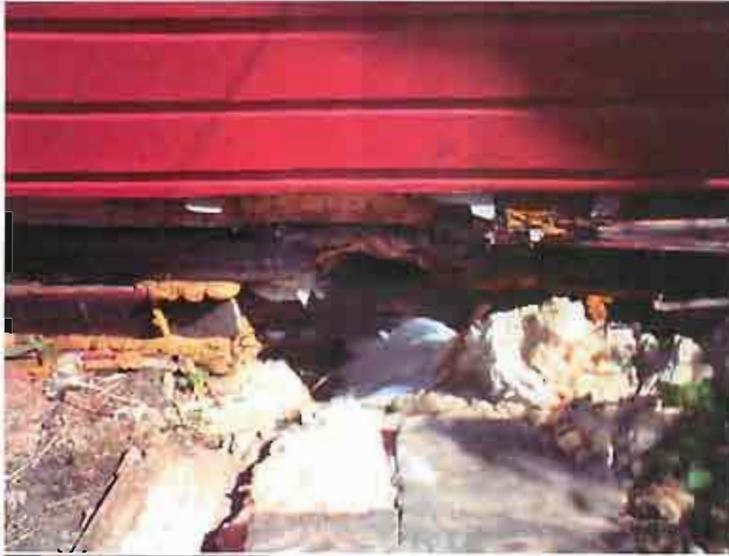
North Wall Showing Rotten Foundation and Rotting Siding

The building's existing foundation is of wood on earth and is totally rotten. The existing foundation is a non-issue because of stabilization requirements, the house will receive a new concrete foundation.

Foundation- The project is proposing a new basement with garage under the Historic house. The house will have to be raised above its present location in order to facilitate the excavation, forming and pouring of the new concrete foundation. The main floor of the house will also receive a new floor system. The old system is resting on dirt and is rotted. When the new foundation and floor system are in place, the house will be lowered back to its original position and elevation.
