HISTORIC SITE FORM - HISTORIC SITES INVENTORY

PARK CITY MUNICIPAL CORPORATION (10-08)

Address: 909 Woodside Avenue

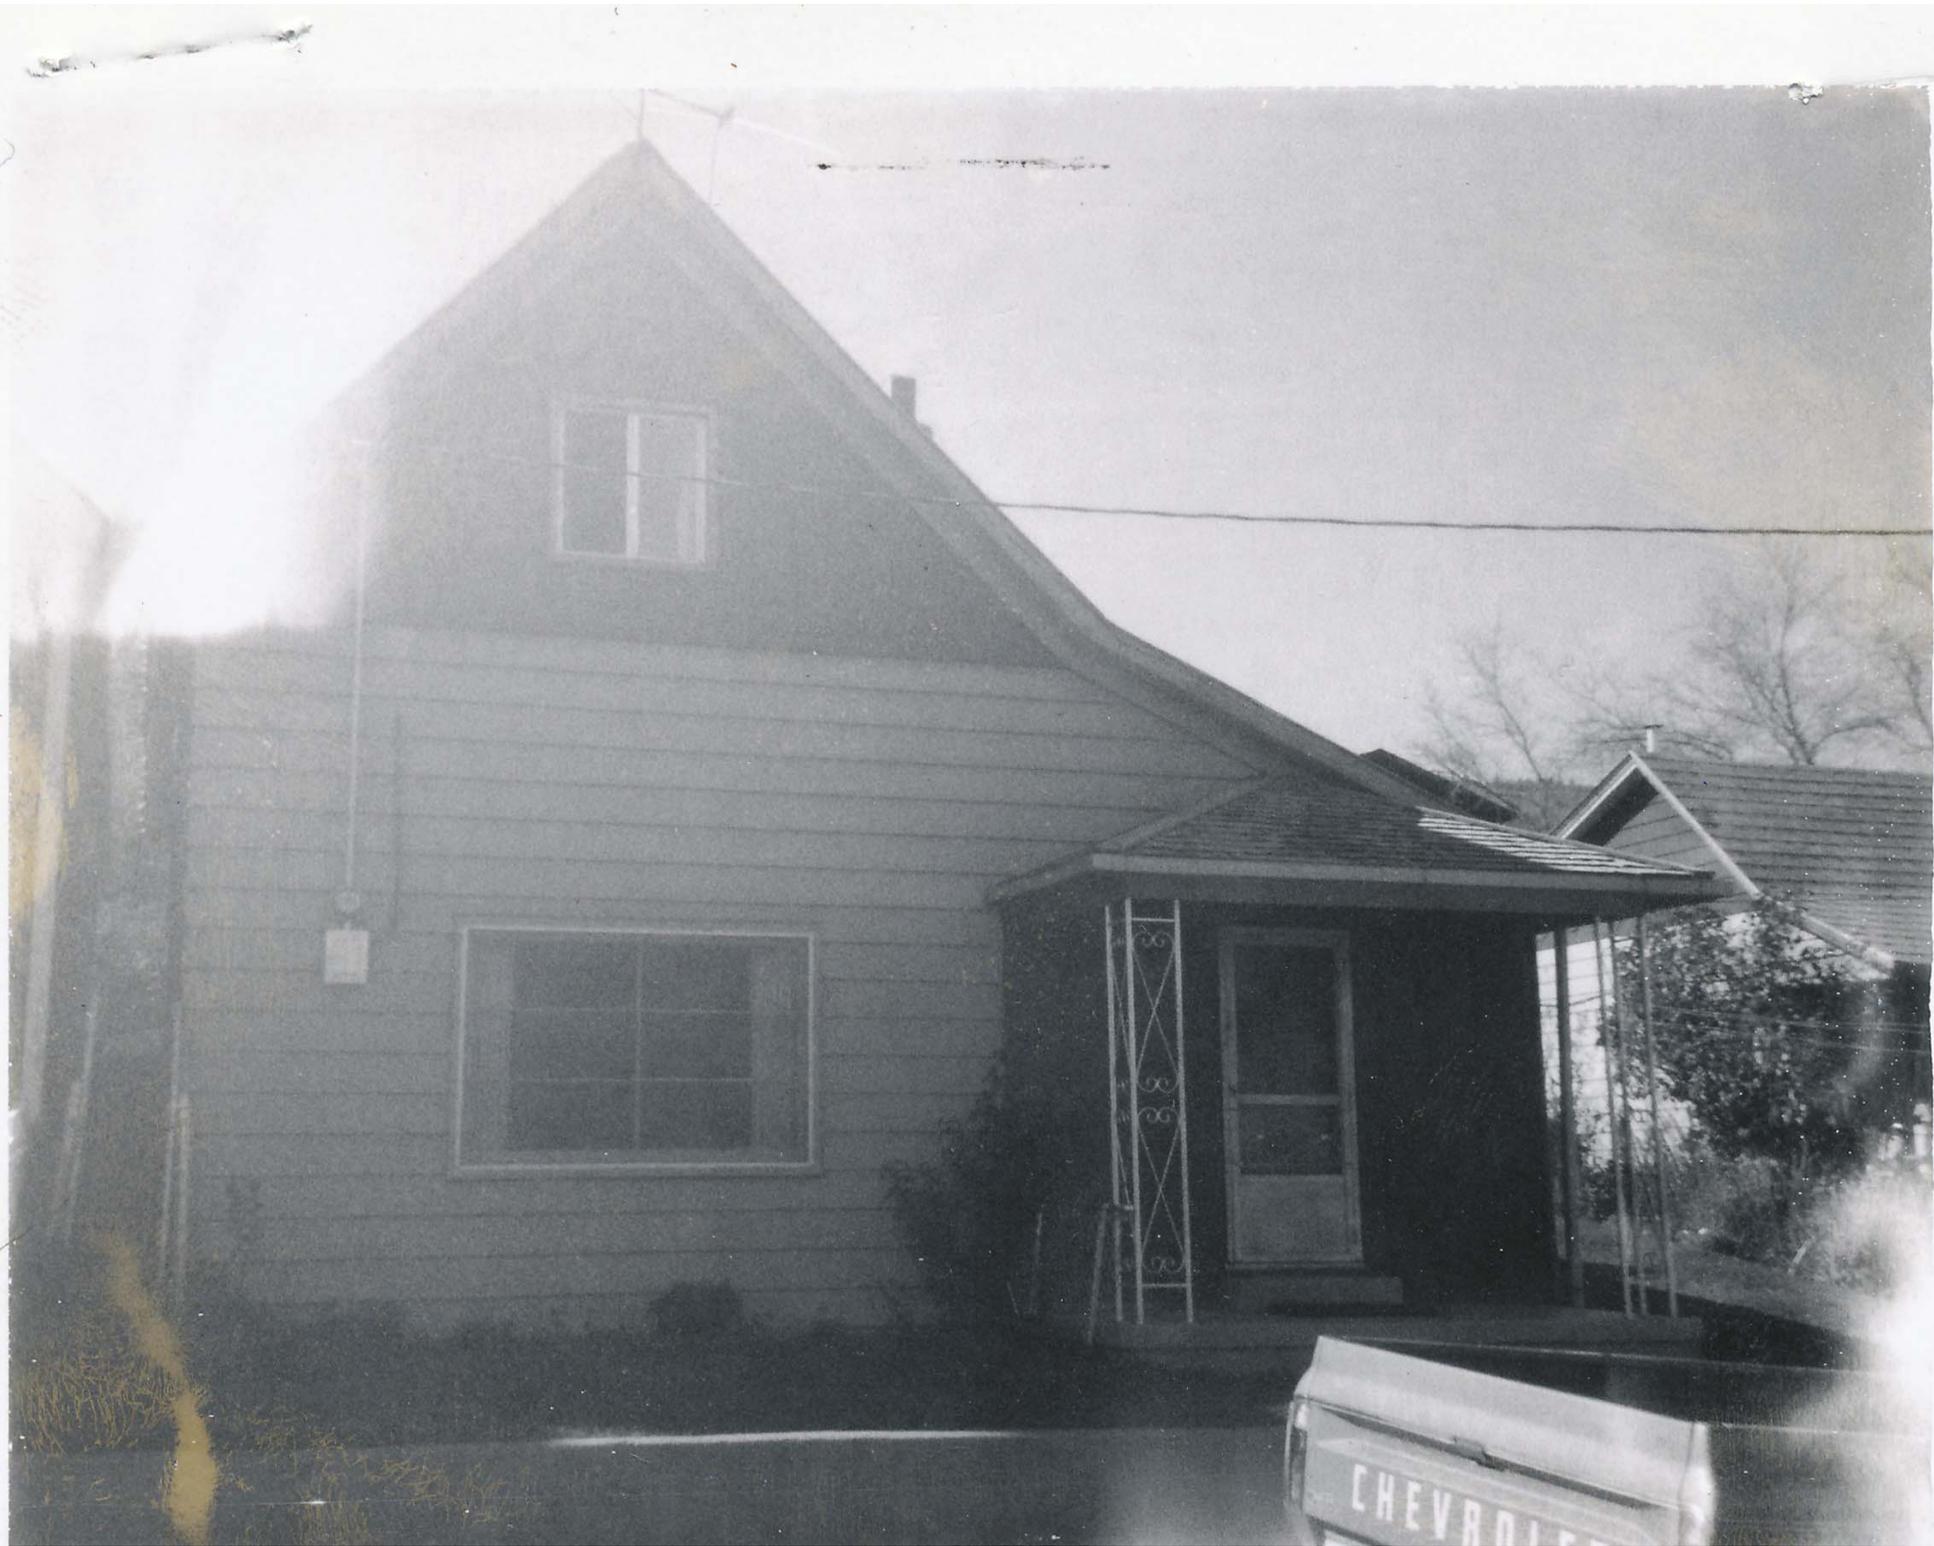
Photo No. 1: East elevation. Camera facing west, 2006.

Design (The combination of physical elements that create the form, plan, space, structure, and style. Describe additions and/or alterations from the original design, including dates--known or estimated--when alterations were made): The 1 ½ story frame side passage type house has been significantly altered. The roof line suggests a front gable block with side passage beneath an extended shed roof. The basic form remains, but is sheathed in newer, incompatible materials. The house is clad in aluminum siding and board & batten siding in the gable end and delineating the porch. The 1907 Sanborn Insurance map suggests a side passage house with full-width front porch. The porch has been replaced with a narrow entry porch with hipped roof supported by open metal work columns. These changes are evident on the 1968 tax card as well as a photograph from that era. The center window on the main façade reflects a WWII-era casement type with multiple horizontal panes separated by thin muntins. In the upper gable, a small side slider has been added.
