# HISTORIC SITE FORM - HISTORIC SITES INVENTORY

PARK CITY MUNICIPAL CORPORATION (10-08)

Address: 1007 Woodside Avenue

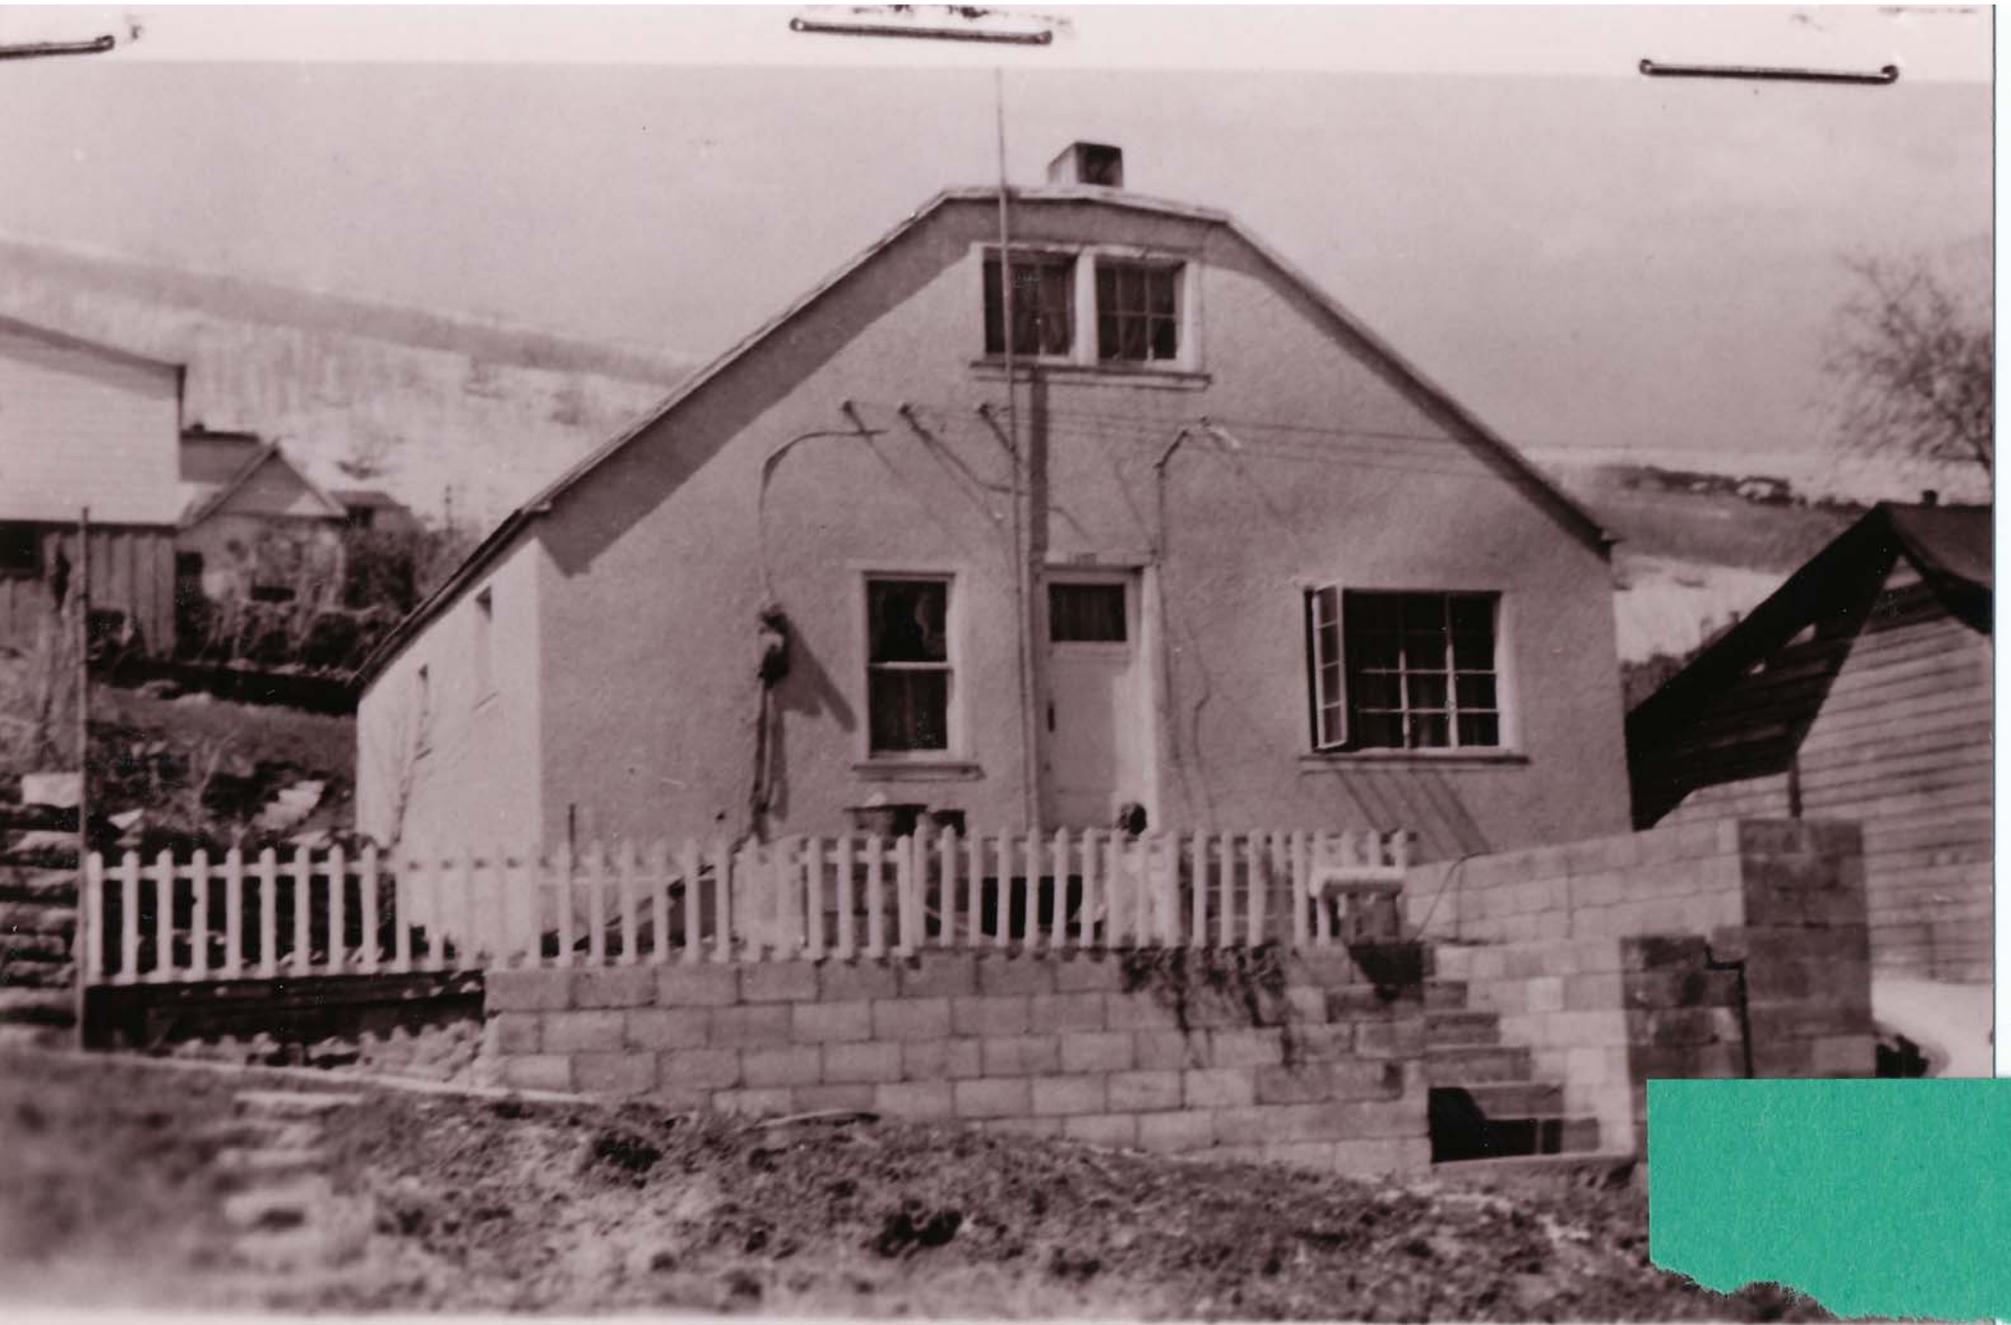
**Photo No. 1:** East elevation. Camera facing west, 2006.

**Setting** (The physical environment--natural or manmade--of a historic site. Describe the setting and how it has changed over time.): The setting has been altered from what is seen in the early tax photo. The front yard is now physically and visually dominated by a two-car garage, wooden entry steps, and a low retaining wall.
