# HISTORIC SITE FORM - HISTORIC SITES INVENTORY

PARK CITY MUNICIPAL CORPORATION (10-08)

Address: 1158 Woodside Avenue

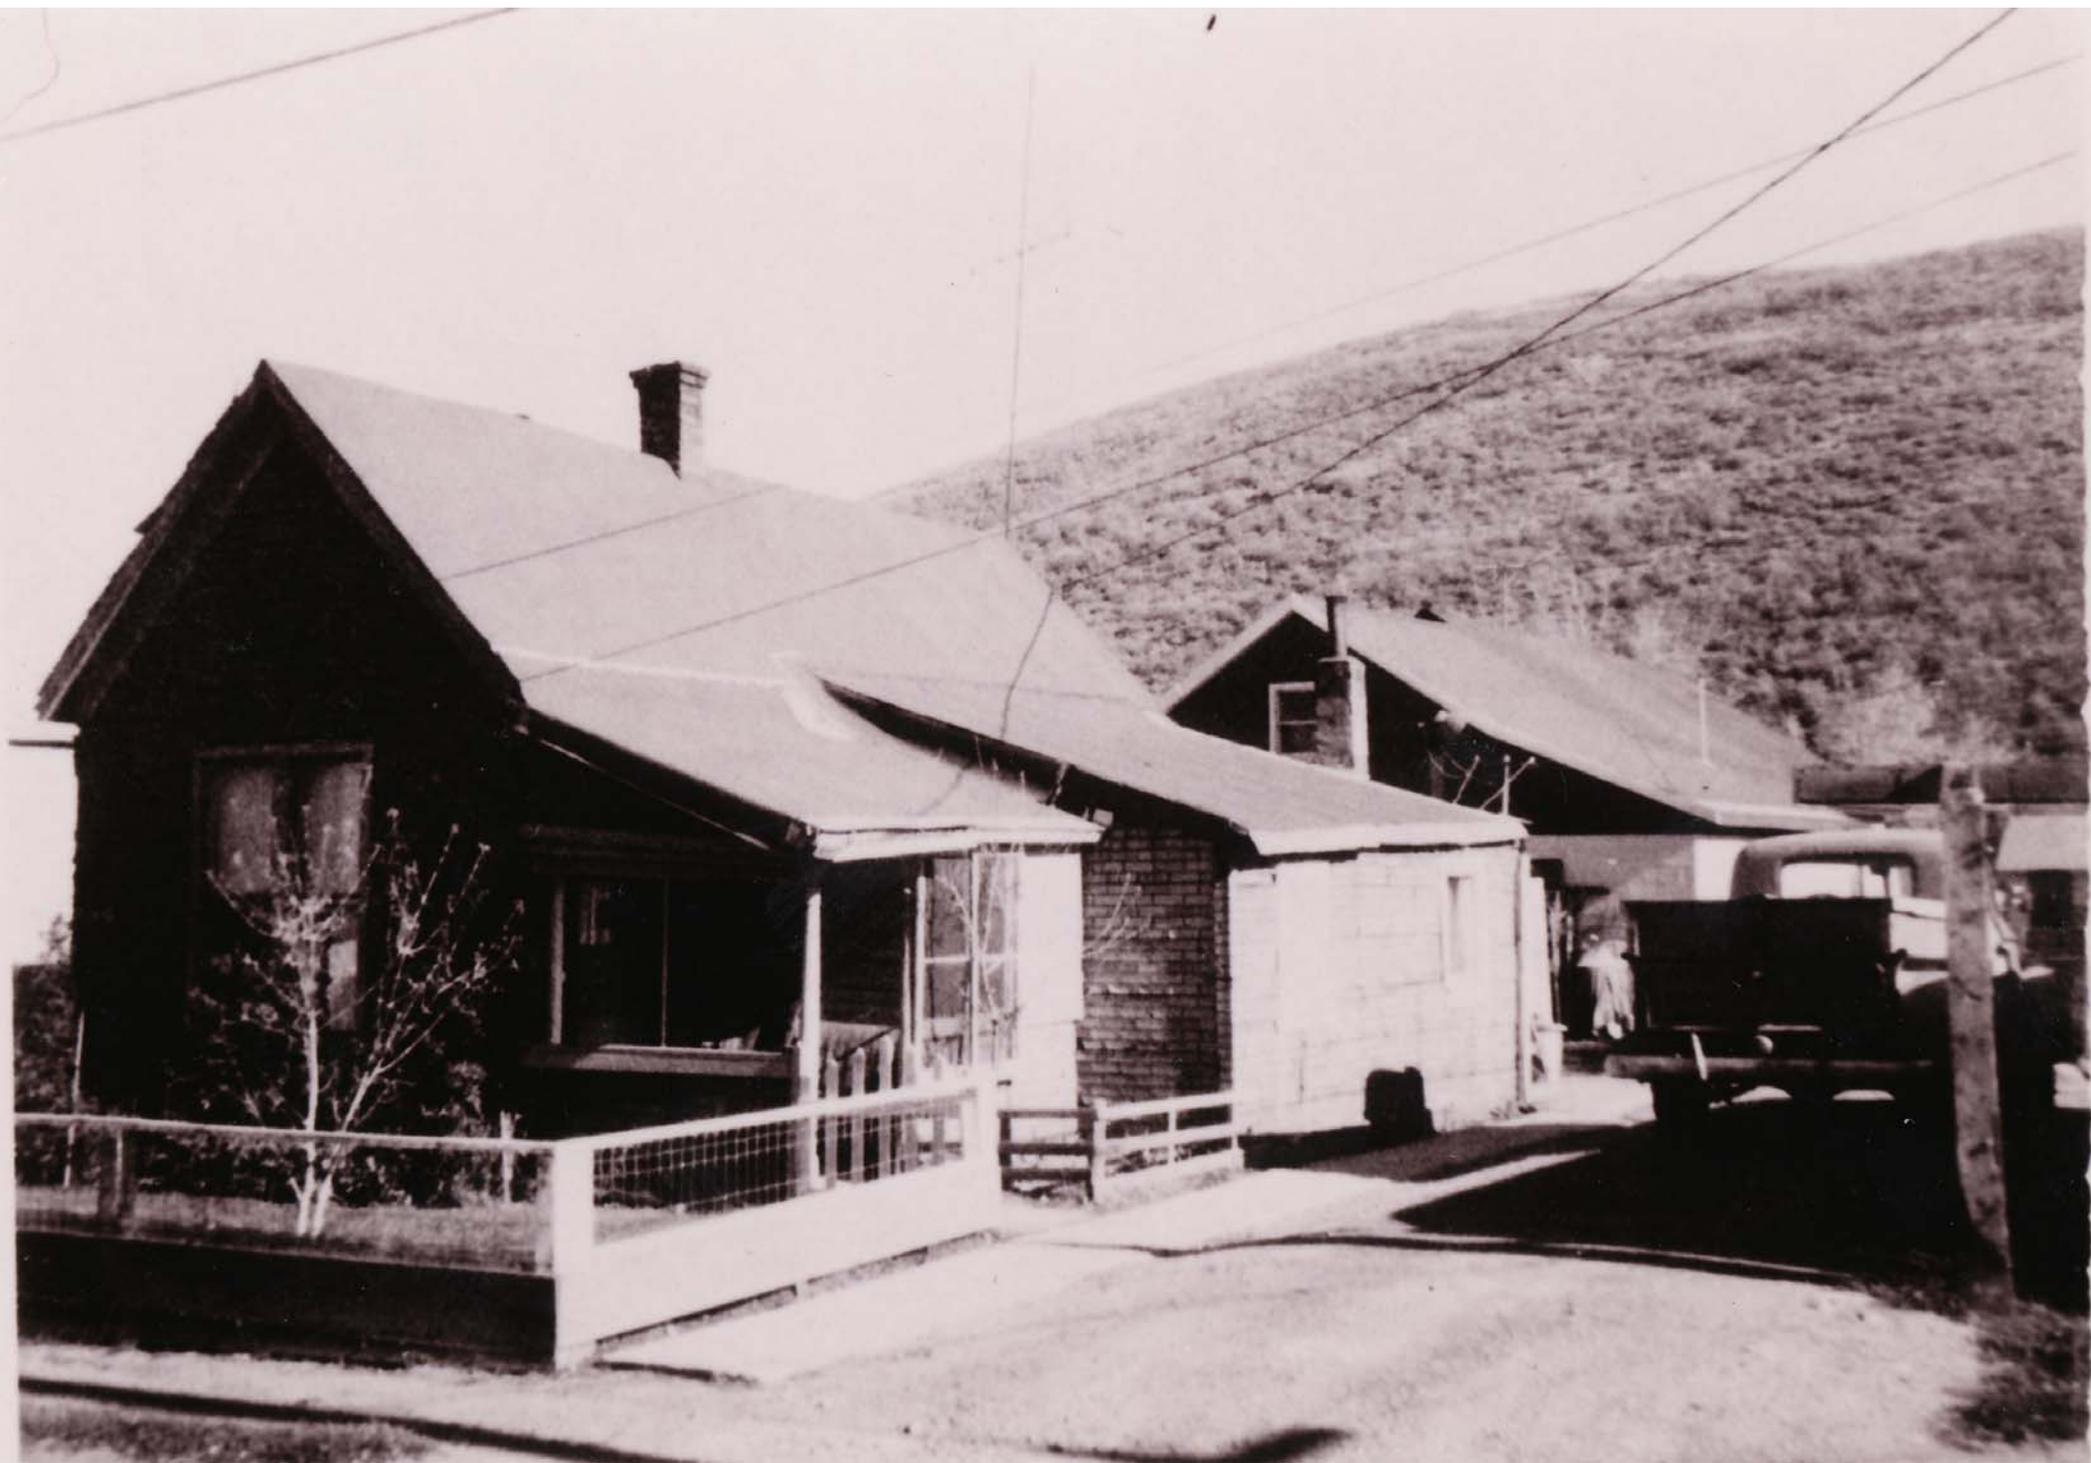
**Photo No. 1:** West elevation. Camera facing east, 2006.

Walls: Stucco on the main gable front and south lean-to addition and narrow lap siding on a small section of enclosed porch.

Roof: Gable and extended shed porch and shed addition; sheathed in standing seam metal. Central brick chimney rises through the ridge.

Windows: Paired double-hung sash type and aluminum side slider type.

**Design** (The combination of physical elements that create the form, plan, space, structure, and style. Describe additions and/or alterations from the original design, including dates--known or estimated--when alterations were made): The one-storey frame house has been significantly altered. The 1949 tax card indicates the house had siding rather than the stucco seen today. The 1907 Sanborn Insurance map shows the house as a simple rectangle (approximately 28'x12') with the narrow end facing the street. In 1952 (according to the 1949 tax card), the porch closest to the street was added, along with the center lean-to addition, and a rear leant-to porch. According to the 1958 tax card, the house was sheathed in brick-tex over the siding, as seen in the tax photo. The tax card also notes that the house was remodeled using scrap lumber. By 1968, the house was still sheathed in brick-tex (according to the tax card) and a rear addition had been constructed. It is not clear when the stucco was applied. The changes are significant and diminish the site's original character.
