**PARK CITY MUNICIPAL CORPORATION
HISTORIC PRESERVATION BOARD
CITY COUNCIL CHAMBERS
May 21, 2014**

The Board of Adjustment (BOA) remanded the appeal of the Historic Preservation Board's (HPB) Determination of Significance (DOS) of 632 Deer Valley Loop to the HPB due to new evidence submitted by the applicant at the appeal. Staff recommends the HPB review the new evidence and find that the structure meets the criteria for a significant site.

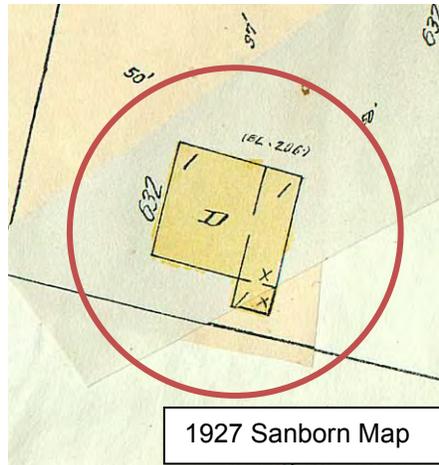
As the applicants' research demonstrates, the structure was expanded between 1912 and 1918. In 1918, owner Carl Hoger transferred the property to Willis A. Simmons. The quit claim deed describes the structure as a "four room frame dwelling house." The four(4) room cottage first appeared on the 1927 Sanborn Fire Insurance Map, shown below:

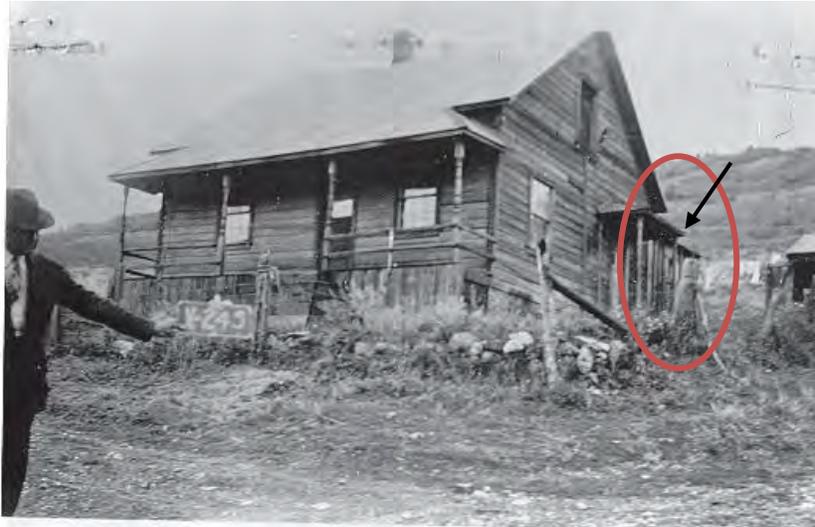
Above. The arrow denotes the structure to the rear of the building in the late 1930s. It is unclear if this is a short-lived addition or an unidentified out building.

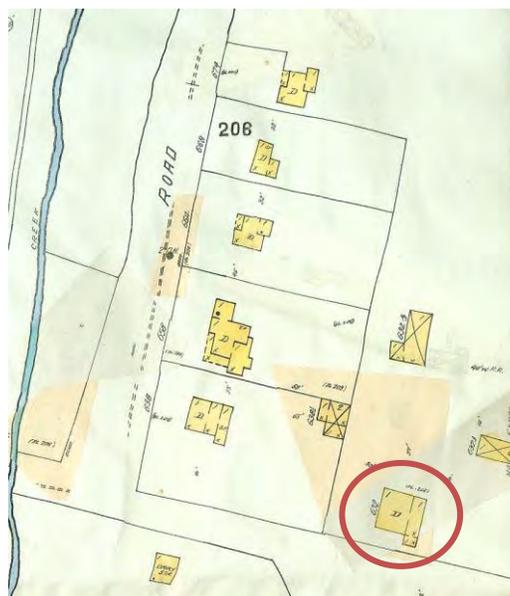
Below. The 1927 Sanborn Fire Insurance Map shows that the lots in this neighborhood were larger than typical Old Town lots and the houses were scattered and spaced a good distance apart. Of these neighboring houses, only the three (3) on Rossie Hill Drive are extant.

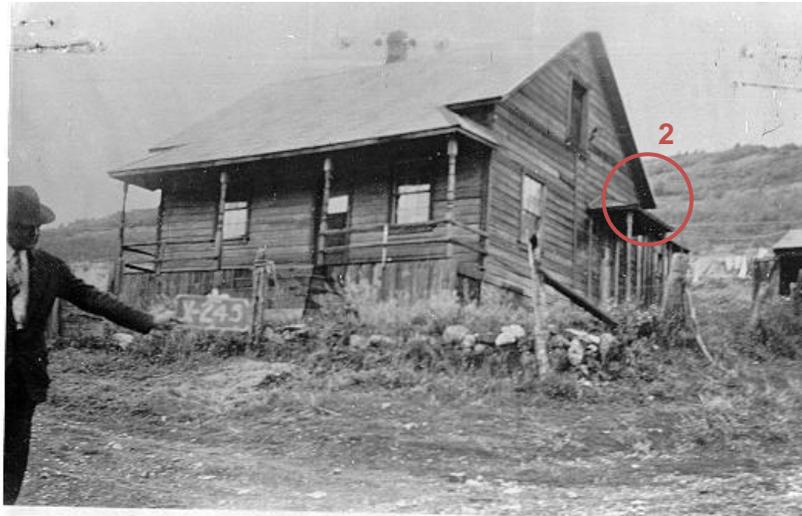
1. *Mudroom extends beyond the original south wall of the side-gable structure.*
2. *The historic photo shows that the side-gable is symmetrical and the eave is detached. The current photograph shows that the gable has been shortened in order to add the shed roof of the addition.*

In reviewing these criteria, Staff finds that the Essential Historical Form has not been lost. A slight change has been made to the rear gable, as it appears to have been slightly shortened in order to extend the shed roof of the c.1969 addition. This addition, however, does not detract from the Essential Historical Form, nor does it significantly obscure the Essential Historical Form of the building when viewed from the primary public Right-of-Way. Further, no new additions of upper stories have been constructed atop the historic structure. There is also no evidence that the structure was moved from its original location to a Dissimilar Location.

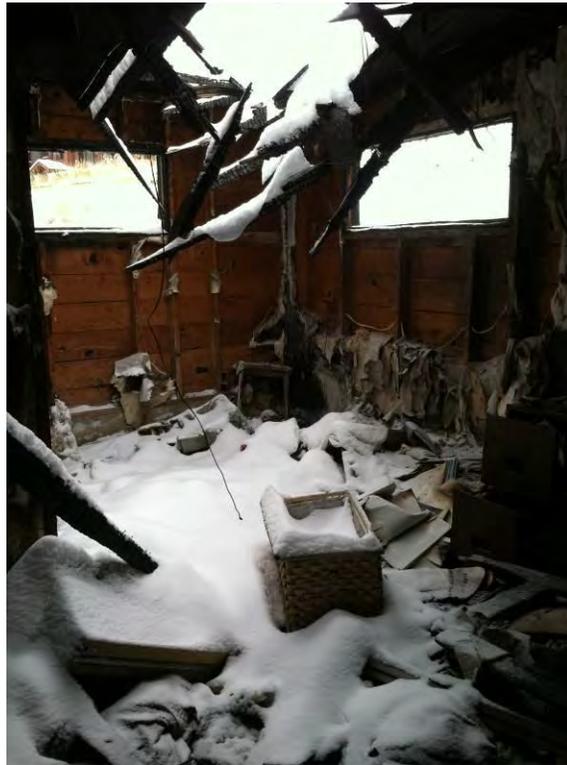
As seen in the picture below, the wall construction of the new addition consists of stud walls covered by horizontal planks. This is more modern construction method than the rudimentary “wood tent” construction of the historic structure. The window openings appear to be the originals, and they are not indicative of the sizes, proportions, or orientation of historic windows.

Photograph shows stud wall framing and original window openings of the c.1969 addition.

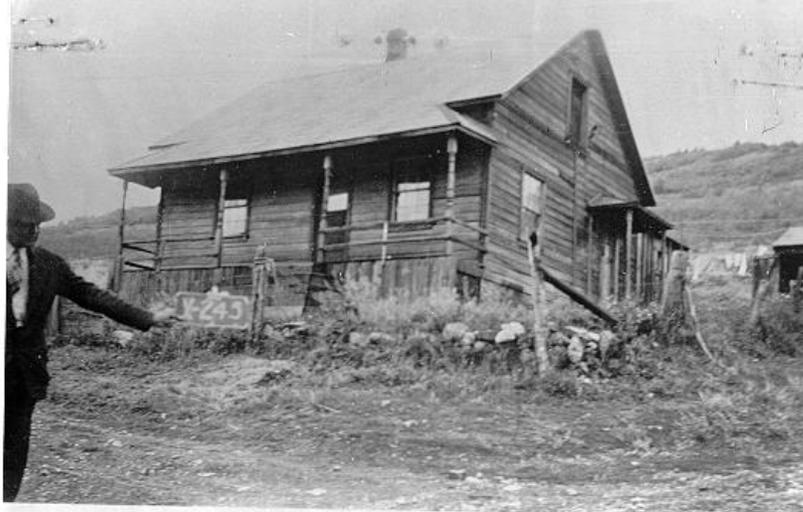
Late-1930s tax photograph

Staff finds that the late 1930s tax photograph is an accurate record of what likely existed in the historic period. Though the 1927 Sanborn Map does not depict a full-width porch across the façade of the house as shown in the tax photograph, it is likely that this porch existed during the historic period and may have been constructed immediately after the Sanborn survey. In their research, the applicants also points out that the front porch was likely constructed by Carl Hogar at the same time he made the front door, between 1912 and 1918, in order to access the front door that sits roughly six feet (6') above grade. In analyzing the 1930s tax photograph to a current photograph of the structure, it is evident that the essential side-gable form of the house exists today.

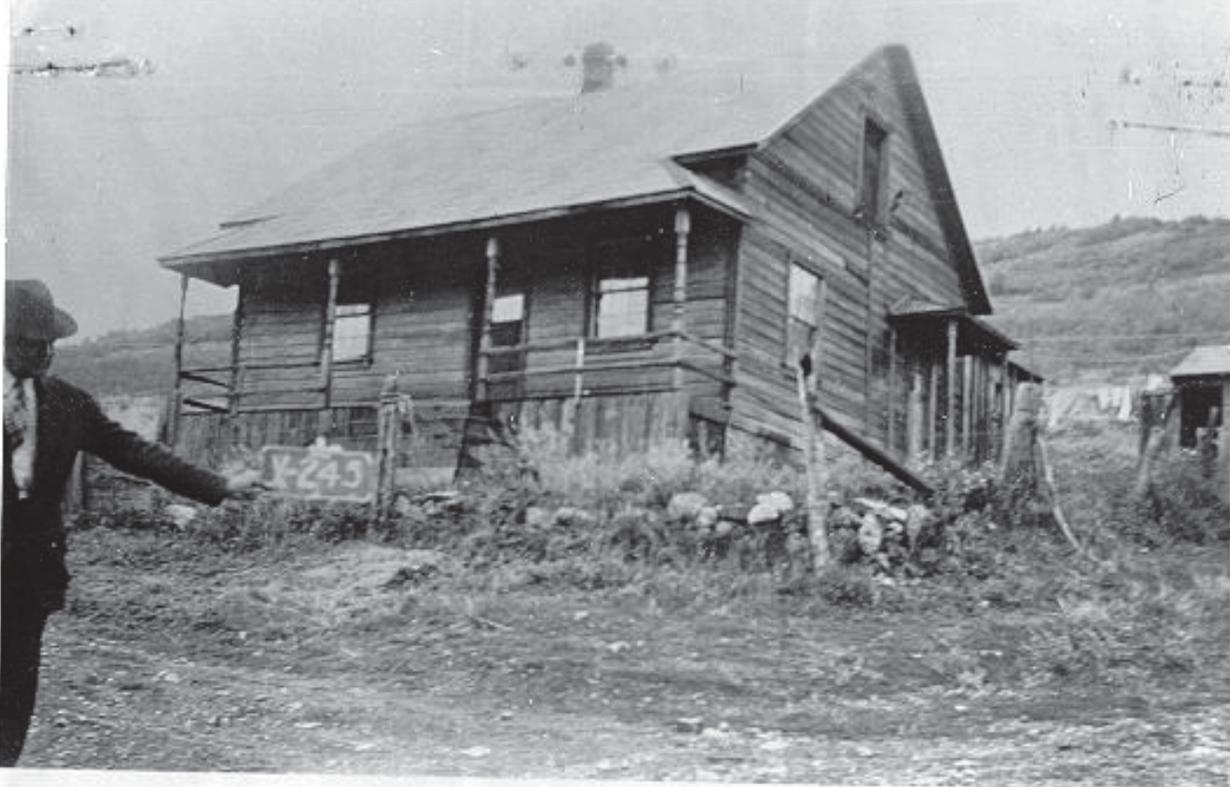
A single photograph from the late-1930s tax assessment depicts the structure in much the same form as it exists today (Exhibit B). One-over-one double-hung windows framed the central entry door on the front porch. The front porch had a hip roof supported by turned porch posts. Horizontal railings framed the porch while vertical siding enclosed the area beneath it. On the west elevation, a side entry porch covered shielded a side door. The one-story rear addition is visible behind the porch. An attic entrance or window is provided at the top of the gable on the west elevation. This photograph documents the appearance of the structure during the Mature Mining Era.

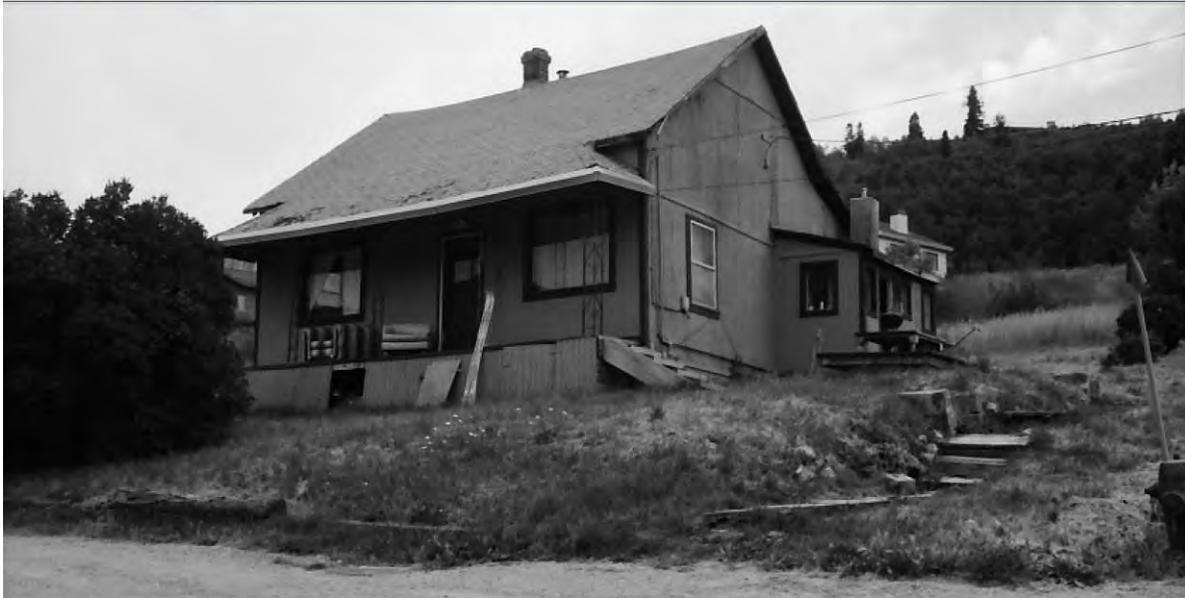
After 1969, the house appears to have been renovated. The double-hung windows on the façade were removed and expanded to install larger, undivided rectangular windows. The original wood double-hung windows throughout were replaced by aluminum windows. The Bricktex siding was covered with new wood vertical siding, concealing the attic window. The turned wood porch posts were replaced with new decorative metal columns. A brick chimney was installed above the enclosed side porch that was later repaired with thick layers of Portland Cement. The following c.1990s photograph shows the house largely as it exists today.

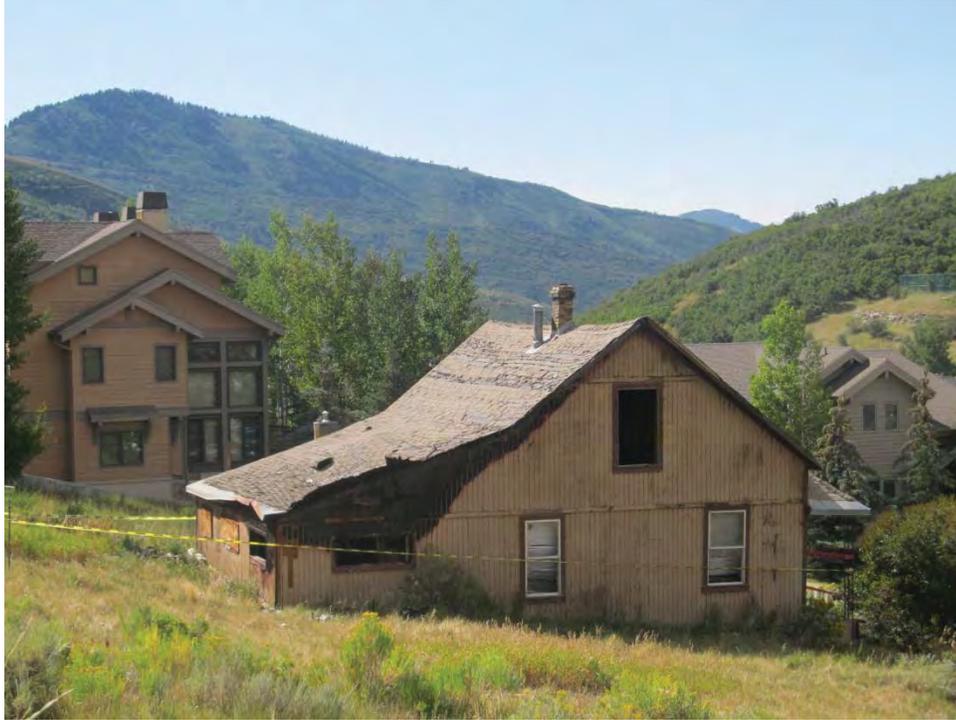
East Elevation (note fire damage)

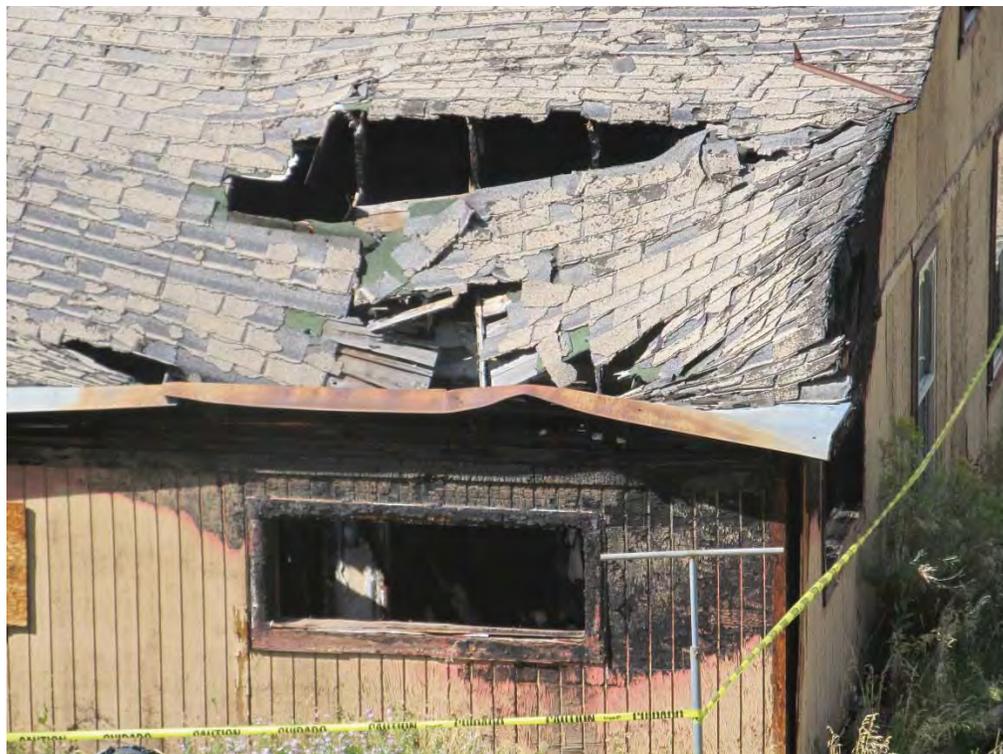
Fire Damage on South Elevation

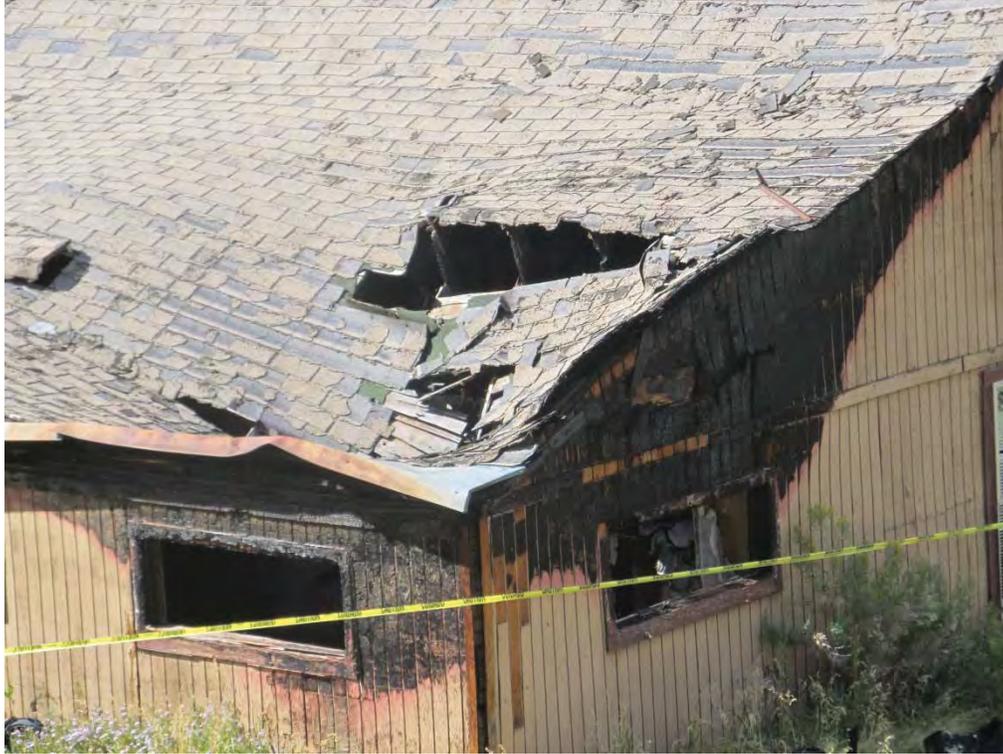
Fire damage at southeast corner

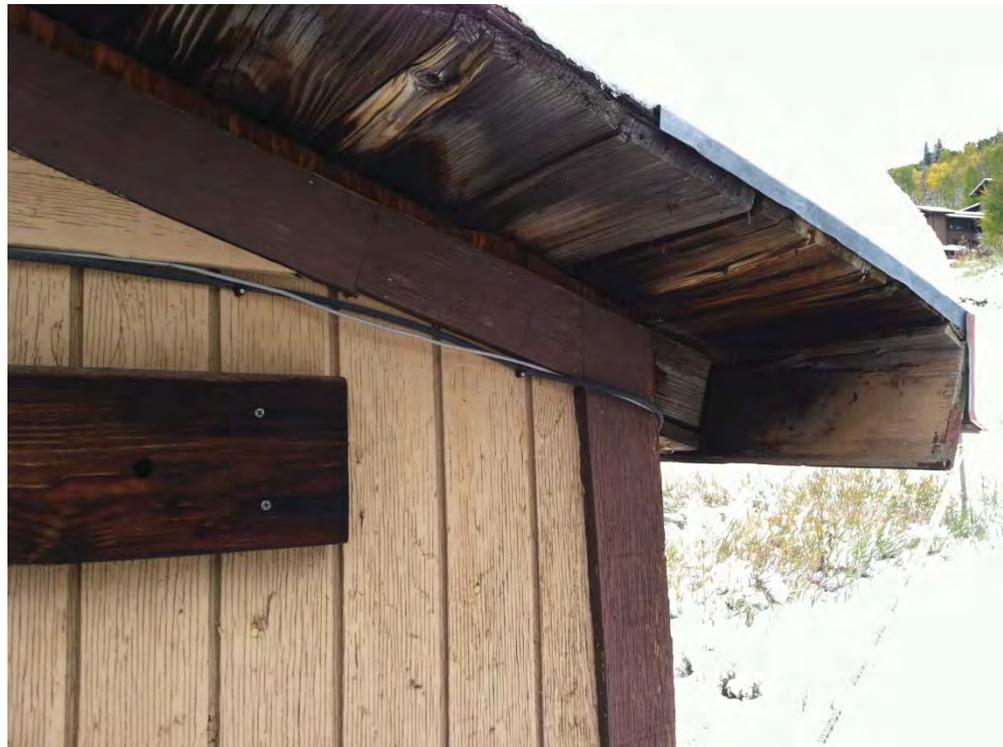
Exposed roof eave, showing old growth timber

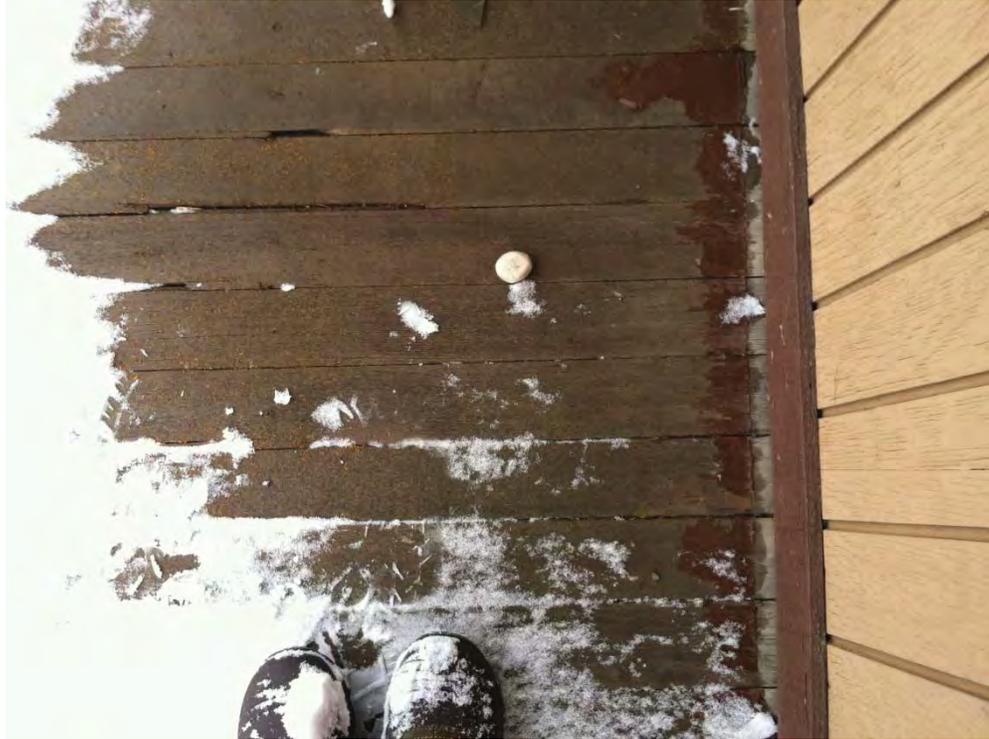
Wood floorboards on porch

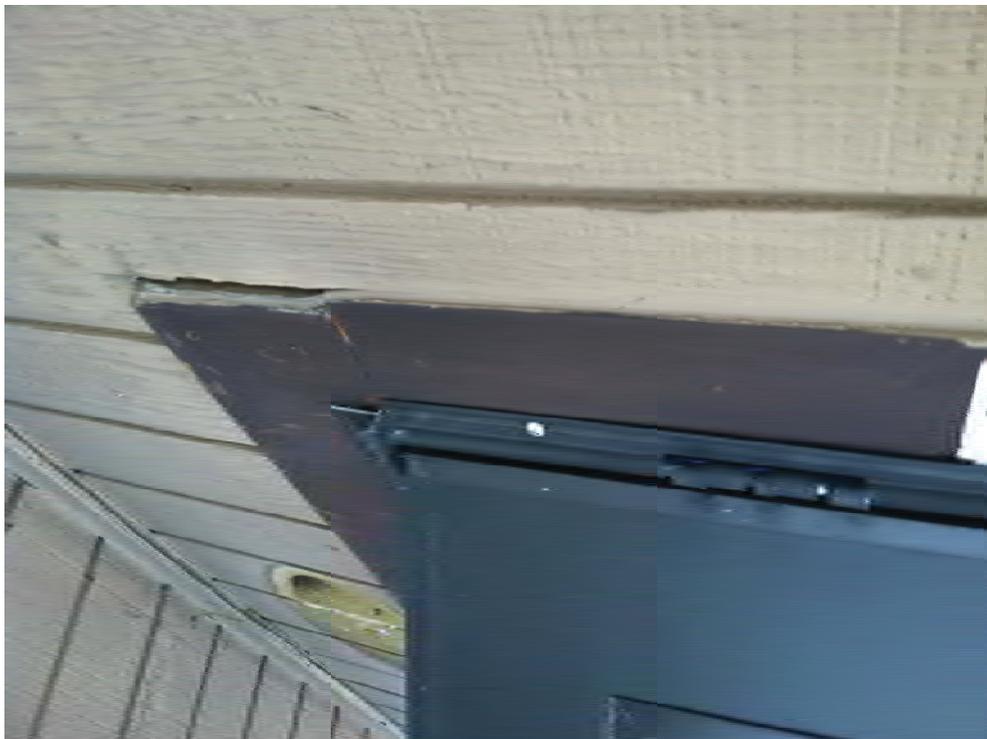
Original wood trim. Note the reveal. Layers of Bricktex and vertical wood siding have hidden much of the reveal on this original trim.

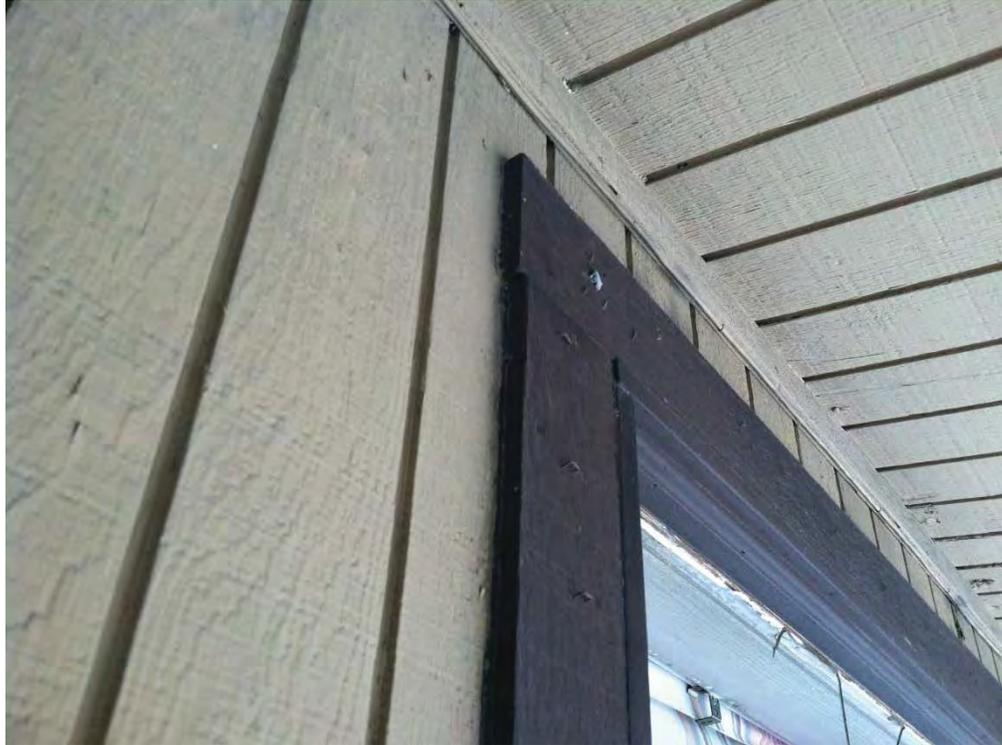
Original wood trim. Note the reveal. Layers of Bricktex and vertical wood siding have hidden much of the reveal on this original trim.

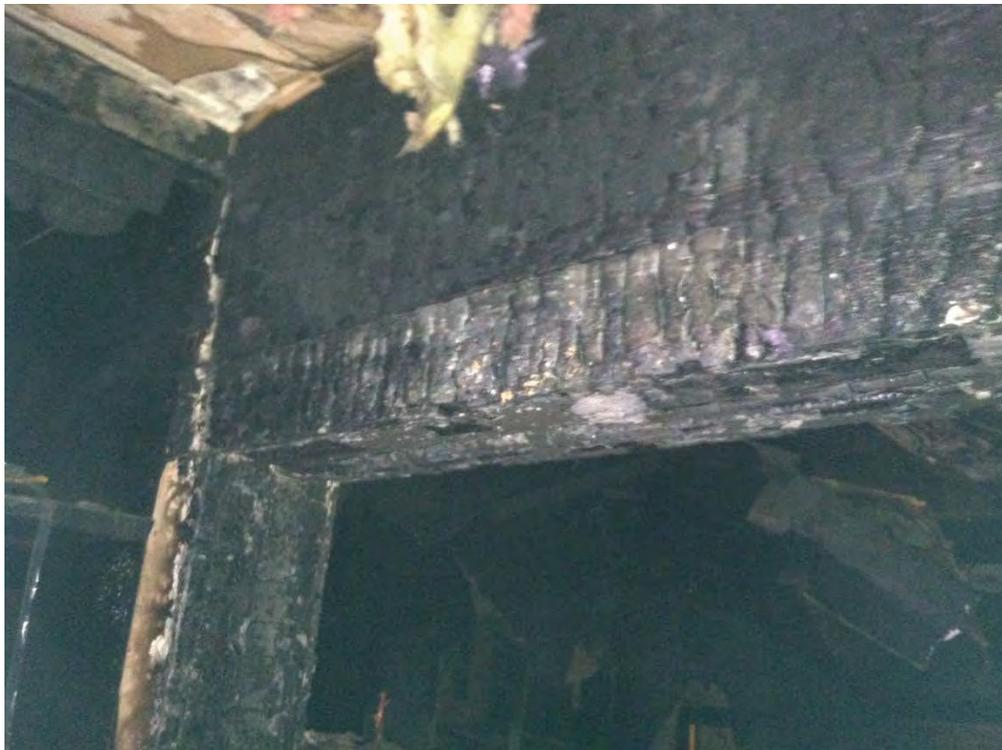
Charred ceiling structure, interior

A fire on May 17, 1999, severely destroyed the rear of the structure. Though it had a negative impact on the rear addition, the remainder of the historic structure remained intact on the hall-parlor portion of the house. Years of deterioration and exposure to the elements should have resulted in greater damage and rapid decline of the exposed walls and roof joists; however, they are in surprisingly fair condition.

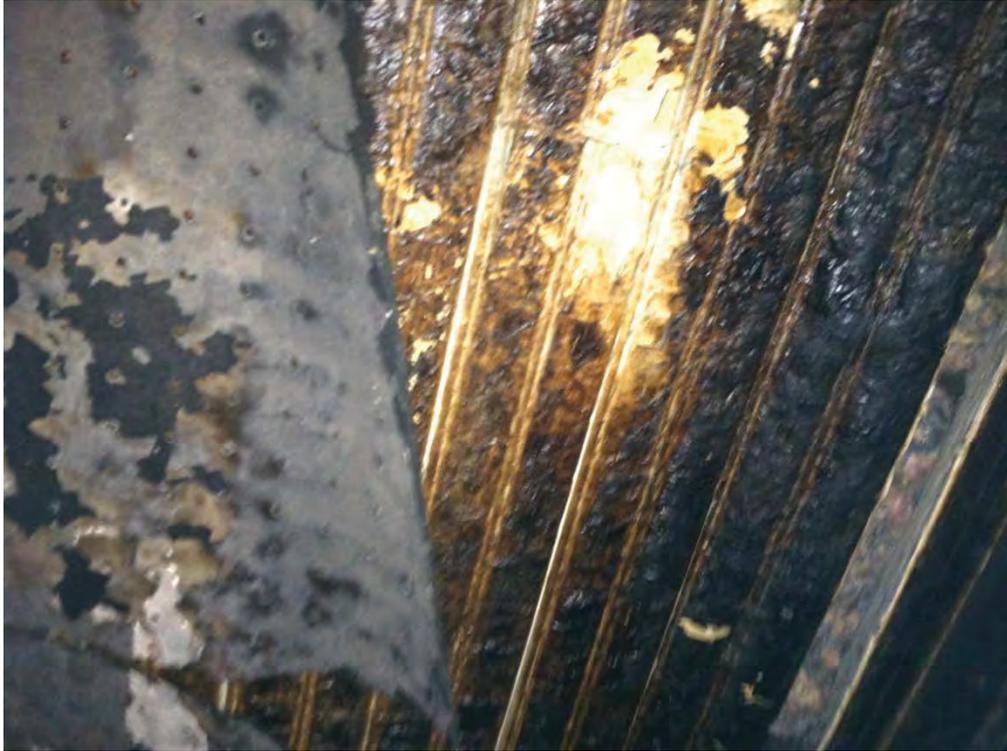
Charred bead-board ceiling in kitchen

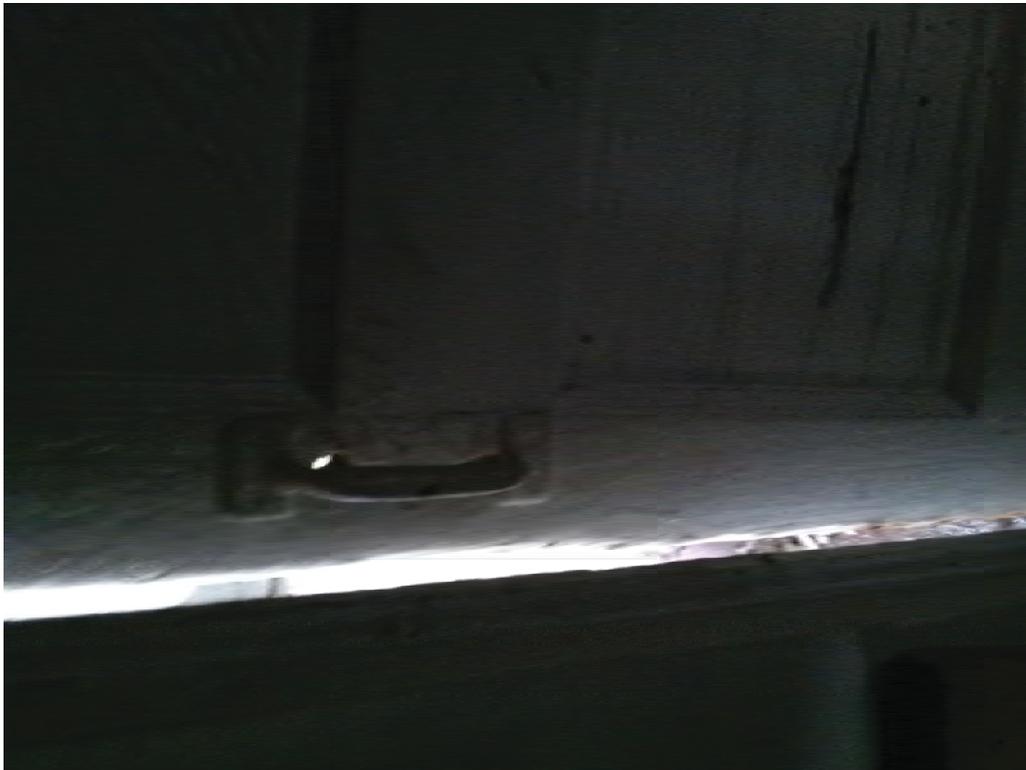
Historic paneled wood door with antique hardware.

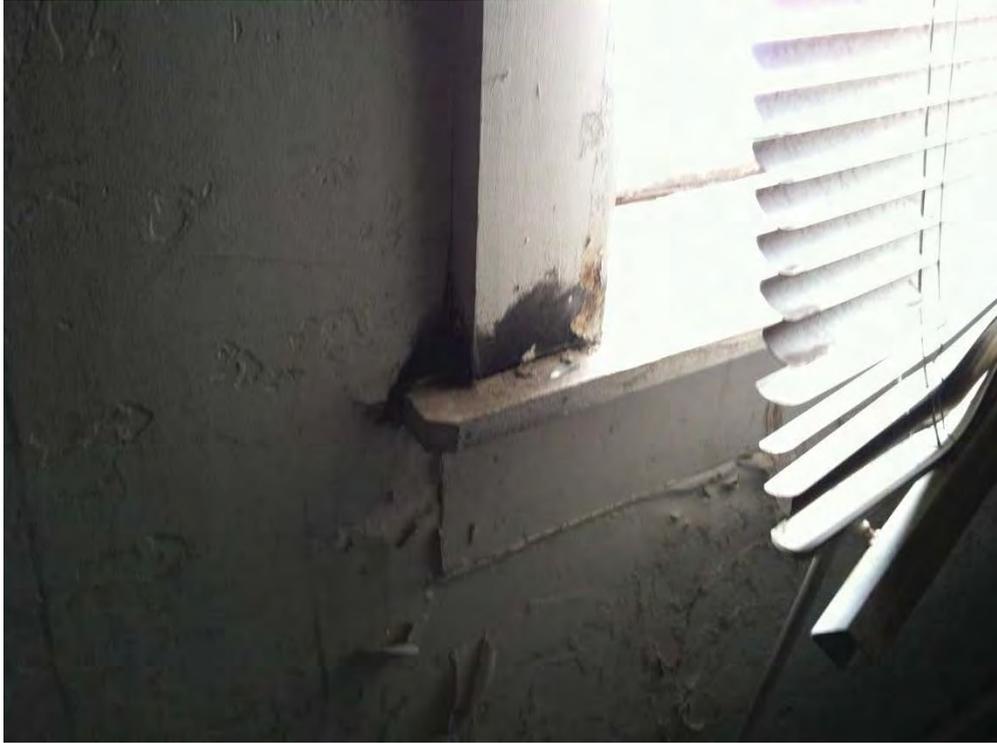
Historic interior wood window trim in front bedroom.

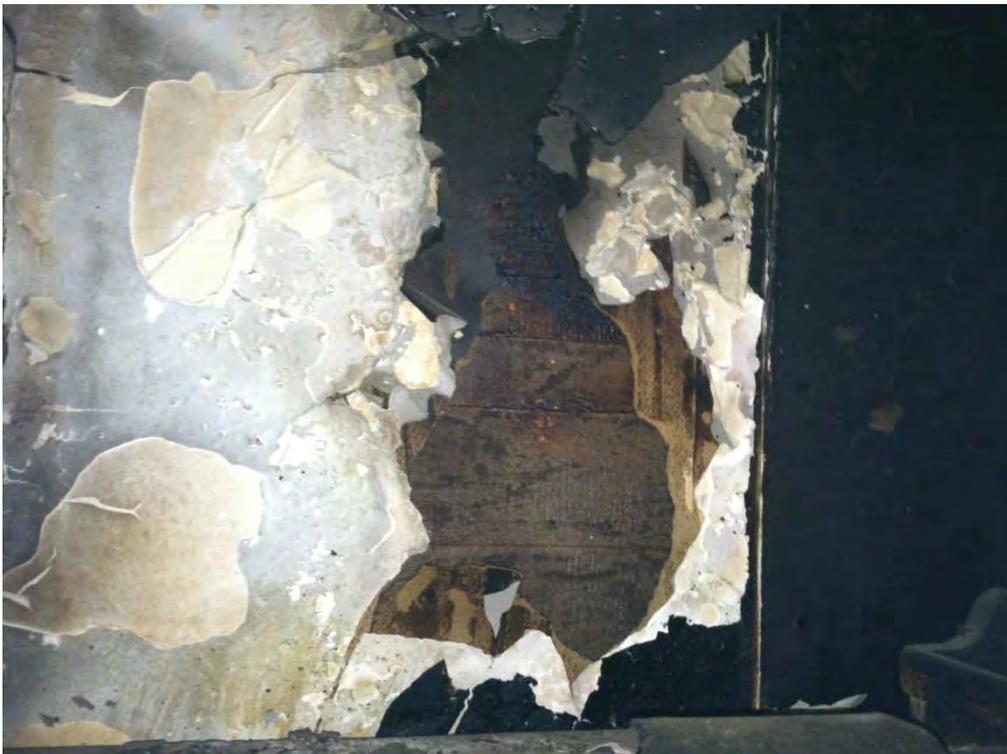
Wall paper applied atop wood wall structure

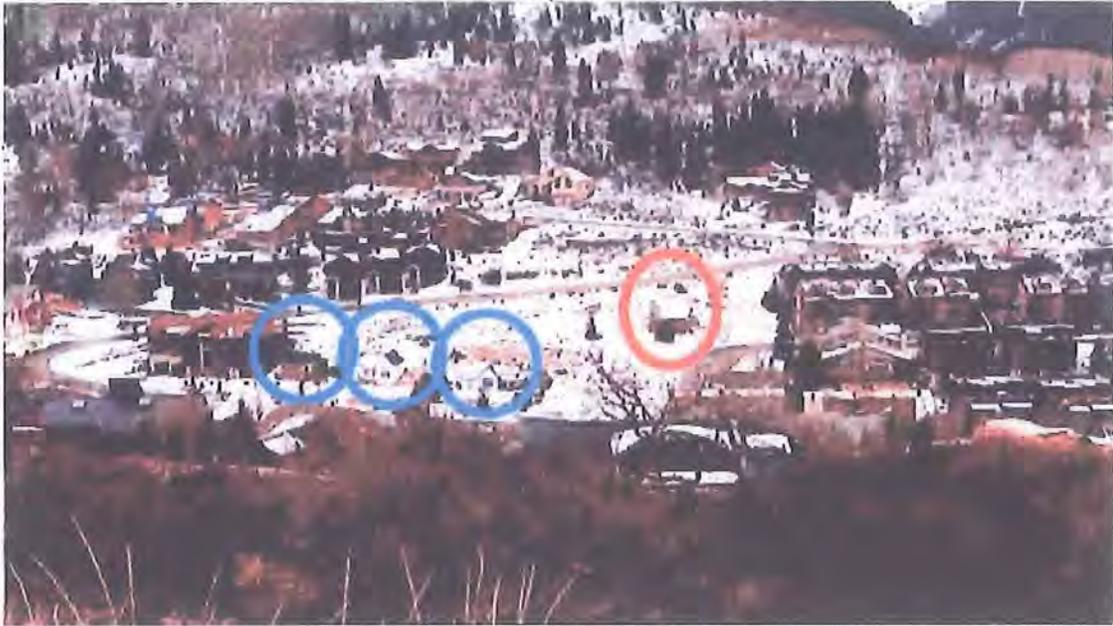
4. This property is a buck tooth in the remaining precinct. This building clearly is an outlier to the remaining three adjacent older buildings. It would be very hard to make the case that this building (red circle below), when considered with the other three, actually adds to the ensemble. It's an ugly buck tooth and it's preservation does not achieve any higher goal in my mind.

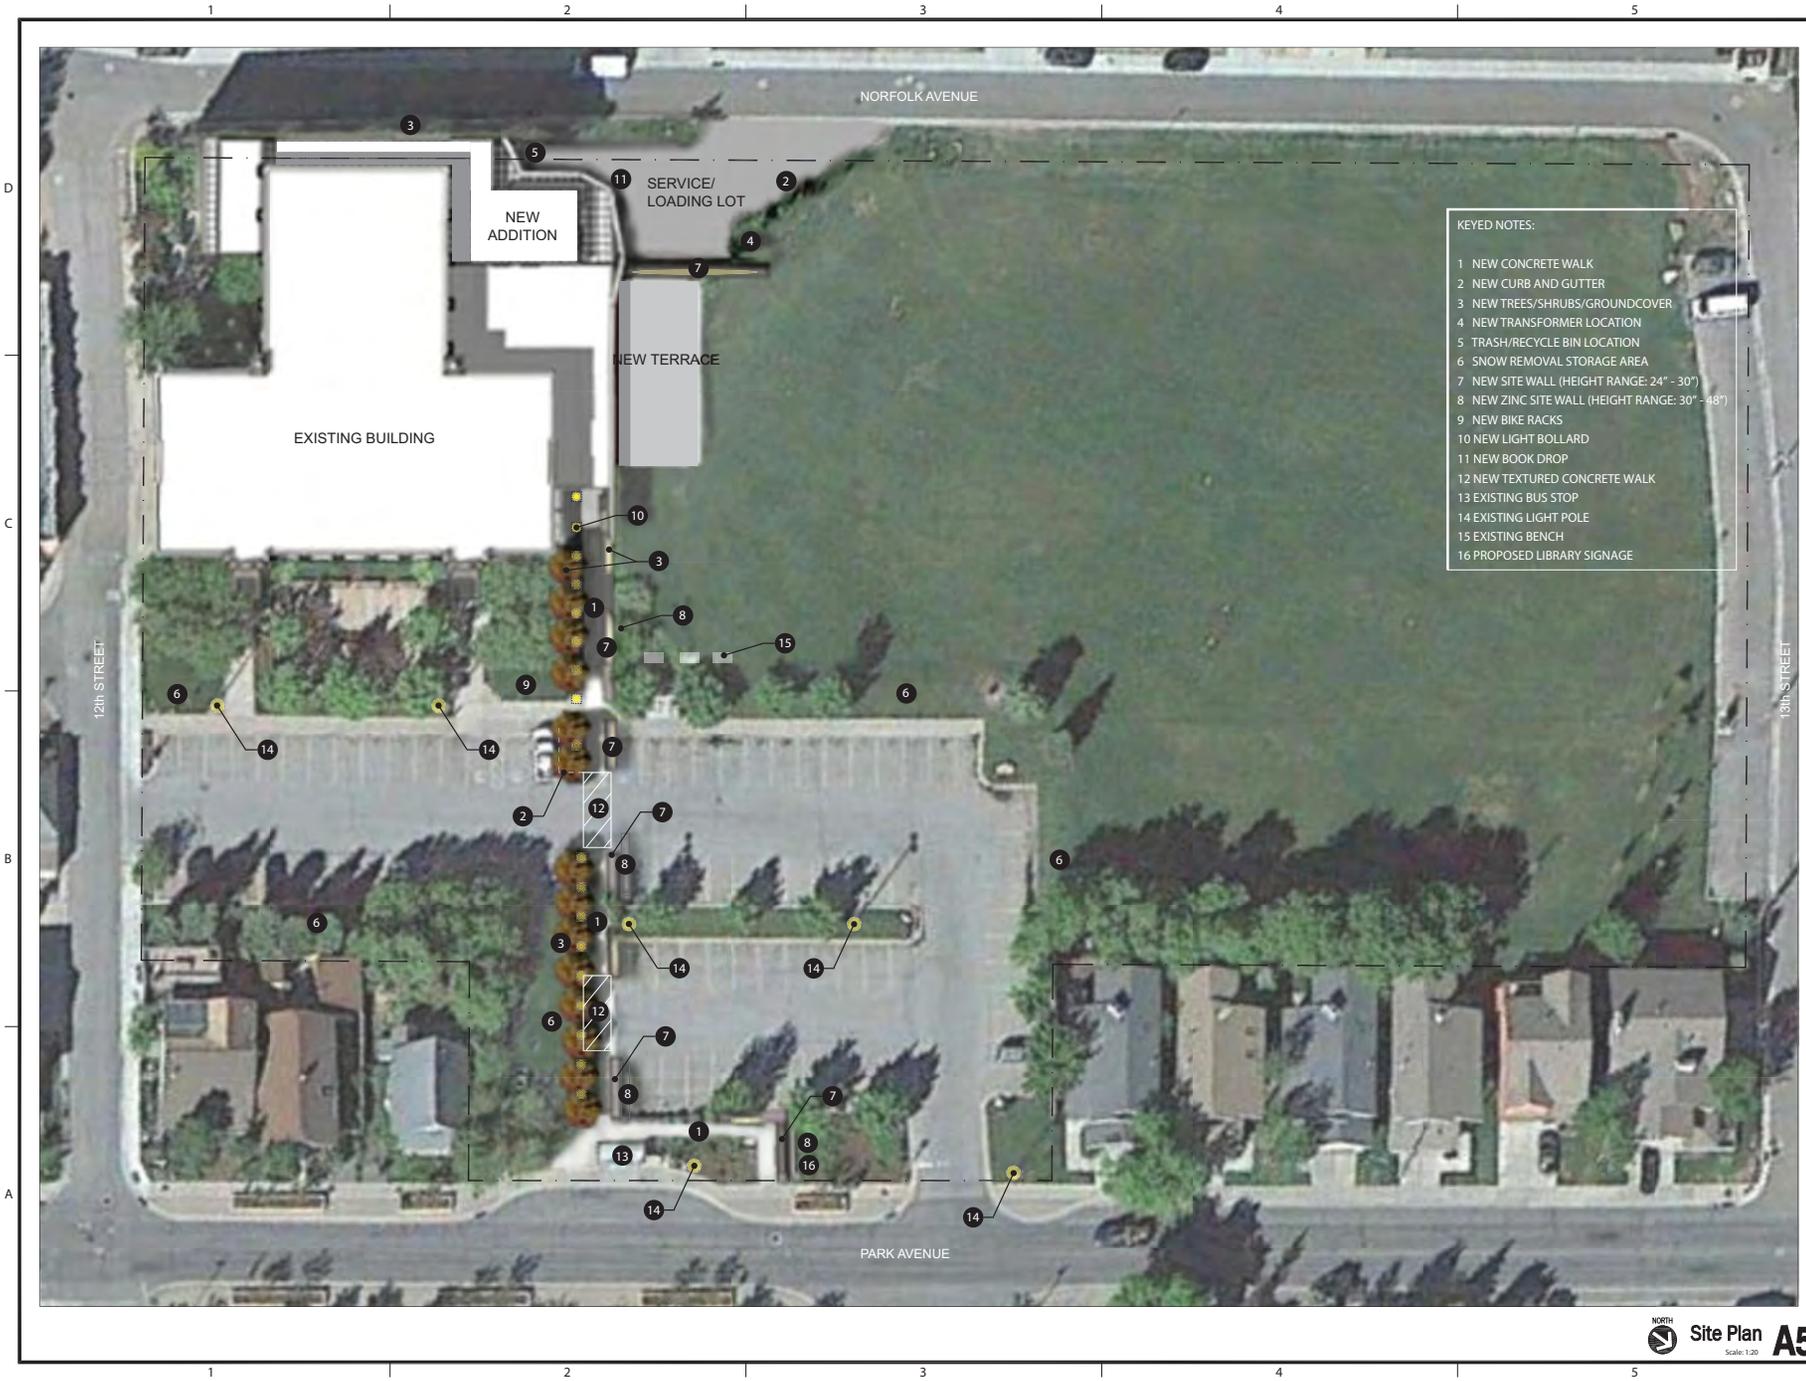
Site Plan AS102
 Scale: 1:20

- KEYED NOTES:**
1. NEW CONCRETE WALK
 2. NEW CURB AND GUTTER
 3. NEW TREES/SHRUBS/GROUNDCOVER - SEE ALSO LANDSCAPE PLAN
 4. NEW TRANSFORMER LOCATION
 5. TRASH/RECYCLE BIN LOCATION
 6. SNOW REMOVAL STORAGE AREA
 7. NEW SITE WALL (HEIGHT RANGE: 24" - 30")
 8. NEW ZINC SITE WALL (HEIGHT RANGE: 30" - 48")
 9. NEW BIRE RACKS (QUANTITY: 13)
 10. NEW LIGHT BOLLARD
 11. NEW BOOK DROP
 12. NEW TEXTURED CONCRETE WALK
 13. EXISTING BUS STOP
 14. EXISTING LIGHT POLE
 15. EXISTING BENCH
 16. VAN ACCESSIBLE ADA PARKING STALL
 17. PROPOSED LIBRARY SIGNAGE

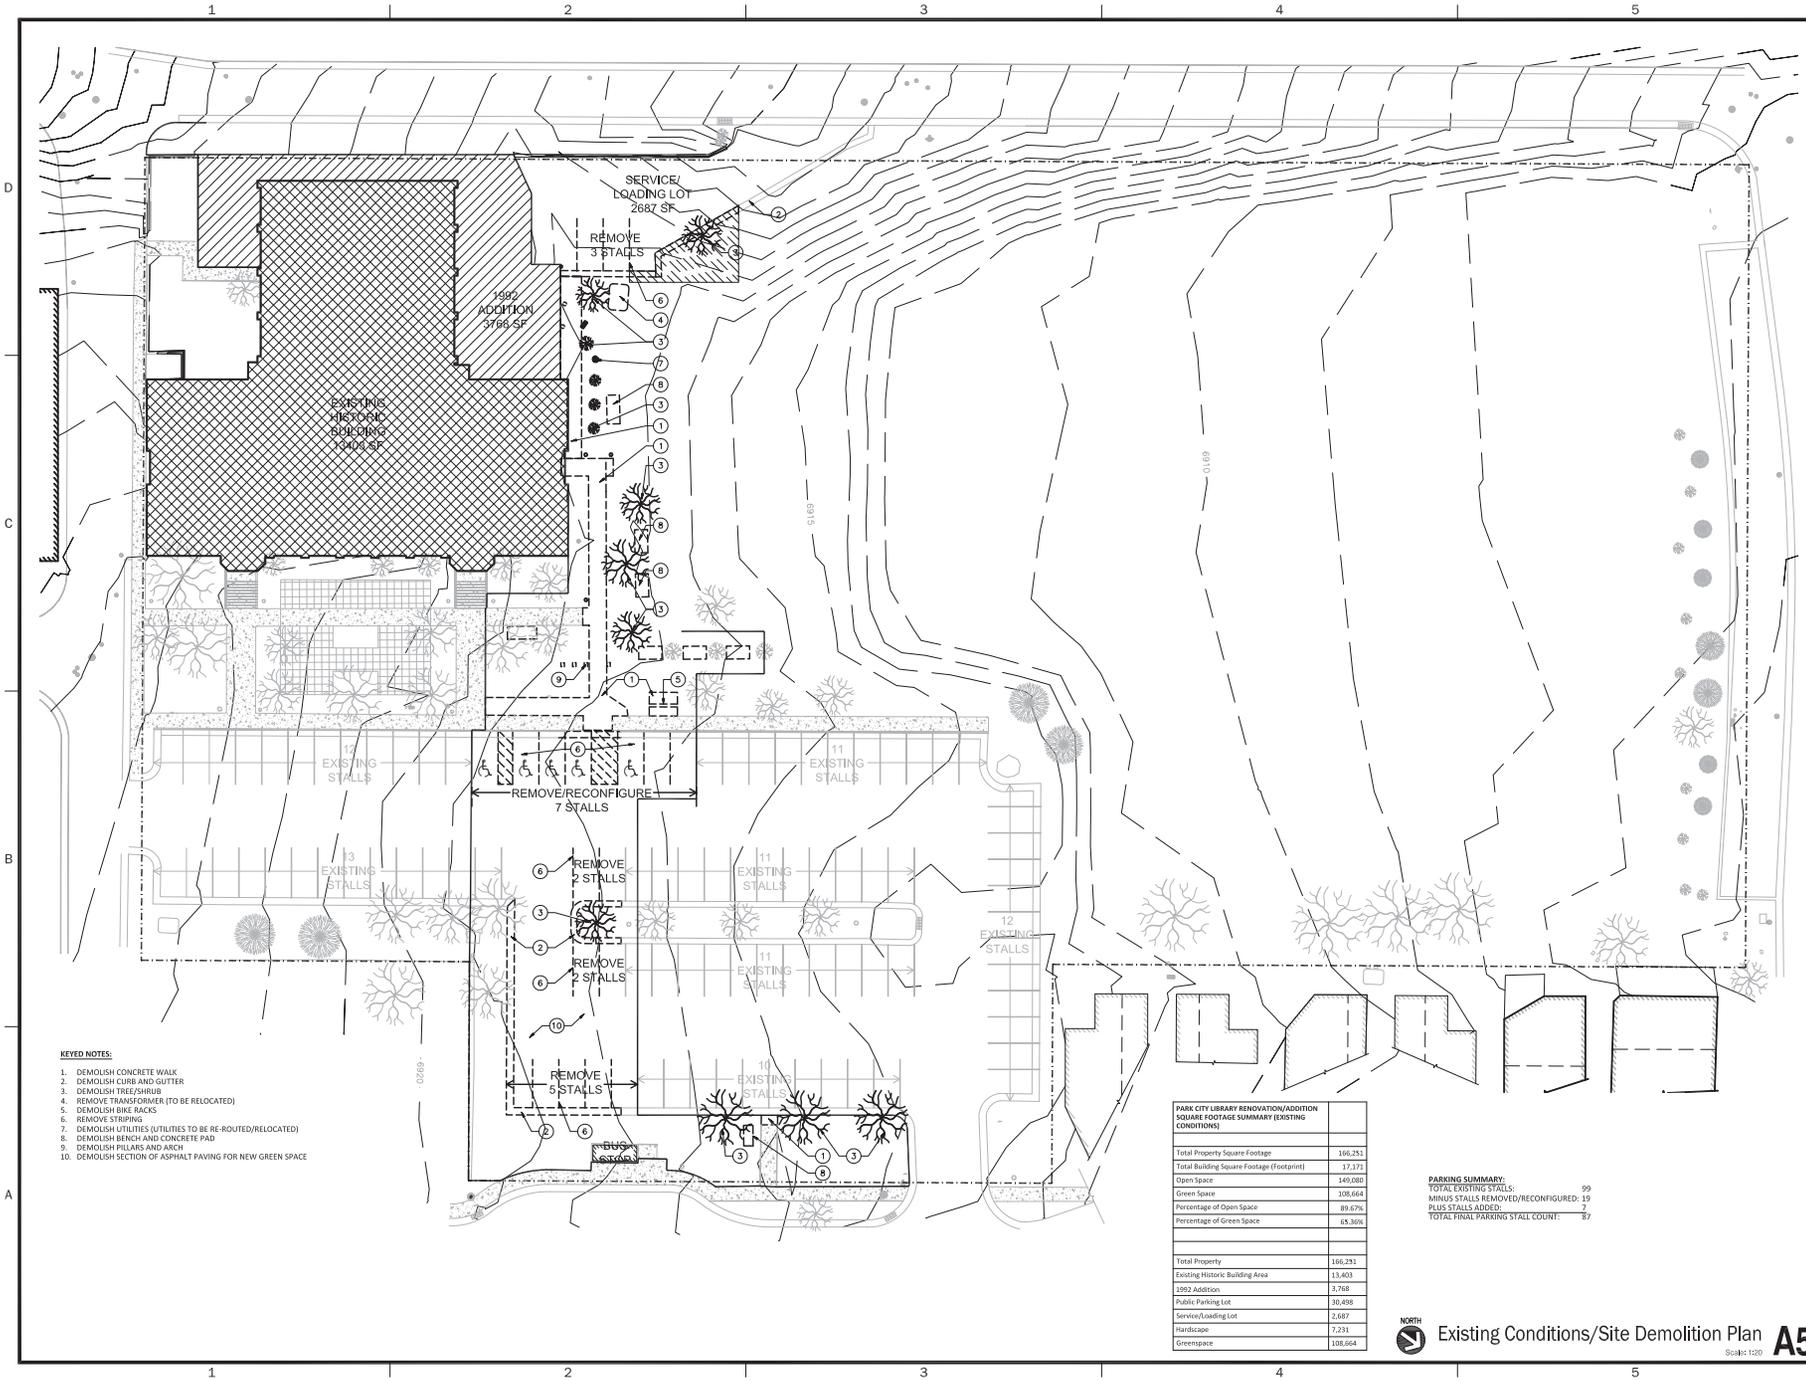
Existing Conditions/Site Demolition Plan
DS101

- KEYED NOTES:**
1. DEMOLISH CONCRETE WALK
 2. DEMOLISH CURB AND GUTTER
 3. DEMOLISH TREE/SHRUB
 4. REMOVE TRANSFORMER (TO BE RELOCATED)
 5. DEMOLISH BIKE RACKS
 6. REMOVE STRIPING
 7. DEMOLISH UTILITIES (UTILITIES TO BE RE-ROUTED/RELOCATED)
 8. DEMOLISH BENCH AND CONCRETE PAD
 9. DEMOLISH PILARS AND ARCH
 10. DEMOLISH SECTION OF ASPHALT PAVING FOR NEW GREEN SPACE

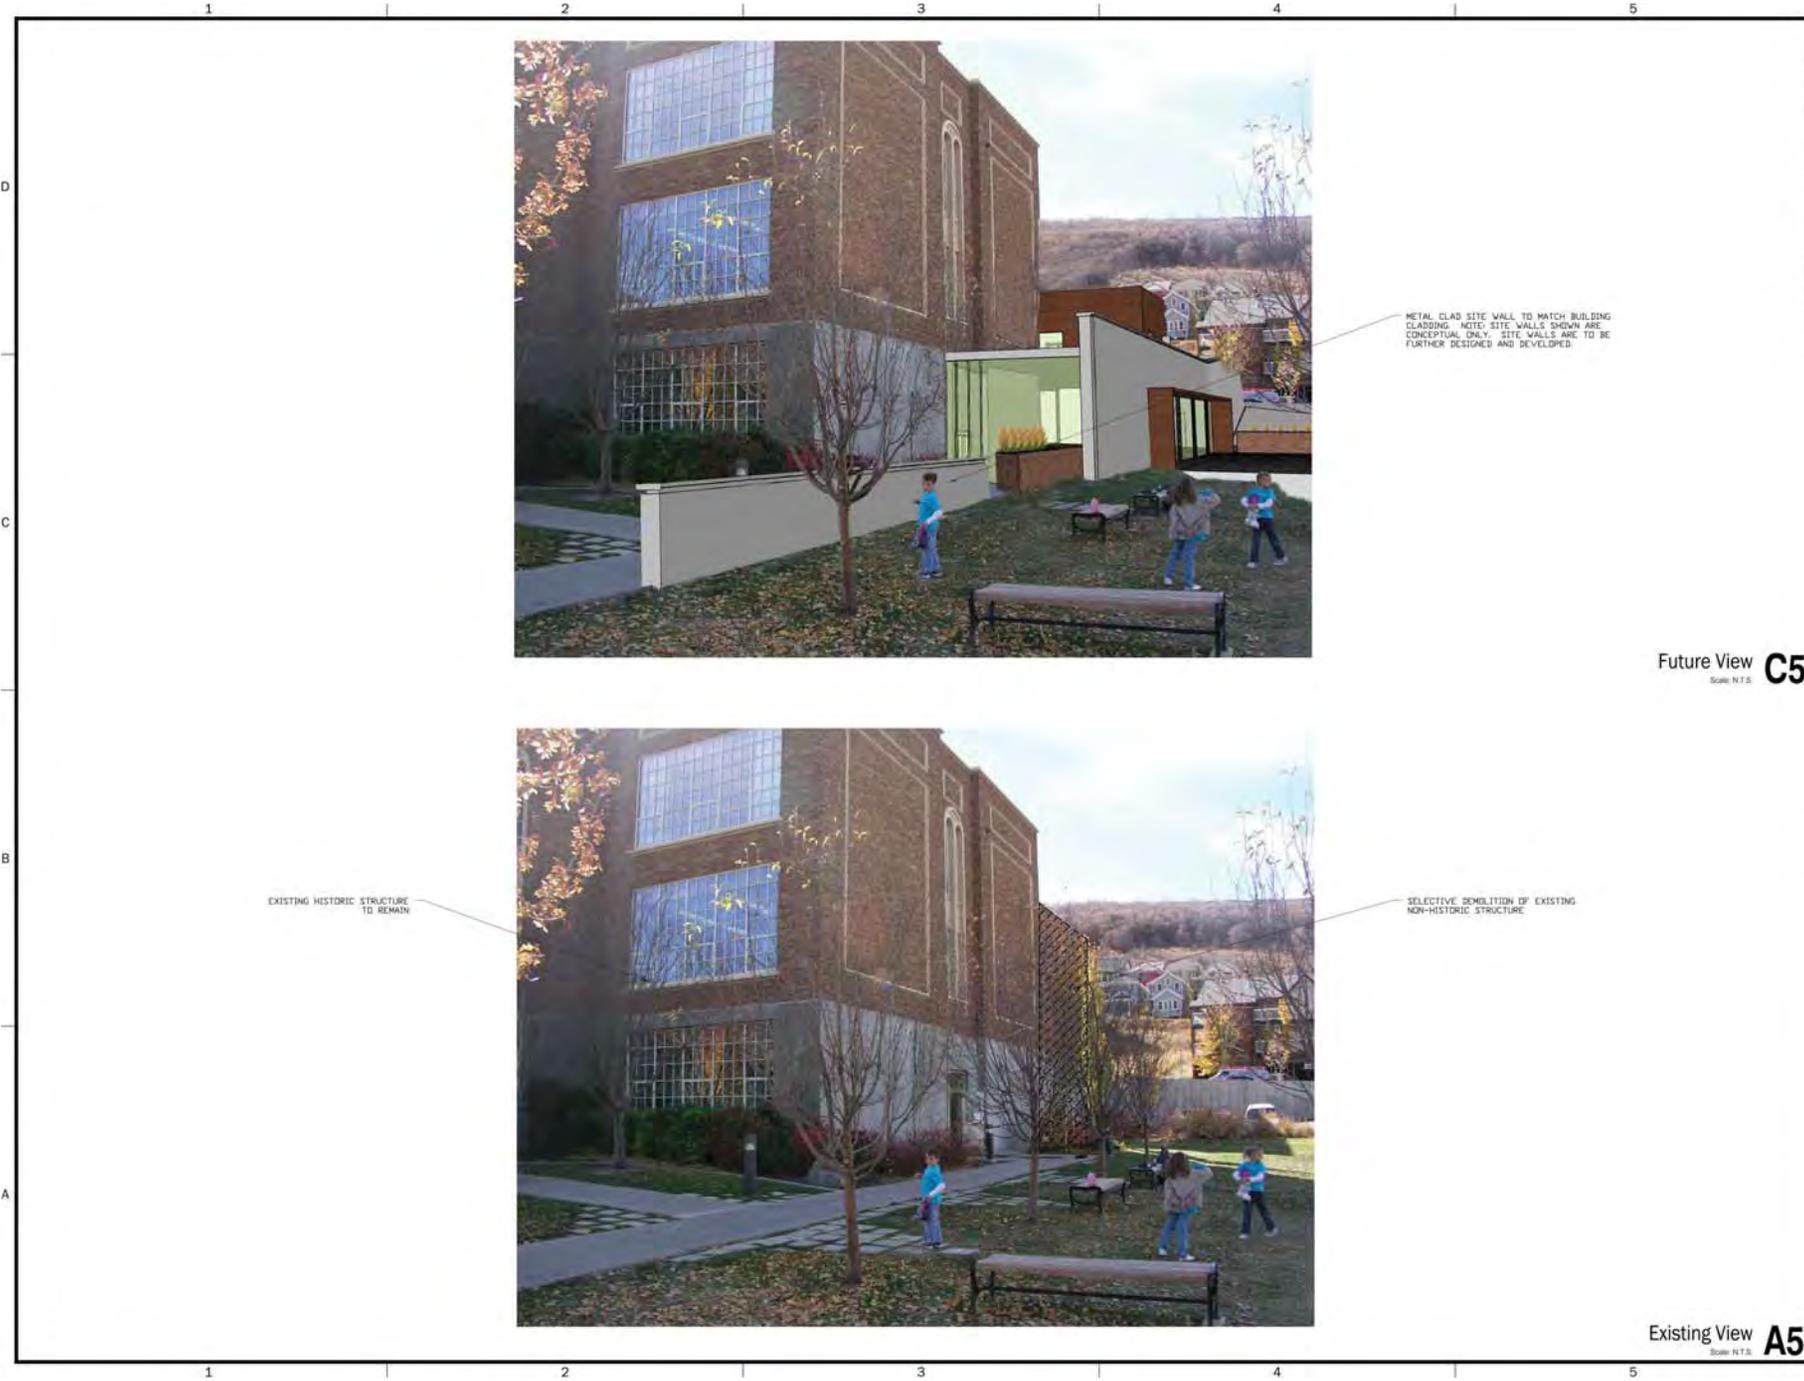
Exterior Views
AR301

METAL CLAD SITE WALL TO MATCH BUILDING CLADDING. NOTE: SITE WALLS SHOWN ARE CONCEPTUAL ONLY. SITE WALLS ARE TO BE FURTHER DESIGNED AND DEVELOPED.

EXISTING HISTORIC STRUCTURE TO REMAIN
