**PARK CITY MUNICIPAL CORPORATION
HISTORIC PRESERVATION BOARD
CITY COUNCIL CHAMBERS
May 21, 2014**

The Board of Adjustment (BOA) remanded the appeal of the Historic Preservation Board's (HPB) Determination of Significance (DOS) of 632 Deer Valley Loop to the HPB due to new evidence submitted by the applicant at the appeal. Staff recommends the HPB review the new evidence and find that the structure meets the criteria for a significant site.

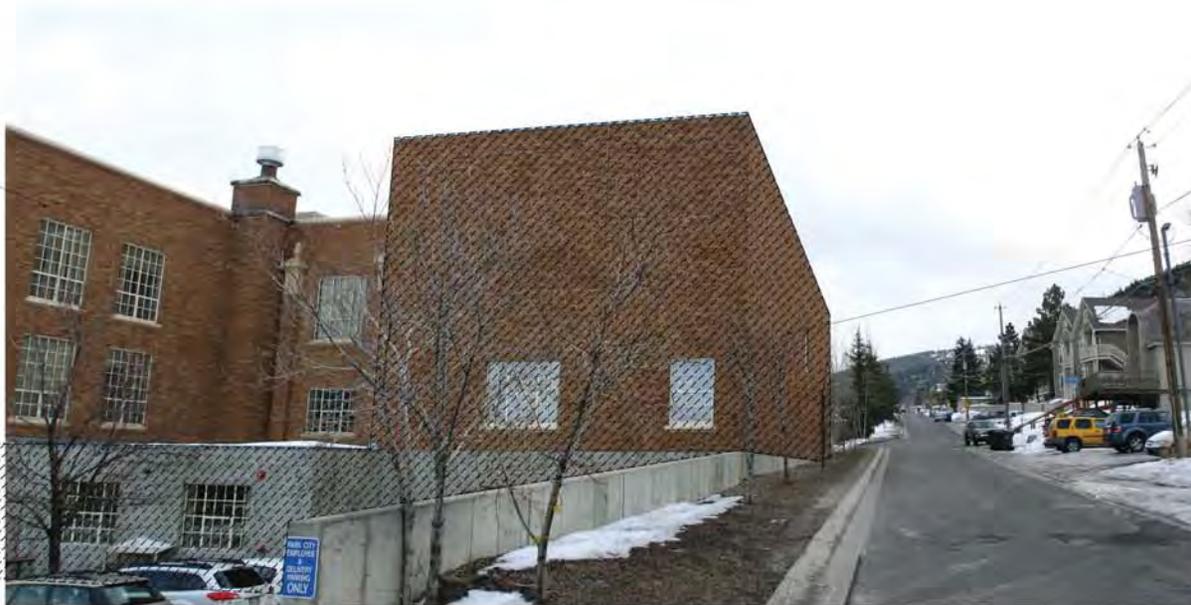
EXISTING HISTORIC STRUCTURE TO REMAIN

SELECTIVE DEMOLITION OF EXISTING NON-HISTORIC STRUCTURE

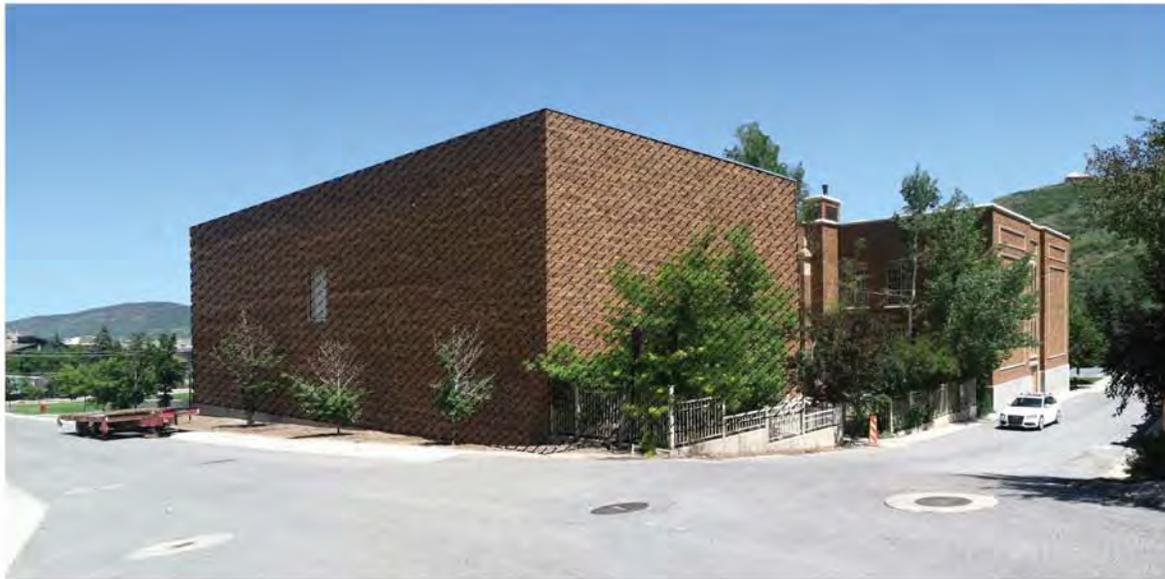
EXISTING HISTORIC STRUCTURE TO REMAIN

SELECTIVE DEMOLITION OF EXISTING NON-HISTORIC STRUCTURE

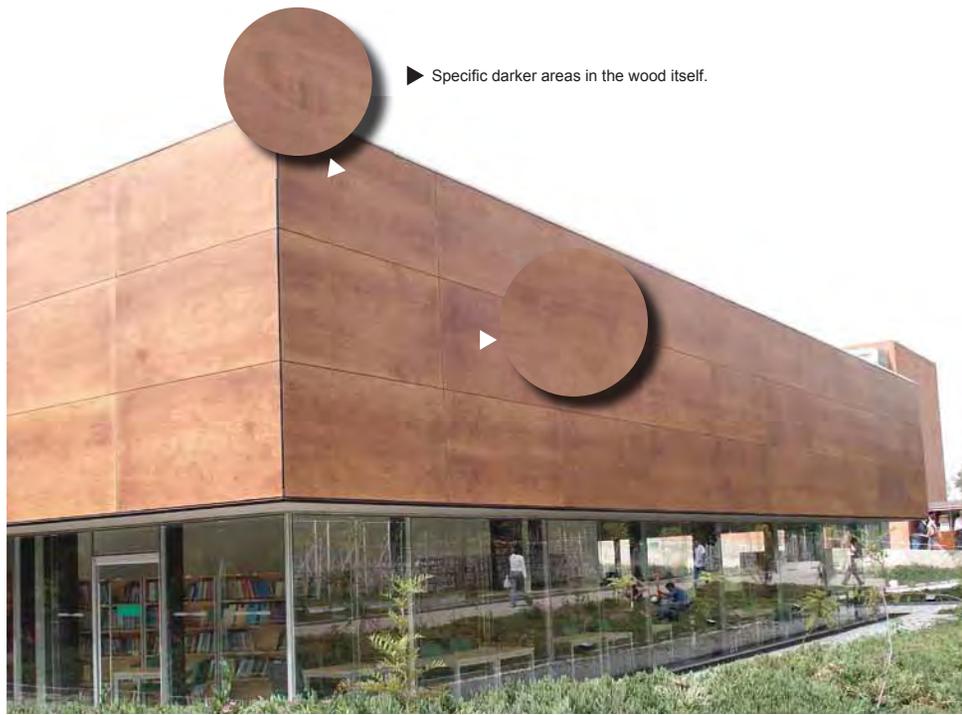
► Transversal mirror images in the wood.

ProdEX belongs to a new generation of products, and **Prodema**, is one of the only companies on the market manufacturing exterior façade panels with wood veneer. **ProdEX** panels may show certain characteristics that are inherent of natural wood itself, such as those indicated in the following examples:

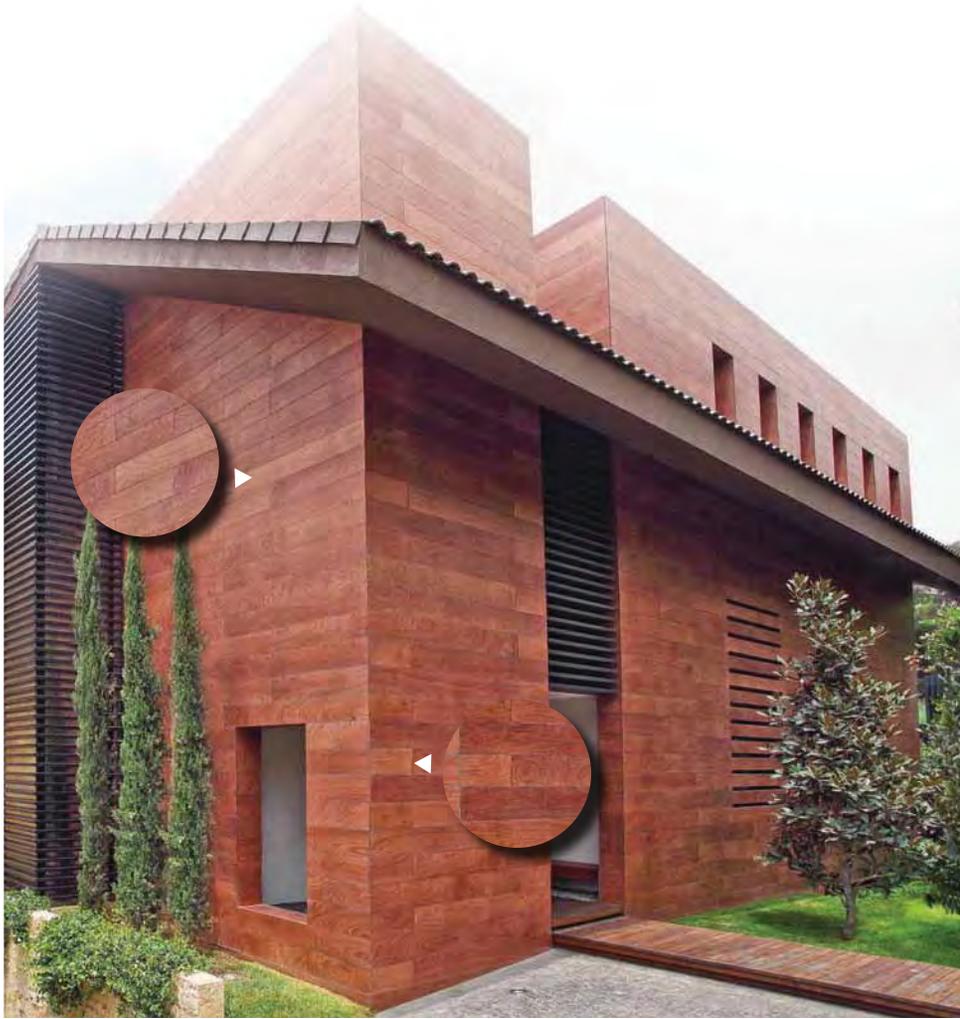
► Variation in colour, shade and shine of different panels made of the same type of wood.

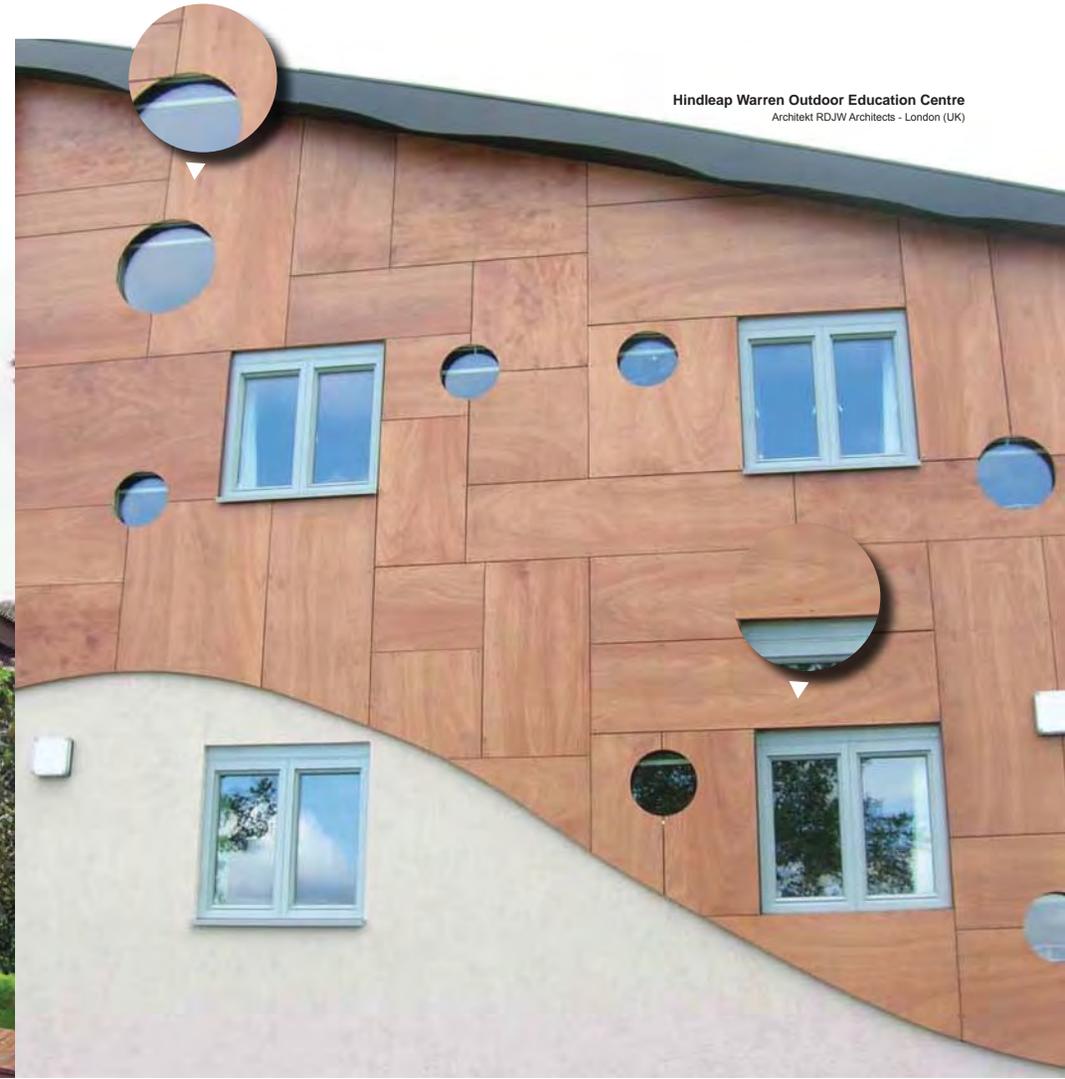
► Knots or holes in the wood coming from the trees themselves.

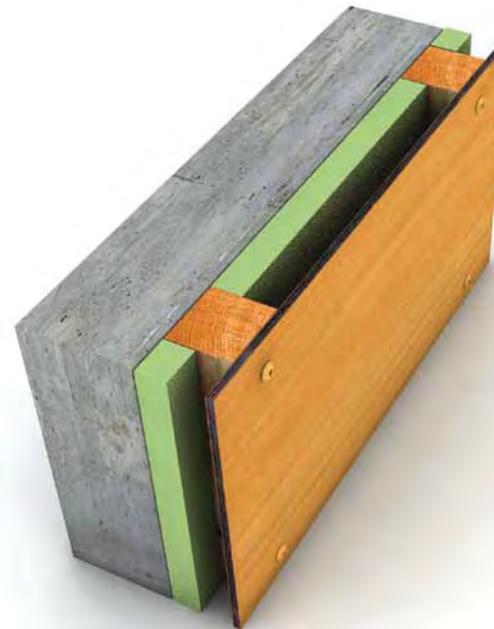
It is essential to use a ventilated façade when mounting **ProdEX** panels. In order for this type of panel to perform correctly, it is very important that the differences in moisture and temperature between both sides of the panel are kept to a minimum. A ventilated façade has several advantages over a conventional façade:

- A ventilated façade provides us with waterproofing against rain and prevents water from penetrating into the air chamber.
- It evenly spreads the water vapour from the building's interior to the exterior.
- A ventilated façade generates constant air ventilation and prevents moisture from getting trapped and dampening the insulation.

- It reduces movements of the building's structure due to the fact that, as it ventilates the façade, temperature changes are reduced.
- It reduces heat bridges to a minimum.
- It achieves an energy saving of between 5 and 10%, as it absorbs less heat in summer and disperses less heat in winter.
- Easy to mount and dismantle, and it is a good solution for restorations.
- It improves sound insulation.

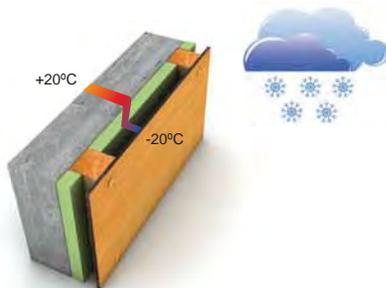
In order for the **ProdEX** ventilated façade to function correctly, both sides of the board must be exposed to the air. To do so, it is important to bear in mind these main points:

- The air space between the panels and the insulation or closure must be at least 20 mm, and all national or local legislation indications must also be observed. For example, the Technical Building Code (CTE) in Spain indicates a space of 30 mm to 100 mm.
- Leave an opening of at least 20 mm in the lower and upper part of the façade, as well as in the doors and windows, so that air can circulate vertically.
- We recommend you use only vertical strips, as they do not interfere with air circulation. Should you use horizontal strips that make vertical ventilation difficult, there must be perforations in said strips to allow 20 cm²/m of ventilation for coverings on façades with a height of up to 1 metre, and 50 cm²/m for coverings on façades with a height of over 1 metre.

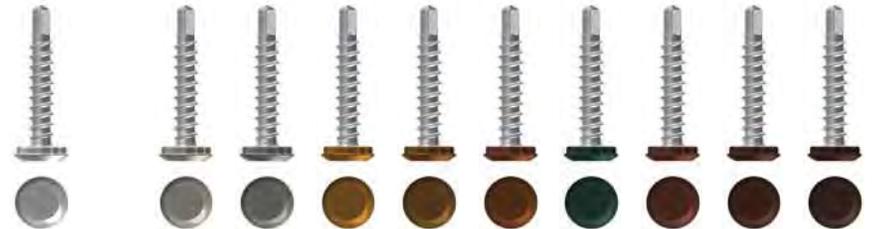
Self-threading screws SFS-SX3-L-12

Ref: Self-drilling screw SFS-SX3-L12-5.5 x 32
Clamping length: ≤ 17 mm.
Size: \varnothing head: 12 mm.
 \varnothing screw: 5.5 mm.
L: 32 mm.
Material: Austenitic stainless steel 1.4567.
Finishes: Lacquered (pg. 76) or not lacquered.

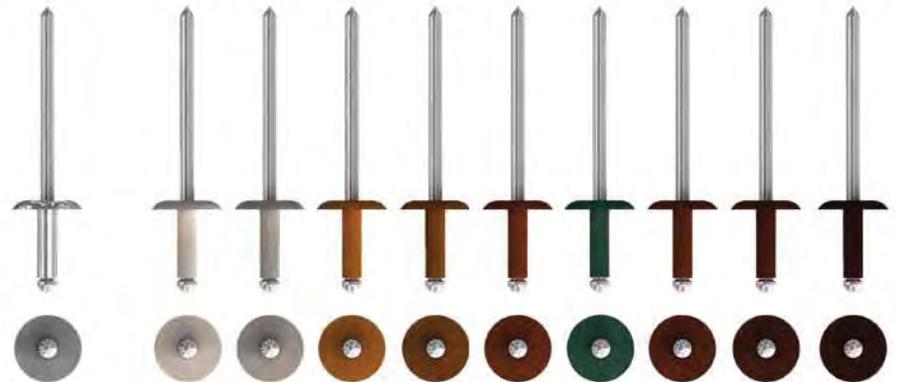
Rivets SFS-AP-16-50XXX

Sizes:
 \varnothing head: 16 mm.
 \varnothing rivet: 5 mm.
 \varnothing head thickness: 1.5 mm.
 \varnothing shaft thickness: 2.7 mm.
L: 16, 18 y 21 mm.
Materials:
Body: AlMg5.
Stem: Stainless steel 1.4541.
Finishes: Lacquered (pg. 76)
or not lacquered.

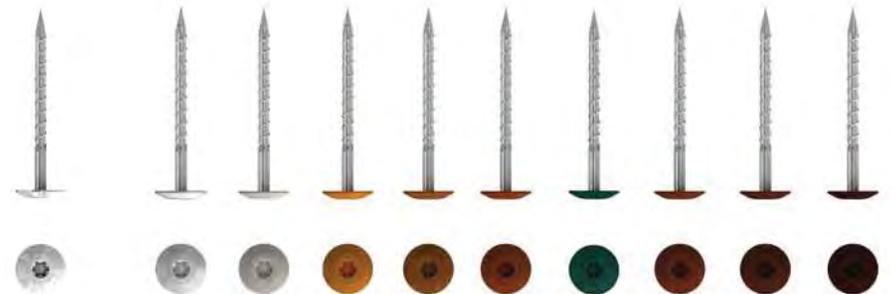
Screws SFS-TW-S-D12-4.8 x 38

Ref: Screw SFS - TW - S - D12 - 4.8 x 38.
Size: \varnothing head: 12 mm.
 \varnothing screw: 4.8 mm.
L: 38 mm.
Material: Austenitic stainless steel 1.4567.
Finishes: Lacquered (pg. 76) or not lacquered.

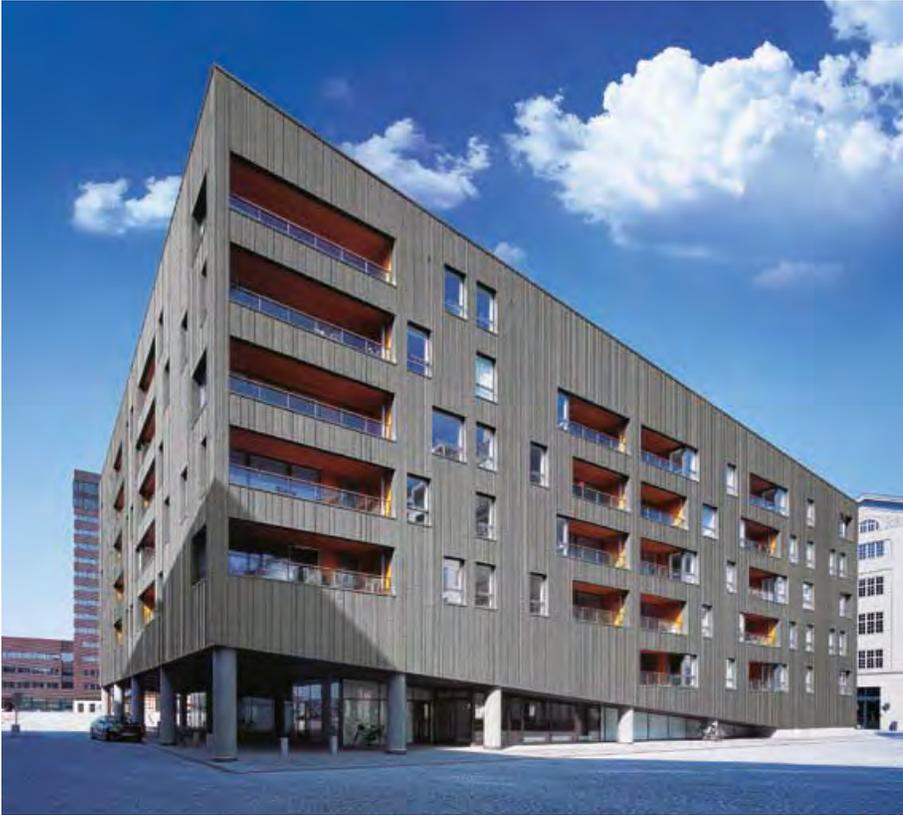
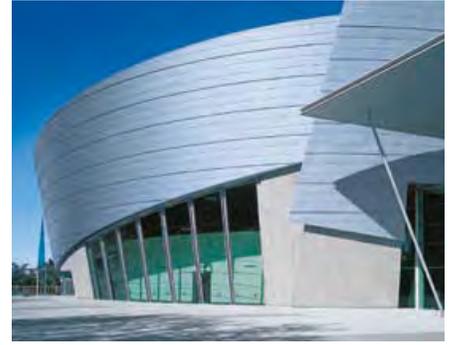
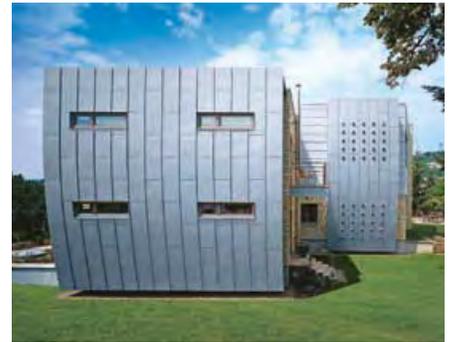
RHEINZINK-Standing Seam Panels

The RHEINZINK-Angled Standing Seam System, commonly used on facades, exhibits strong linear shadows produced by its angled seam configuration. The widespread availability of standing seam fabrication machines ensures consistent forming of panel edges as well as closing of the seams. Differing panel lengths and widths make it possible to achieve even the most complicated geometries. The angled standing seam system can be oriented horizontally, vertically and diagonally.

- Suitable for most building types
- Accommodates complicated geometries
- Can be installed horizontally, vertically or diagonally

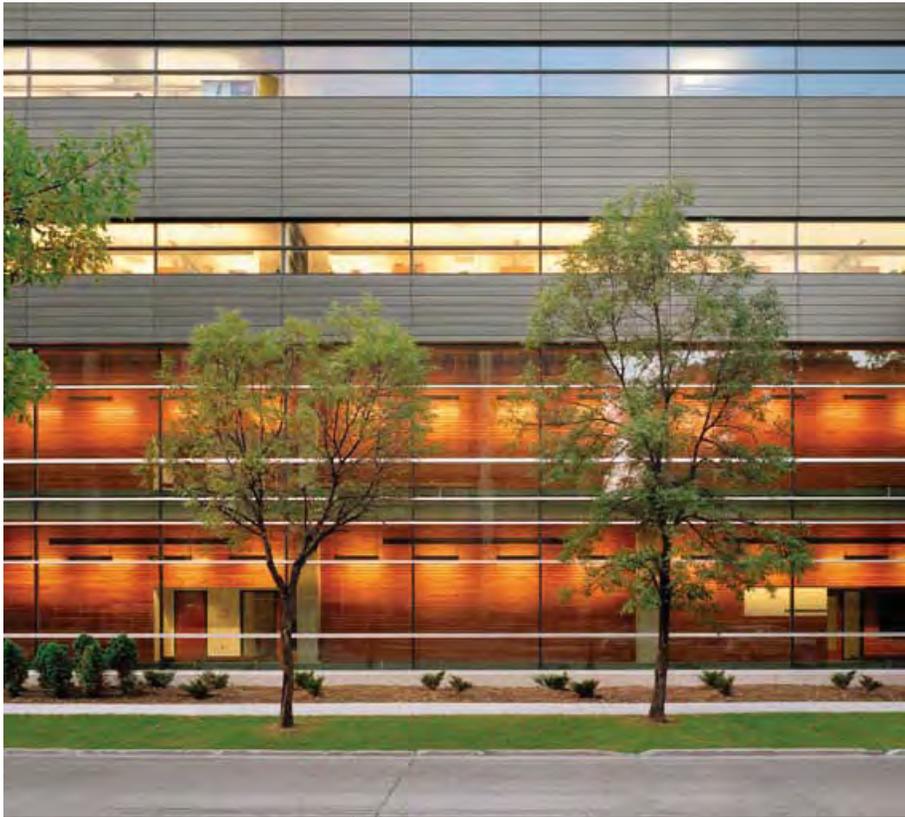
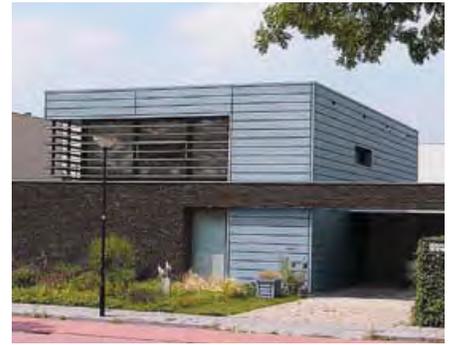
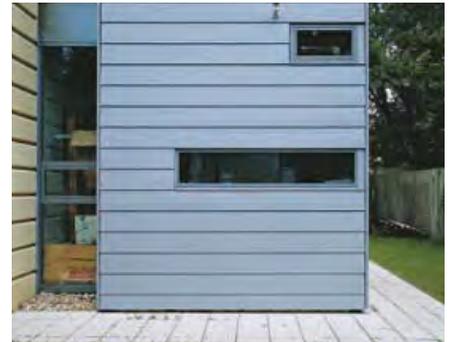
RHEINZINK-Shiplap Panel

Due to its layered characteristics and shadow less joints, the shiplap panel is a unique cladding, reminiscent of wooden façades. When exposed to light and shade, sharp contours appear because of its profile geometry. Contrary to the horizontal and vertical reveal panels, this system does not have any reveals. Precision manufacturing (in accordance with detailed planning and pre-defined panel dimensions) guarantees efficient and optimum installation on site.

- Layered panel look
- Horizontal installation
- Scalloped design

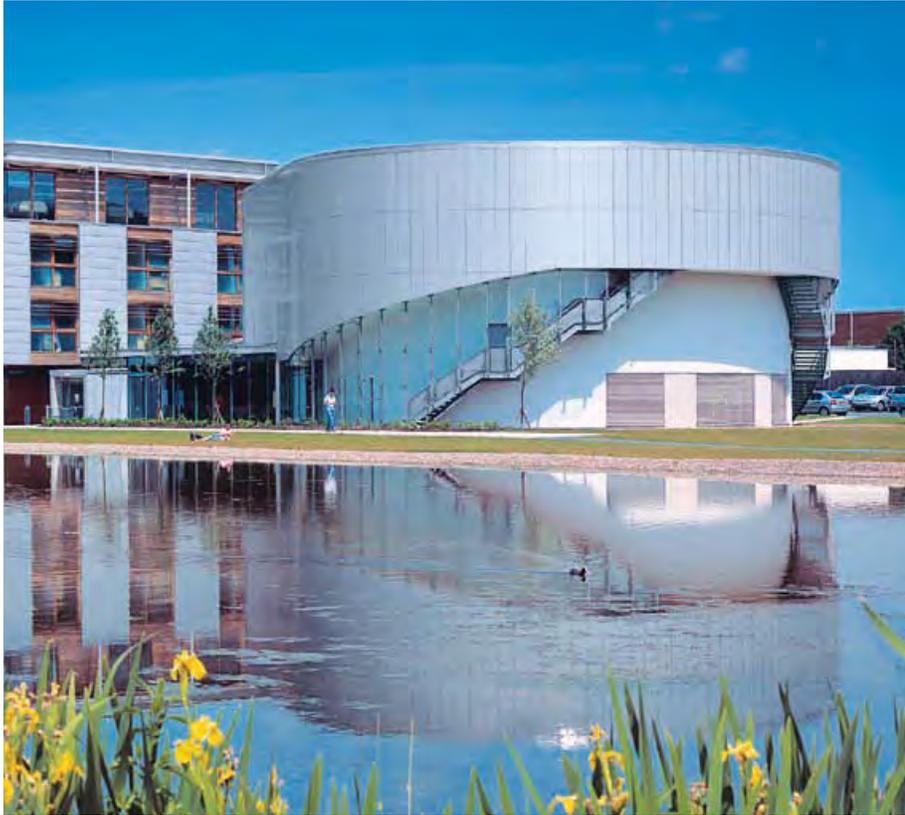
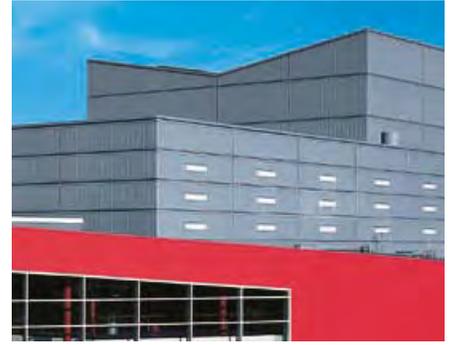
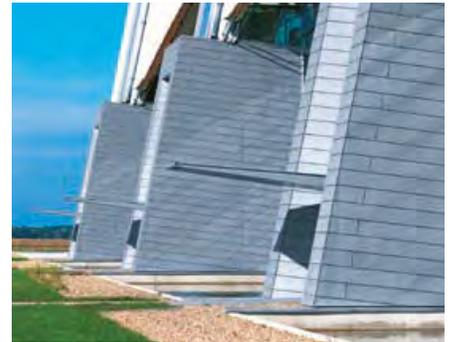
RHEINZINK-Reveal Panels

Along with the horizontal reveal panels, the vertical reveal panels have a variable reveal width ranging from 0-1". With the flexibility of vertical and horizontal installation, the reveal panel offers the designer an exceptional amount of freedom in implementing their ideas. Solutions may be executed quickly when it comes to renovations or retrofitting installations. Installation of this system is done from top to bottom.

- Can be installed horizontally and vertically
- Face width to 13" for horizontal applications
- Face width to 16" for vertical applications

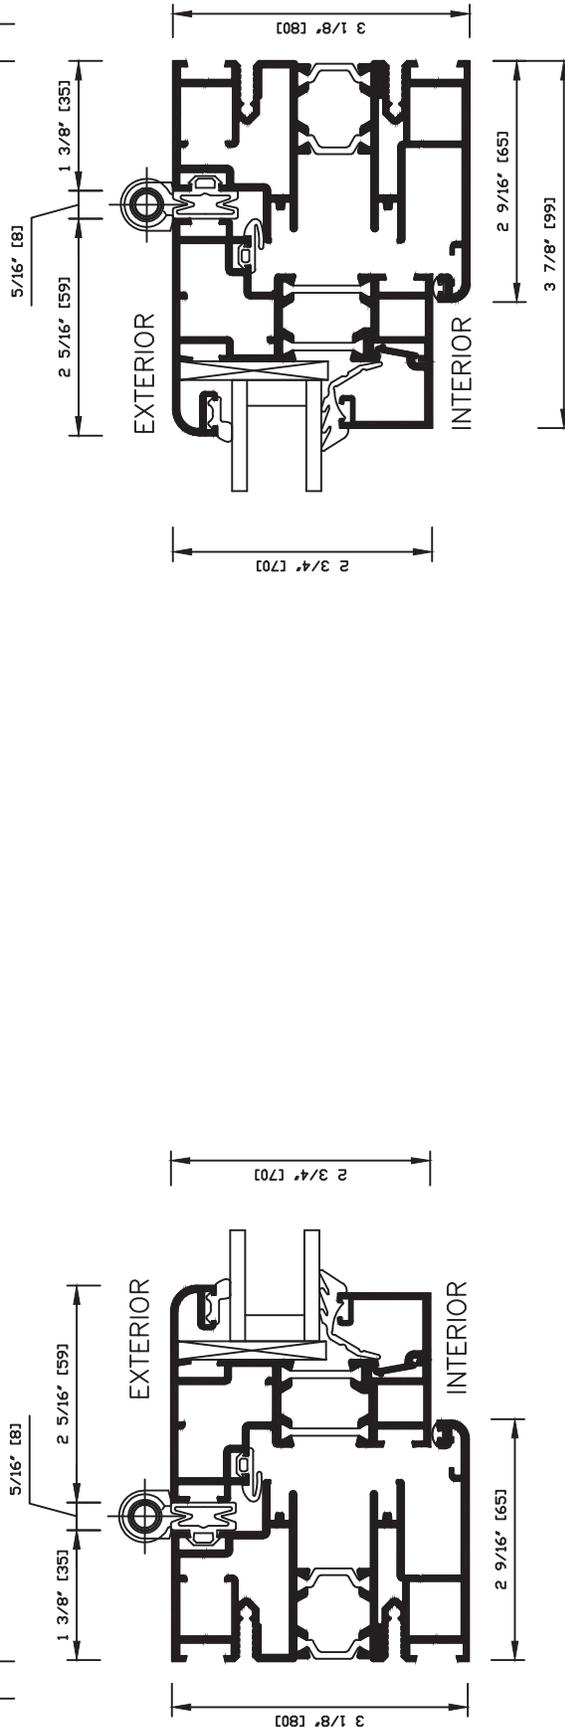
Right Side Jamb

Suggested R.O. Width = 14'-0 3/4" [4286]

Outside Unit Width = 14' [4267]

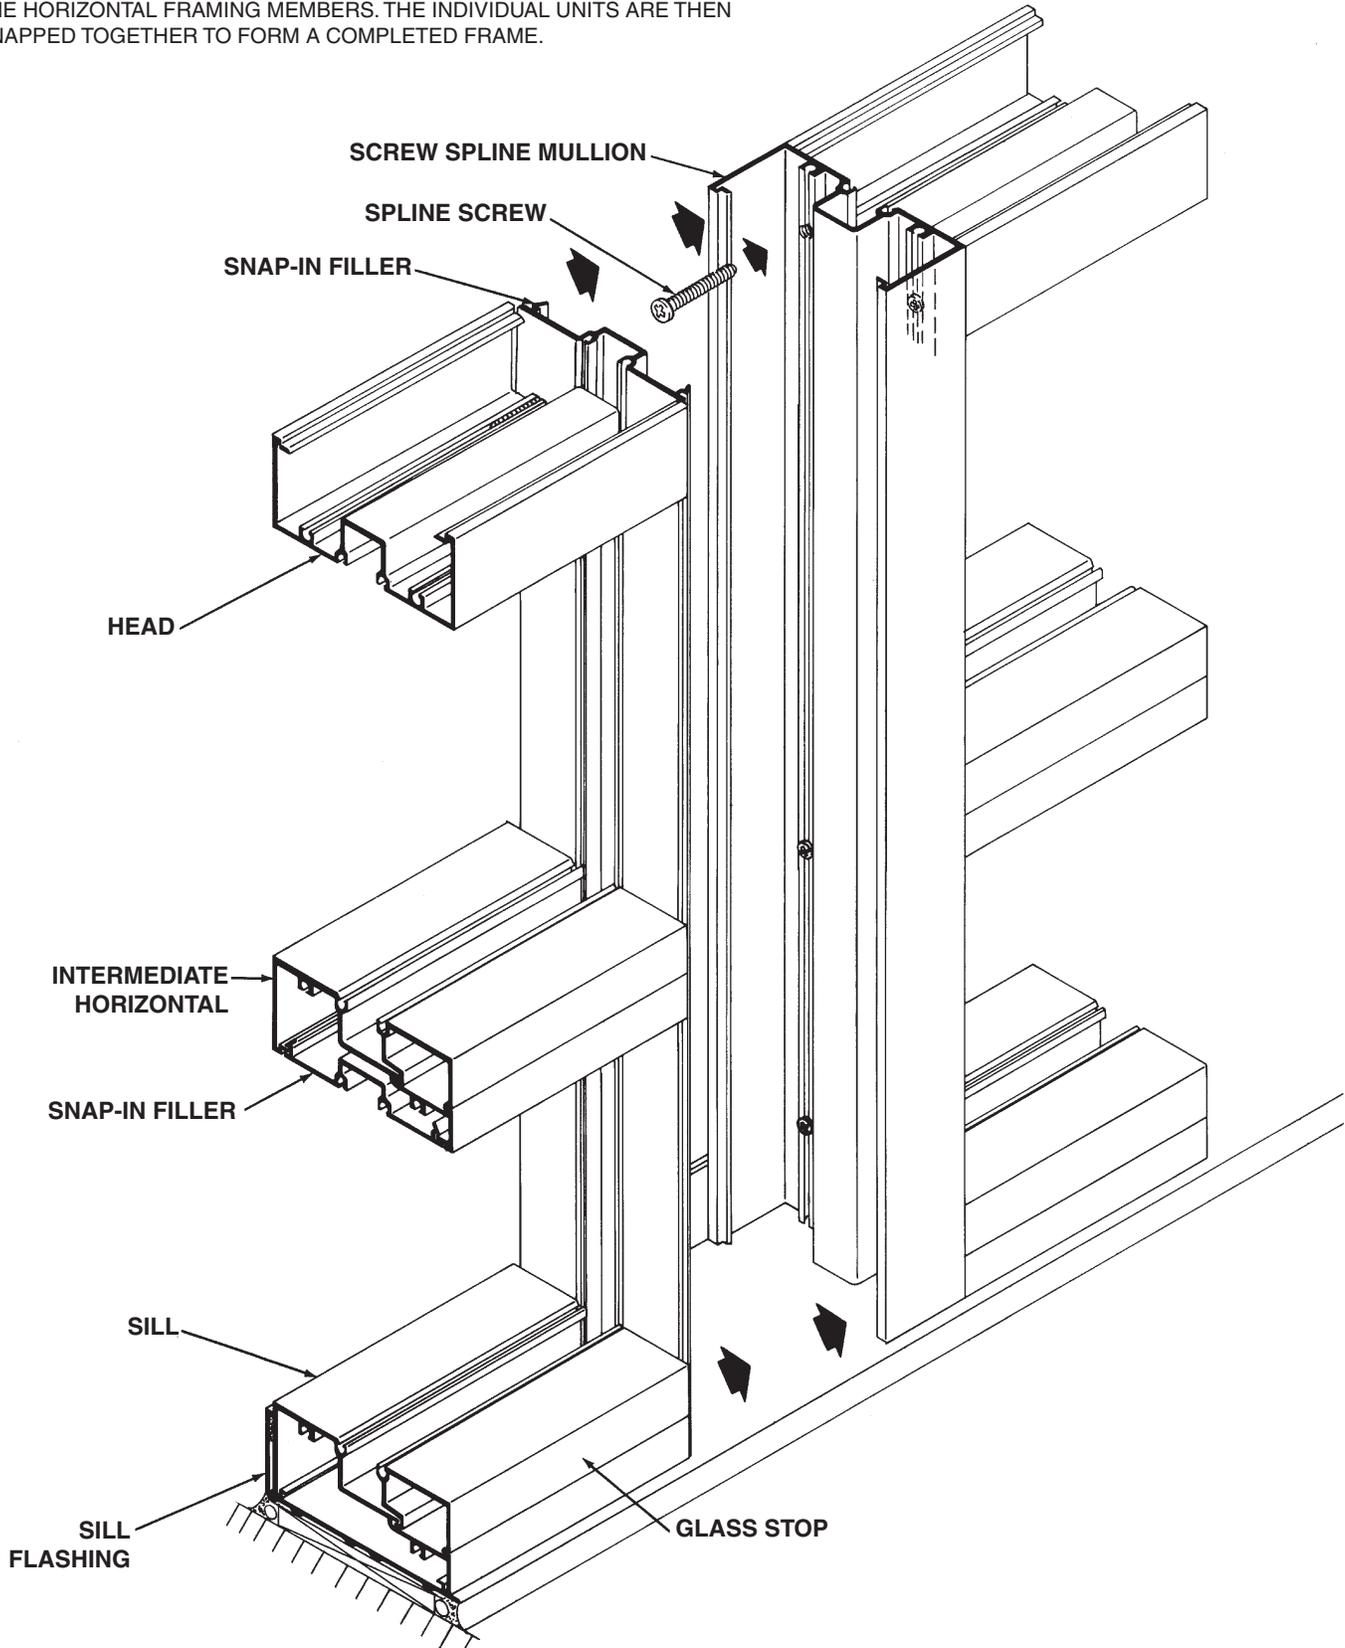
THE SPLIT VERTICAL IN THE SCREW SPLINE SYSTEM ALLOWS A FRAME TO BE INSTALLED FROM UNITIZED ASSEMBLIES. SCREWS ARE DRIVEN THROUGH THE BACK OF THE VERTICALS INTO SPLINES EXTRUDED IN THE HORIZONTAL FRAMING MEMBERS. THE INDIVIDUAL UNITS ARE THEN SNAPPED TOGETHER TO FORM A COMPLETED FRAME.
