# HISTORIC SITE FORM - HISTORIC SITES INVENTORY

PARK CITY MUNICIPAL CORPORATION (10-08)

Address: 946 NORFOLK AVE

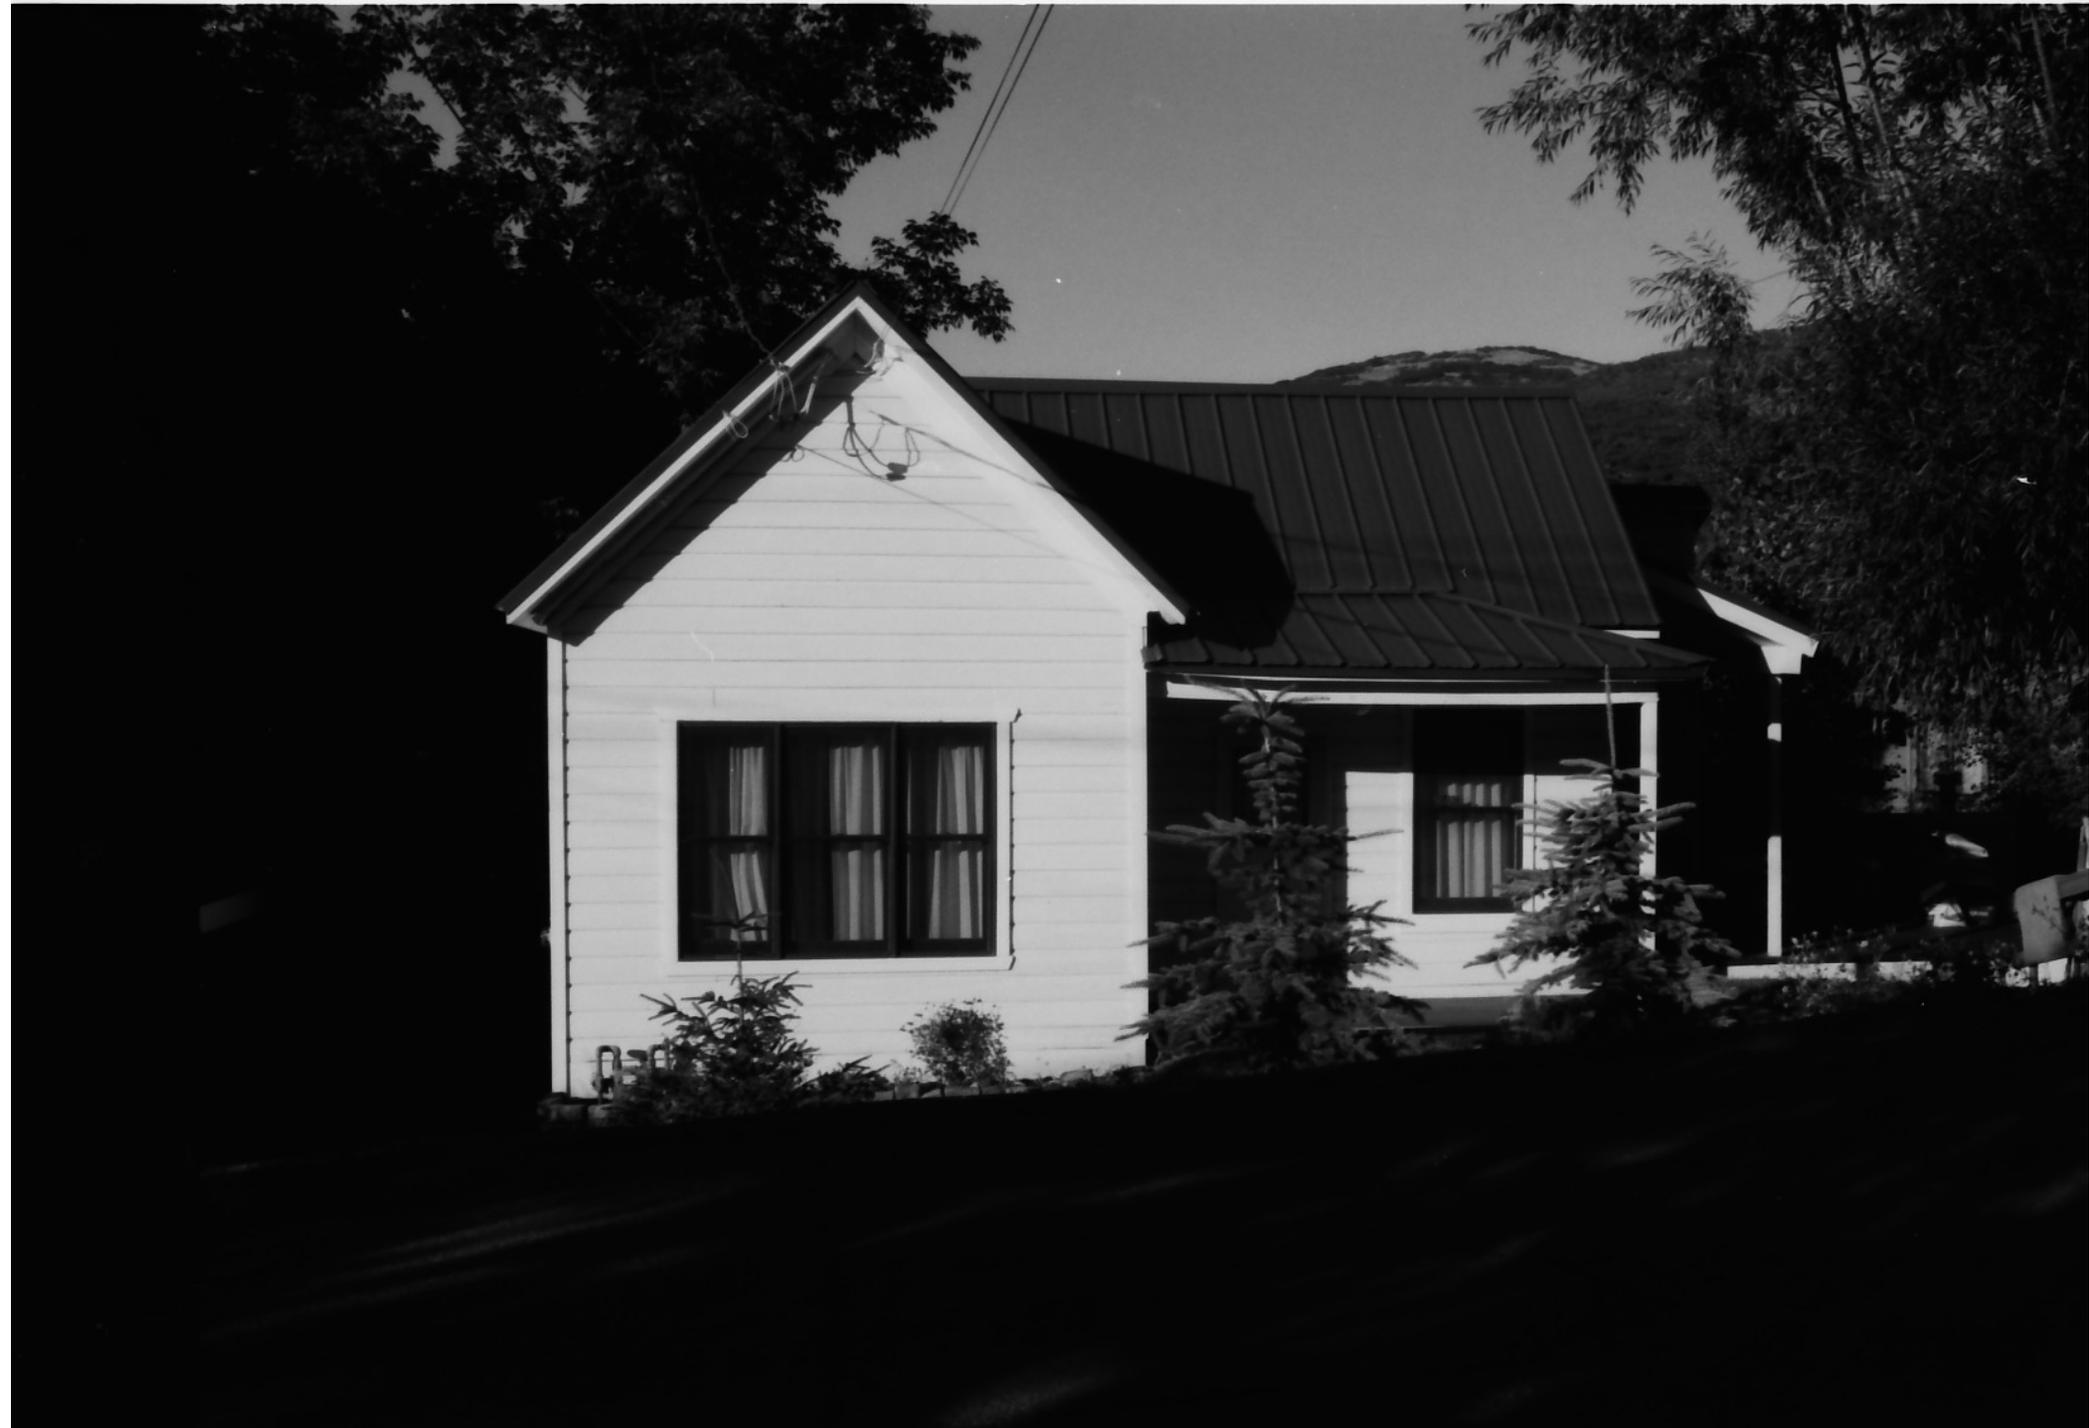
**Photo No. 2:** West elevation (primary façade). Camera facing east, 1995.

Roof: The corbelled chimney as seen in the c. 1940 tax photograph on the rear slope of the roof was removed by the 1995 photograph. The roof is sheathed in standing seam metal materials.

Windows/Doors: The visible windows in the 1995 and 2006 photographs include one-over-one double-hung windows appearing either alone in a vertical opening on the façade or in a group of three in a single opening on the side wall. Both doors visible in the available photographs have single large lights.
