AGENDA

Historic Preservation Board Staff Report

Subject: LMC Amendment Park City Historic Sites Inventory Criteria & Demolition Permits
Author: Bruce Erickson, AICP, Interim Planning Director
Date: October 21, 2015
Type of Item: Legislative – LMC Amendment

Project Name: LMC Amendment regarding Historic Sites Inventory criteria and demolition permits in the Historic District
Applicant: Planning Department
Proposal: Revisions to the Land Management Code

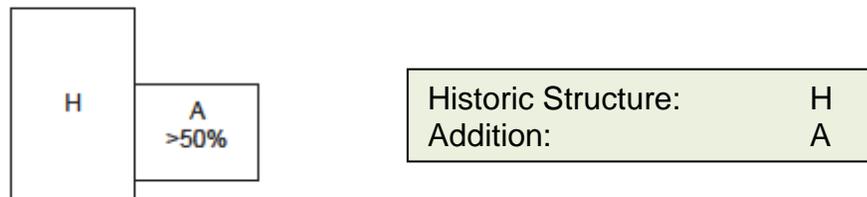
- A transitional element is required for any addition to a historic structure in which the building footprint of the addition is 50% or greater than the building footprint of the historic structure. The historic structure’s building footprint may include additions to the historic building made within the historic period.

- If the addition is less than 50% of the historic structure's building footprint, but exceeds the height of the historic structure due to the height of the addition or its topography, a transitional element is required.
- The width of the transitional element shall not exceed 2/3 width of the connecting elevation.

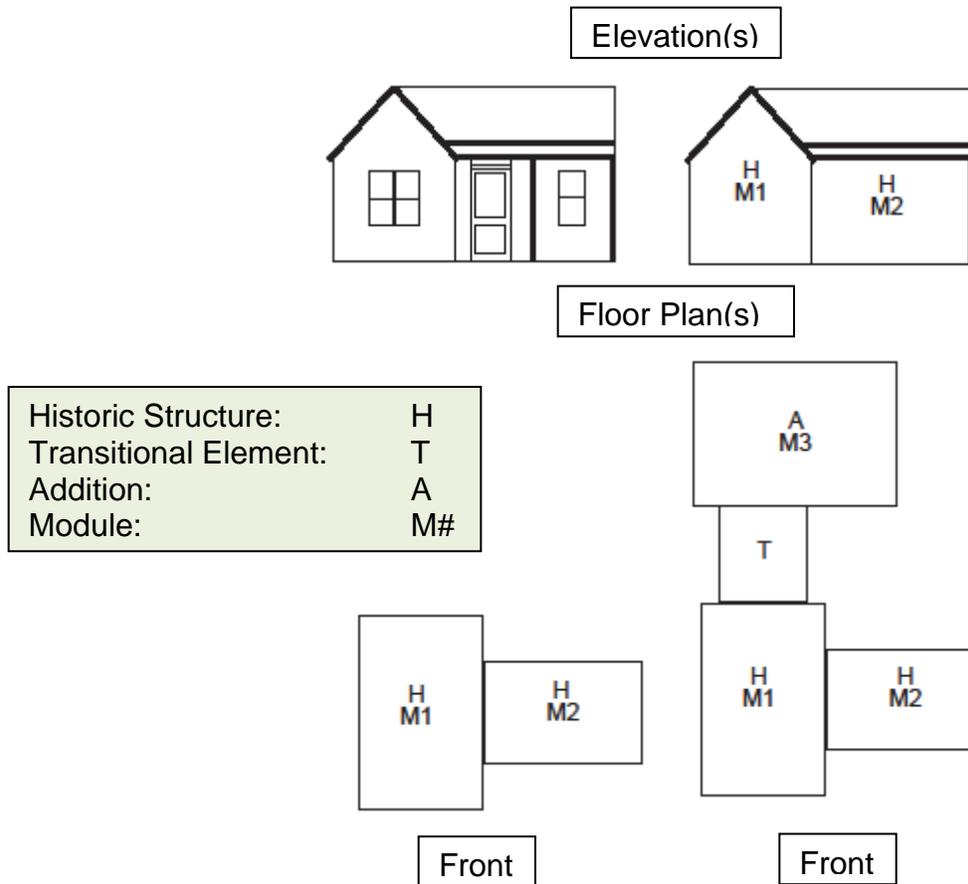
- Additions to historic structures shall be visually subordinate to the historic building. Where the overall size² of the new addition is larger than the historic structure, the volume of the addition shall be broken up into modules that reflect the scale of those seen on the historic structure. Additional modules are encouraged to add articulation and architectural interest.

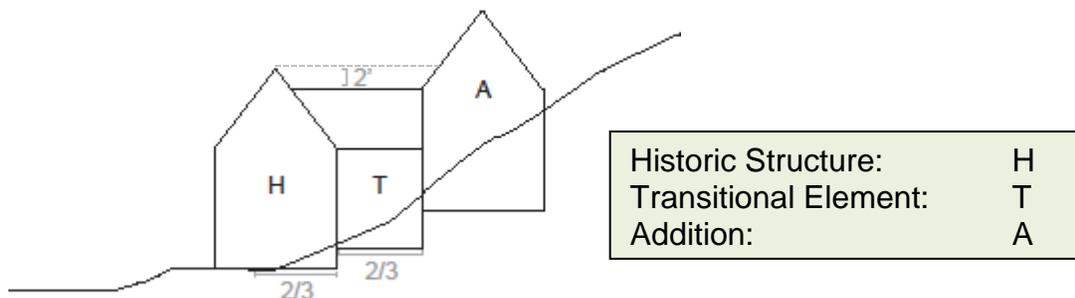
- Where the addition is taller than the historic structure's ridgeline, due to either the height of the addition or the topography, the new addition shall be set back by a minimum of 2/3 length of the adjoining historic module's side elevation.

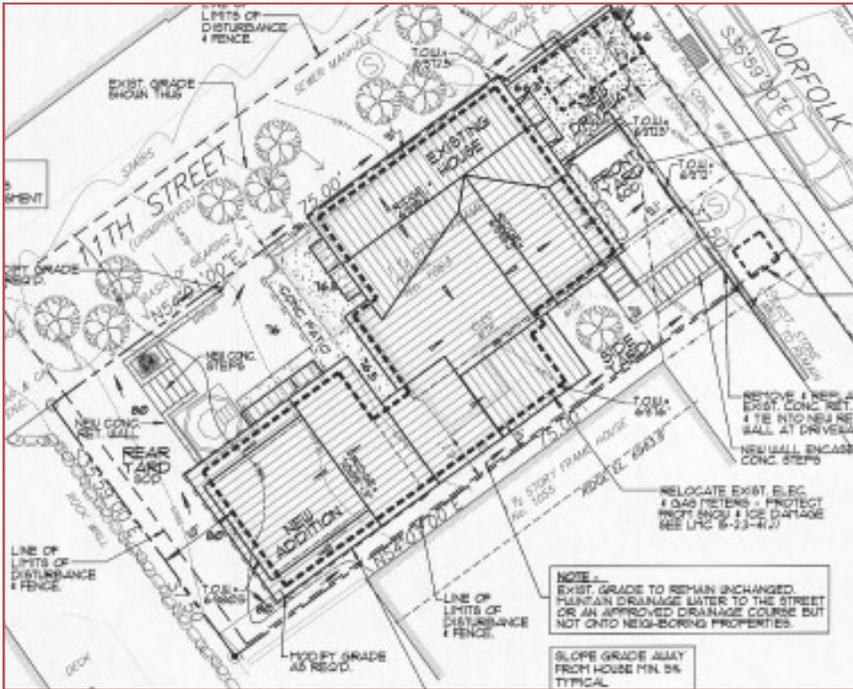
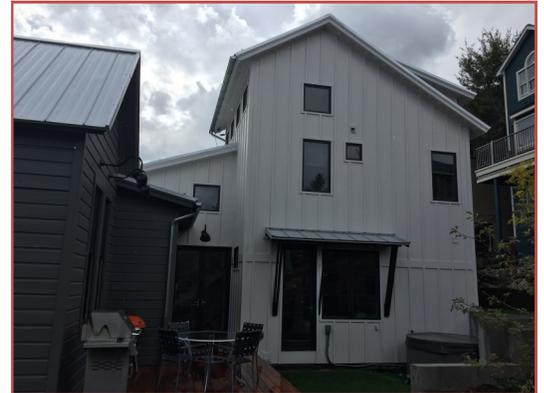
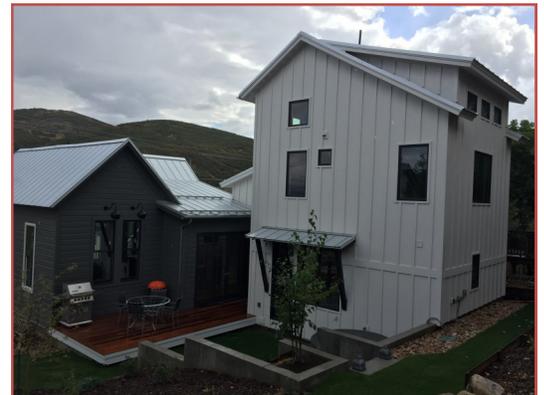
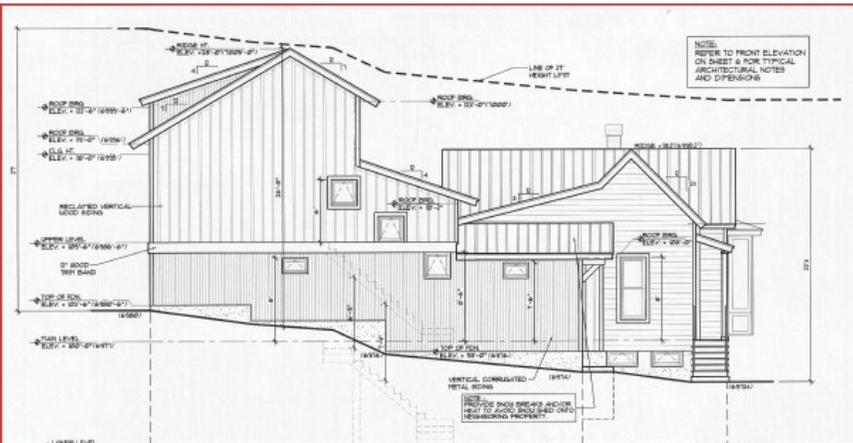
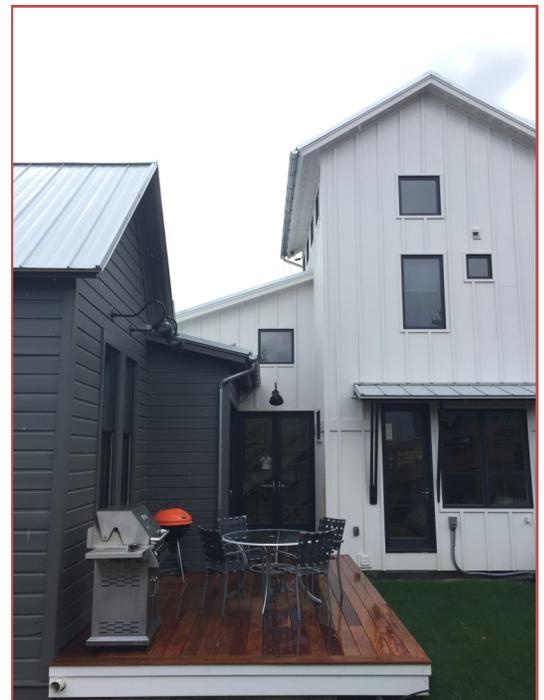
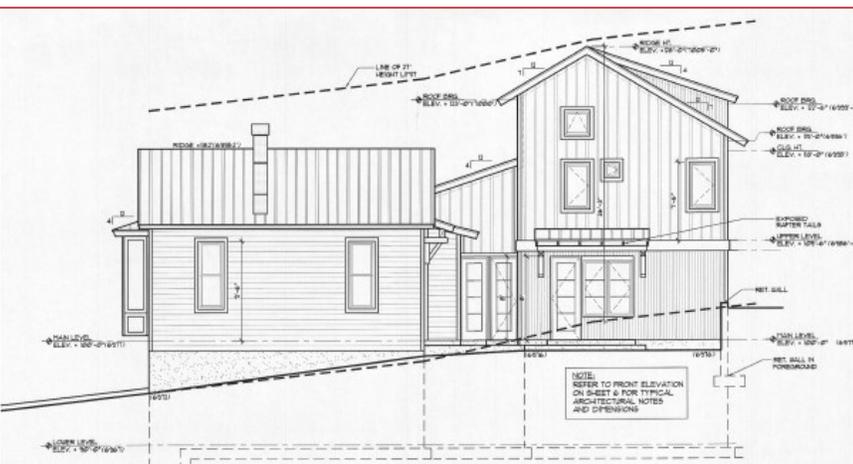
1063 Norfolk

Constructed a new distinguishable transitional element.

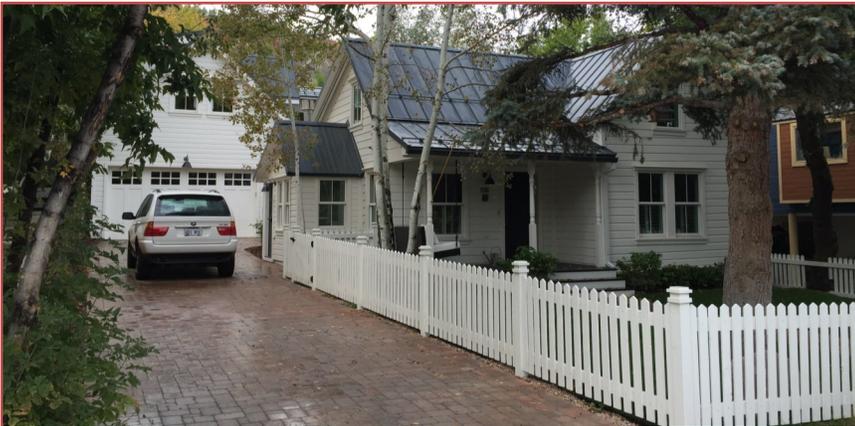
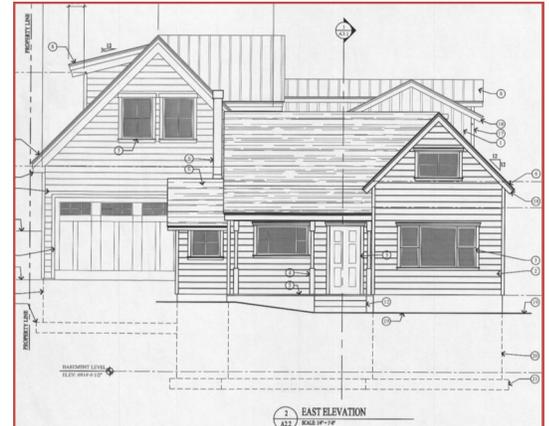
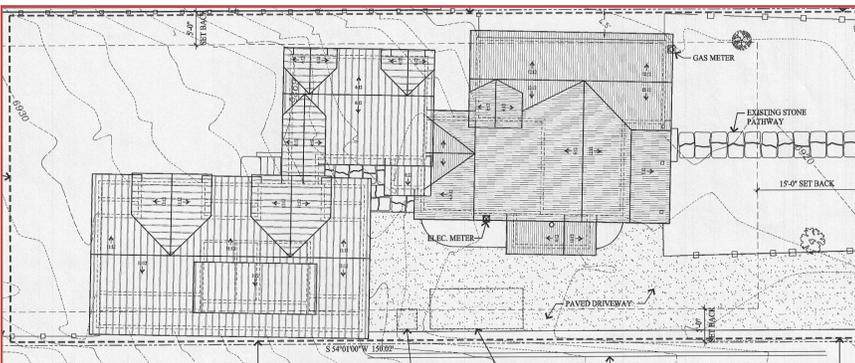
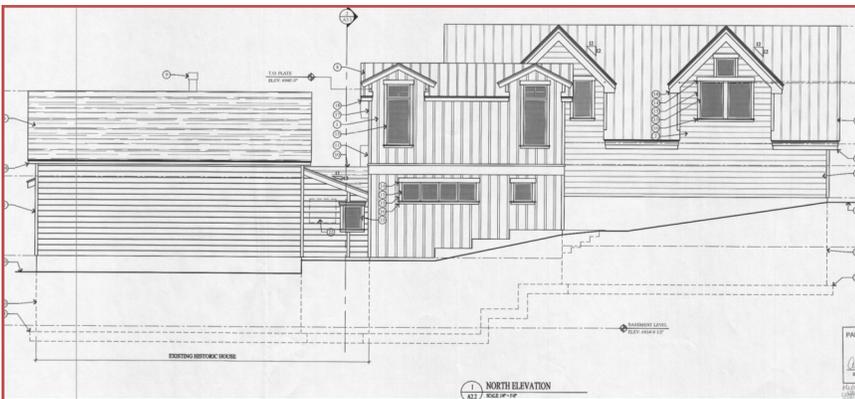
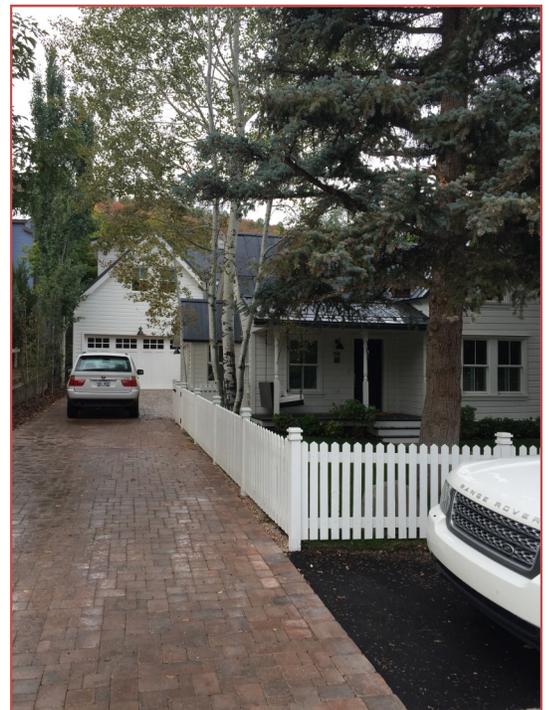
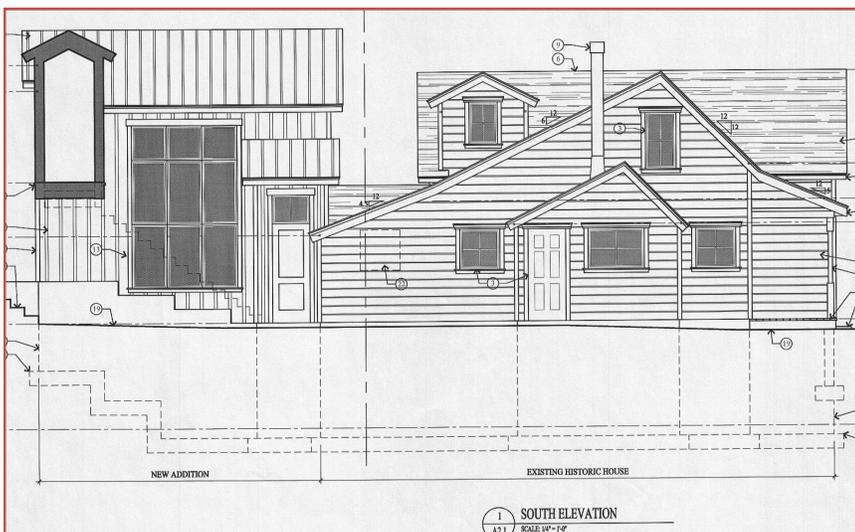
1127 Woodside Avenue

Construction of a rear addition onto an existing accessory structure

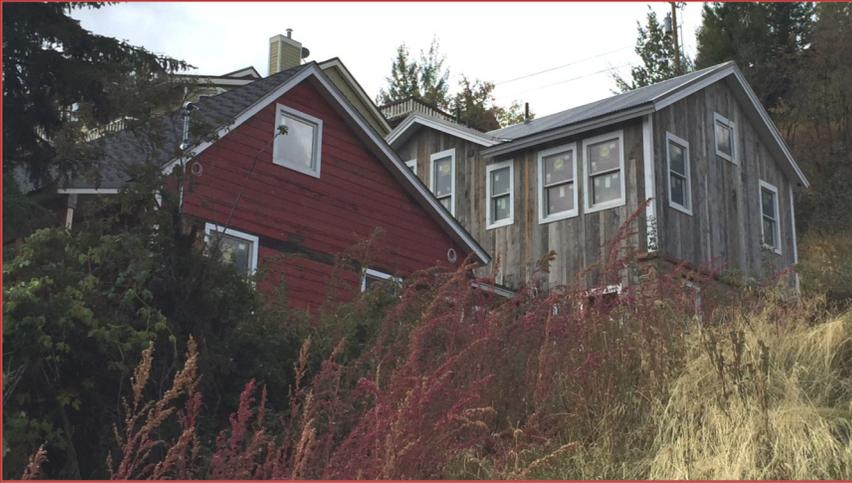
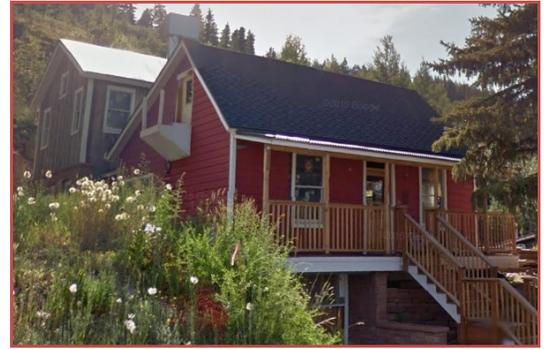
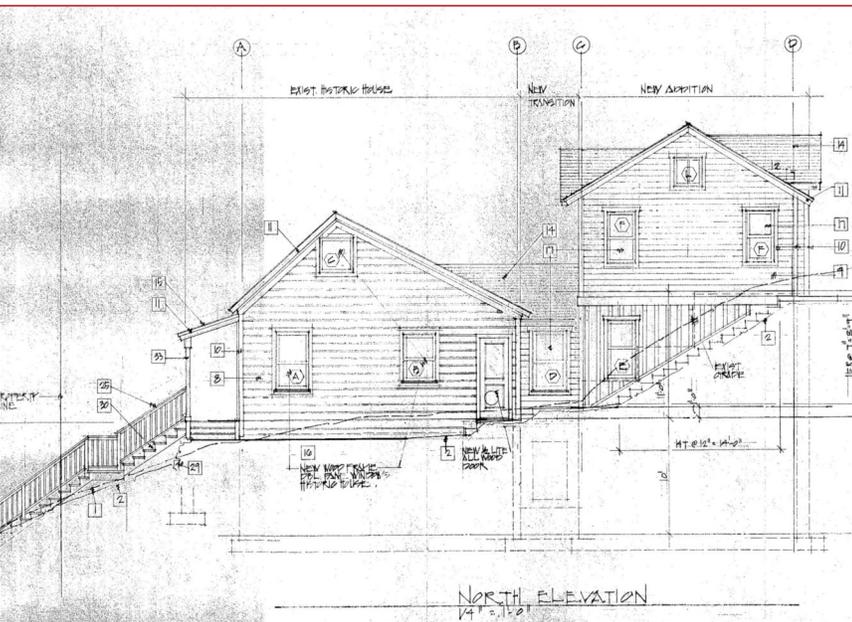
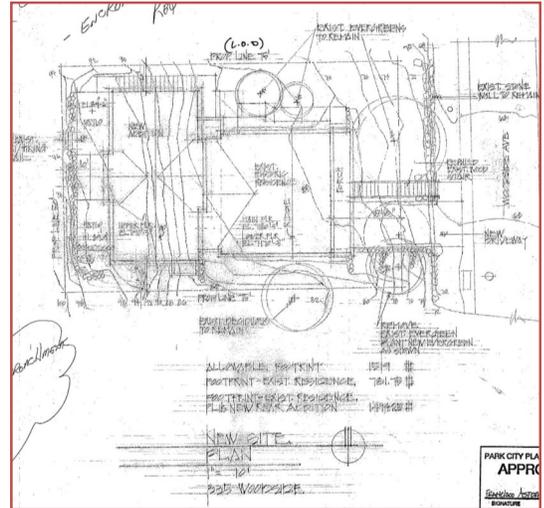
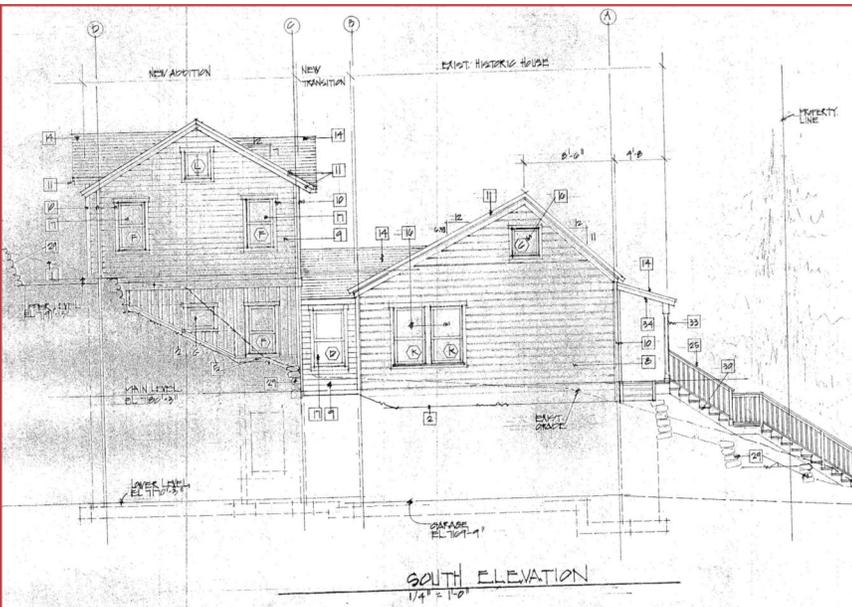
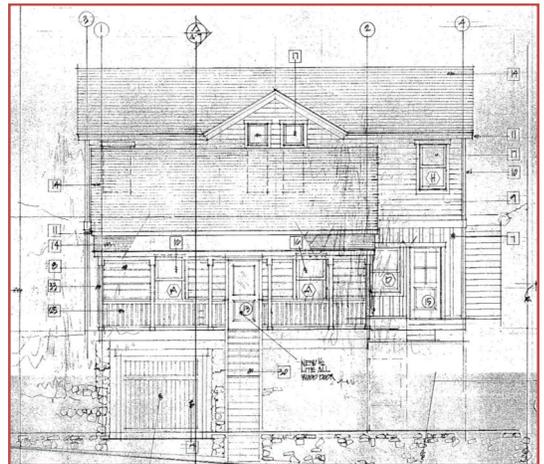
335 Woodside Avenue

Constructed a new compatible addition with a transition element.

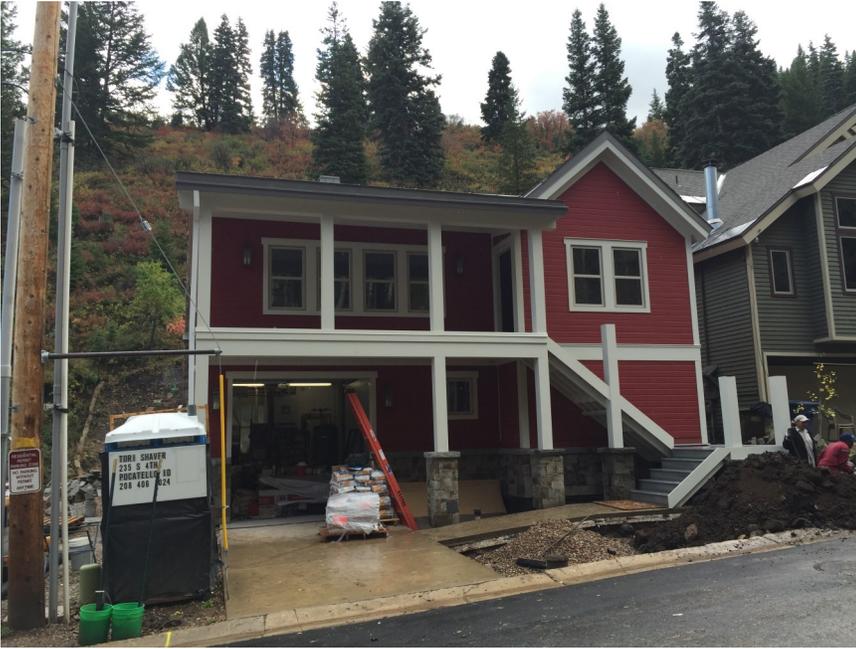
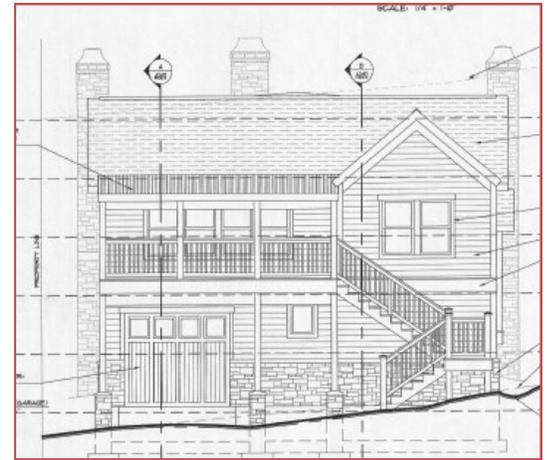
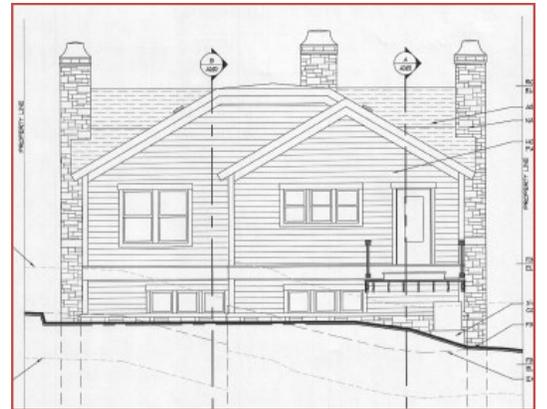
337 Daly Avenue

Very traditional approach to the Design Guidelines.

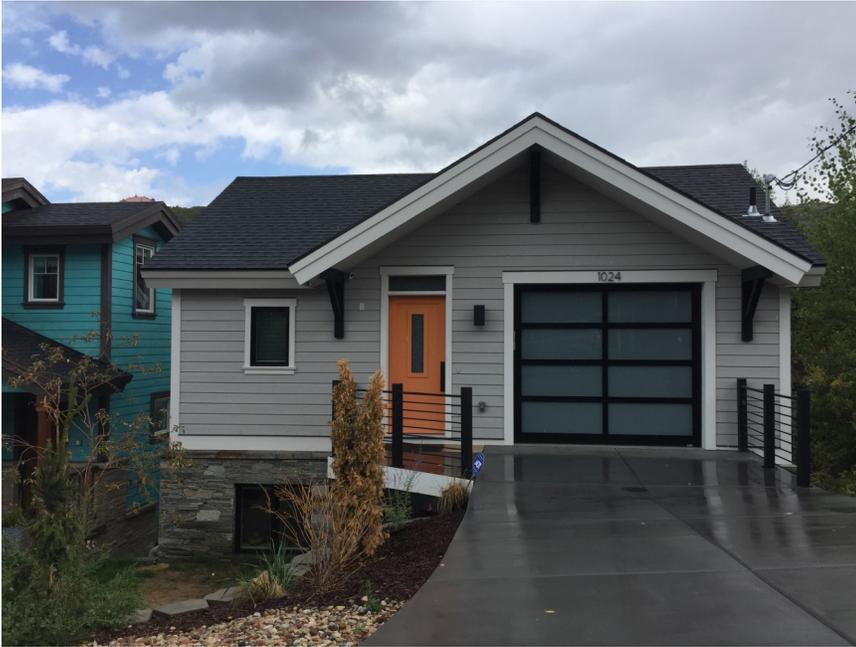
1024 Norfolk Avenue

*New construction that
has incorporated
traditional building forms
and modern elements.*

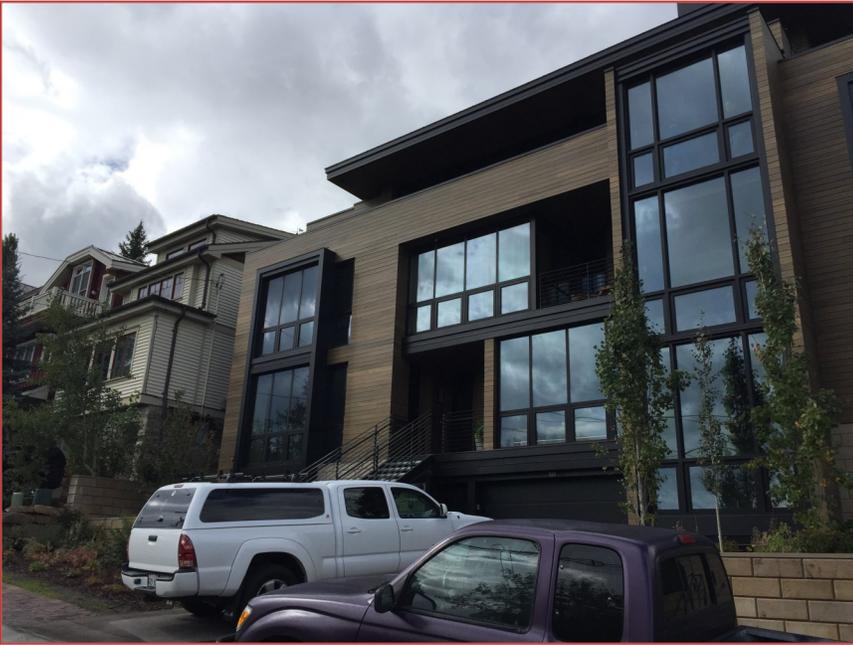
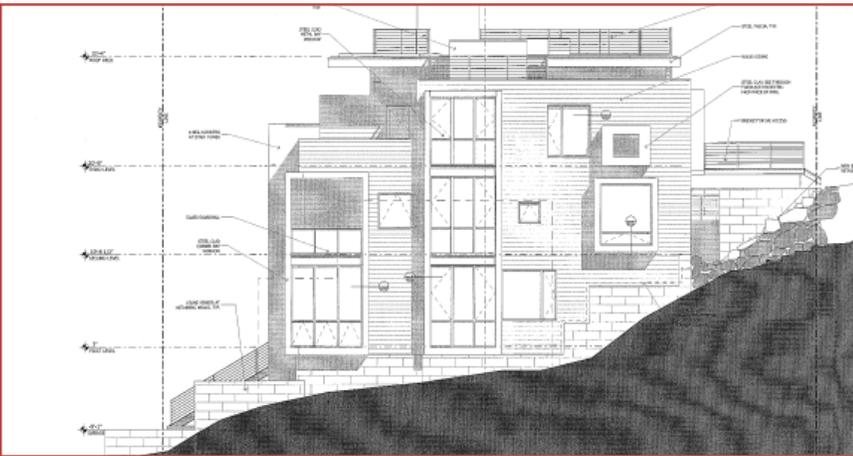
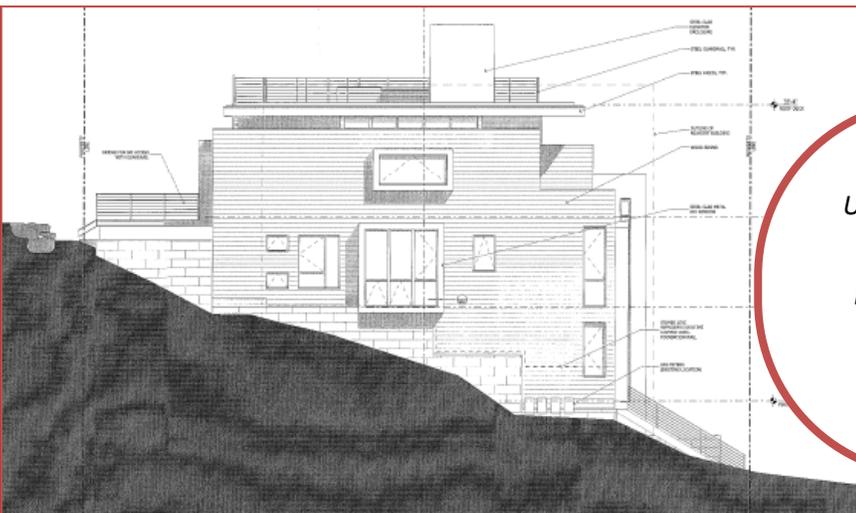
535 Woodside Avenue

Using existing legal non-conformities, the structure is much larger than what is permitted under today's code; however, the applicant also had a very modern interpretation of the Design Guidelines.

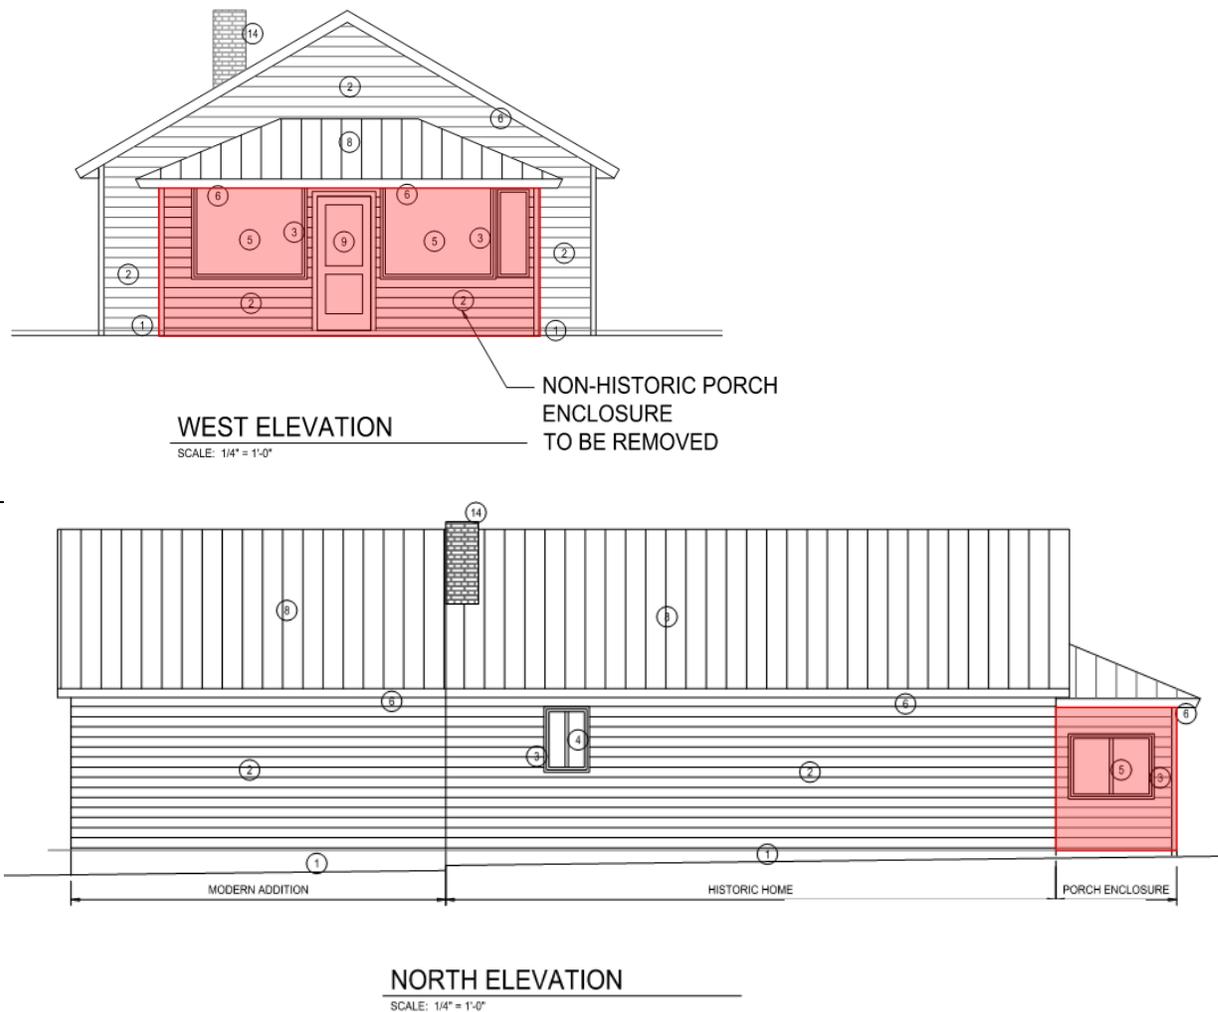
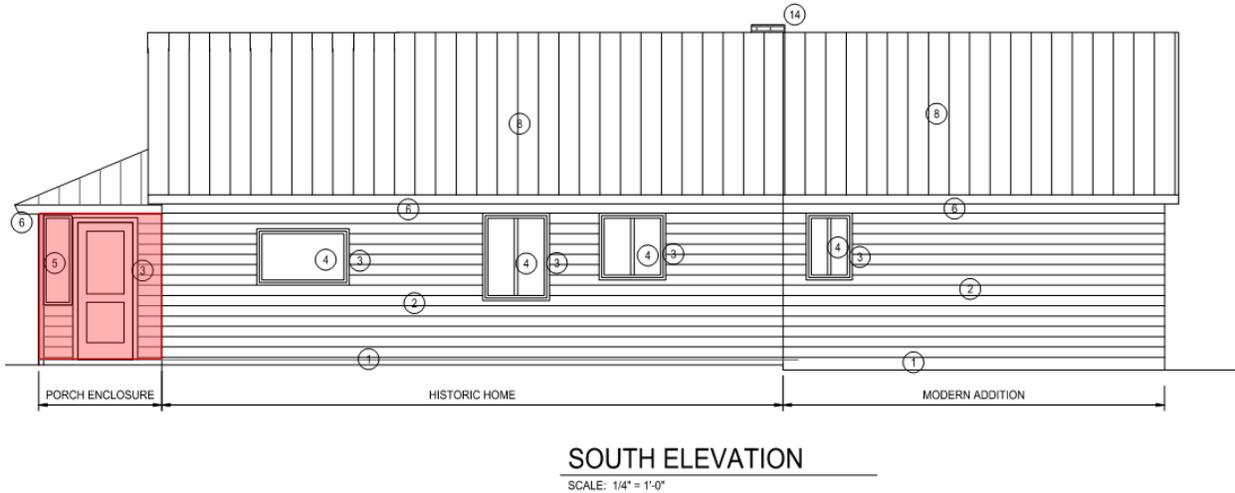
Diagram 1: Shaded portions of the non-historic enclosed porch are to be removed.

The applicant intends to remove the north, south, and west exterior non-historic walls of the non-historic enclosed porch. Staff finds that the original ornate porch was likely screened in or enclosed sometime after the 1940’s. There are no ornate porch posts remaining. Because the existing enclosed porch is not original to the house and was not present in the 1940’s tax photograph, staff finds that removing the north, south and west walls will have no adverse impact on the historic house. The portions of the non-historic enclosed porch that are to be removed can be seen in Diagram 1.

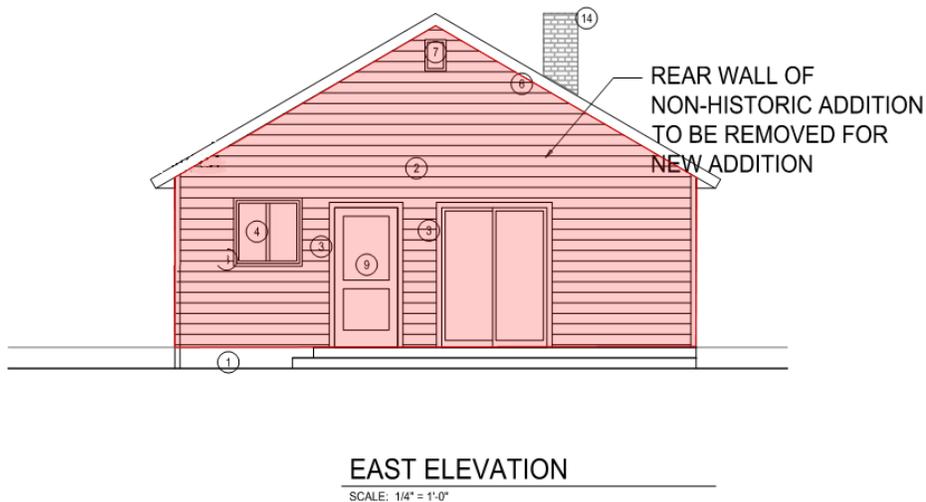
Diagram 2: Shaded portion of the non-historic east (rear) wall is to be removed.

2. Remove the entire (225.5 total square feet) non-historic east (rear) wall of the house. The applicant intends to remove the entire (225.5 total square feet) non-historic east (rear) wall of the house. According to the 1978 Utah State Historic Society Historic Preservation Site Information Form, in 1960, a one-story addition was added to the rear of the historic house with a sun deck in the rear yard. Staff finds that the removal of the rear (east) wall of the historic house will have no adverse impact on the historic house as the rear wall is not original to the historic house and has been deemed non-historic. The area of the non-historic east (rear) wall of the historic house that is to be removed can be seen in Diagram 2.

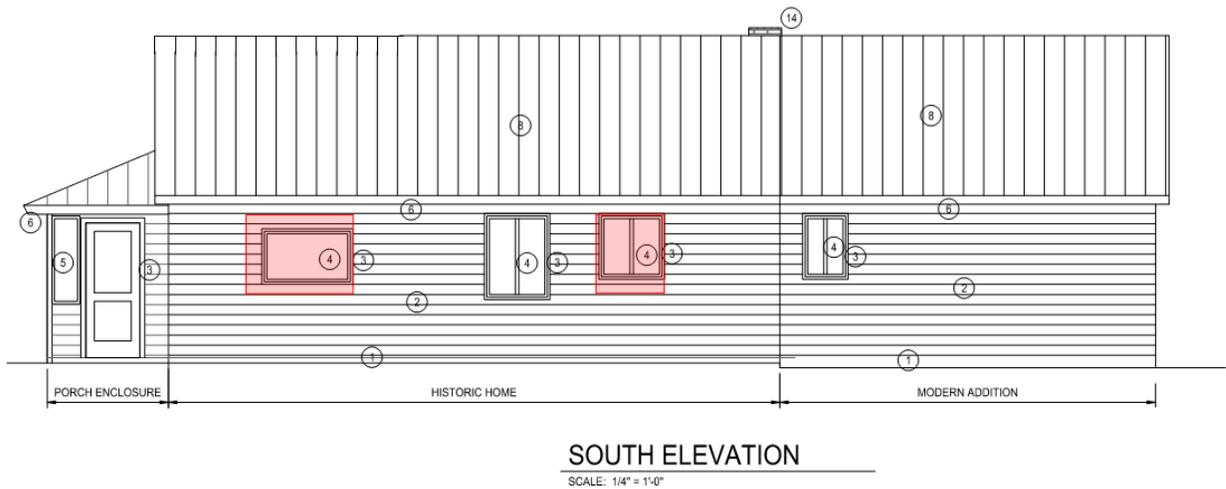
Diagram 4: Shaded portions of the historic south wall of the historic house are to be removed.

The applicant intends to remove portions (6.75 total square feet) of the historic south wall surrounding the existing non-historic windows. The existing windows are non-historic and the openings are not consistent with what would have existed historically (see #7 for complete window analysis and details). The portions of the historic south wall that are to be removed will accommodate historically accurate window openings. Staff finds that the removal of the portions of the historic south wall will have no adverse impact on the historic house and will accommodate details more consistent with the historic house before extensive alterations occurred in the 1960s. The portions of the historic south wall of the historic house surrounding existing windows that are to be removed can be seen in Diagram 4.

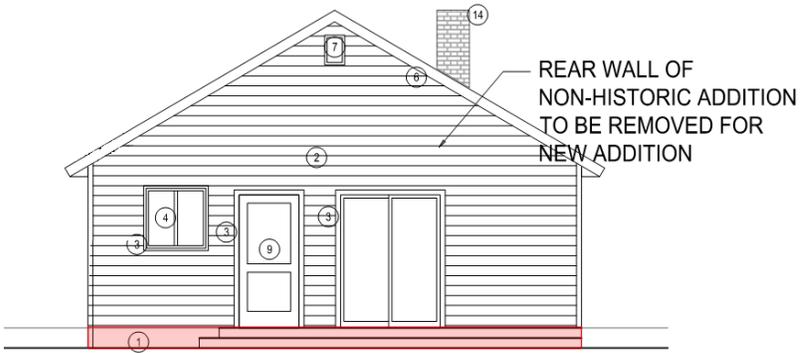
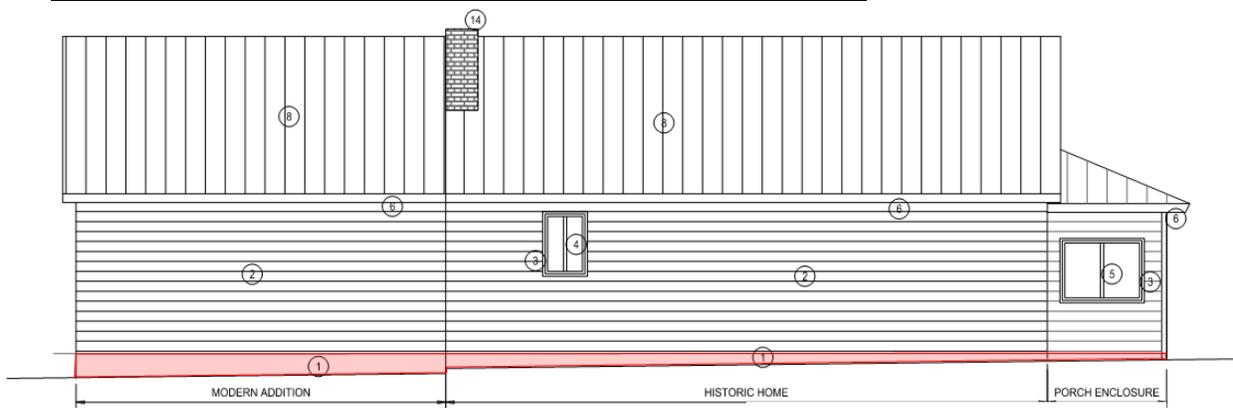
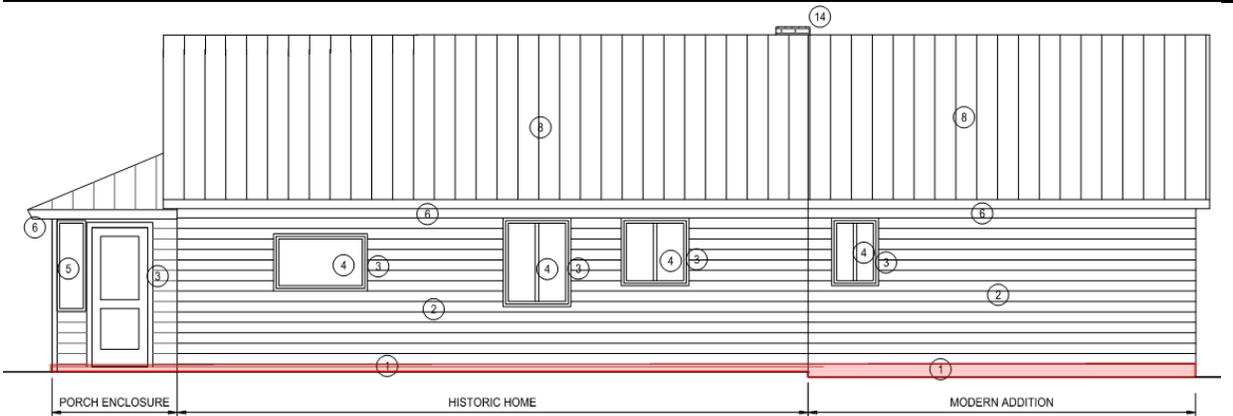
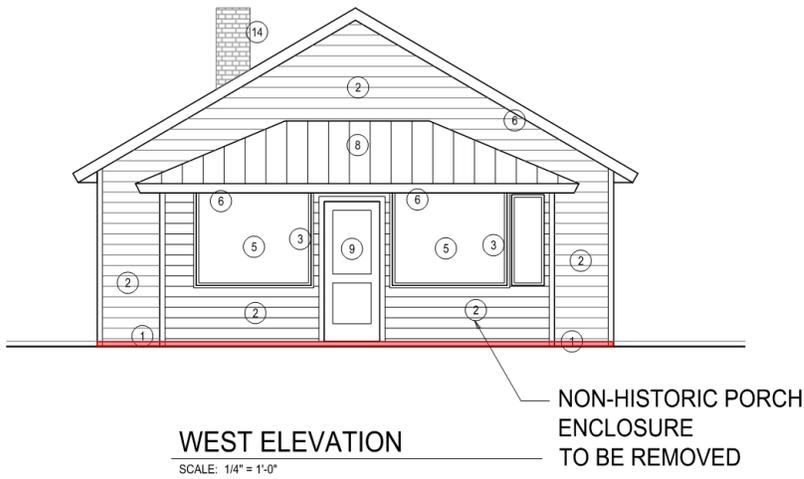
Diagram 5: Shaded portions of the foundation are to be removed.

The applicant intends to lift the non-historic and historic portions of the house and the historic single-car garage accessory structure to replace the existing non-historic and historic portions of the foundation for a new crawlspace. The structure is located within the floodplain. In order to upgrade the foundation to meet the standards for development within the floodplain, the applicant opted to lift the historic house two feet (2') and incorporate a new foundation and crawlspace. The existing non-historic and historic portions of the concrete foundation will have to be removed from the historic house and historic single-car garage accessory structure. Staff finds that lifting the historic house and historic single-car garage accessory structure two feet (2') and incorporating a new foundation will have no adverse impact on the historic house or historic single-car garage accessory structure. The portions of the foundation of the historic house and historic single-car garage accessory structure that are to be removed can be seen in Diagram 5.

12. The applicant will lift the non-historic and historic portions of the house and the historic single-car garage accessory structure for a new crawlspace and replace the existing non-historic and historic portions of the concrete foundation.

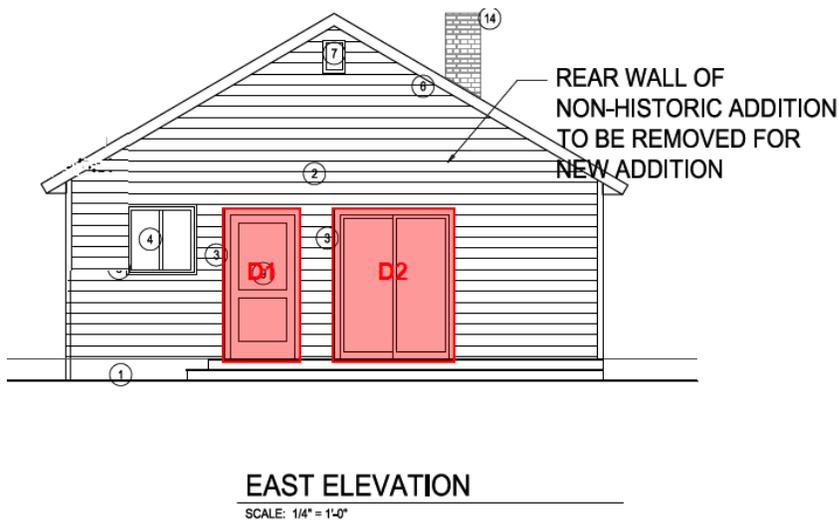
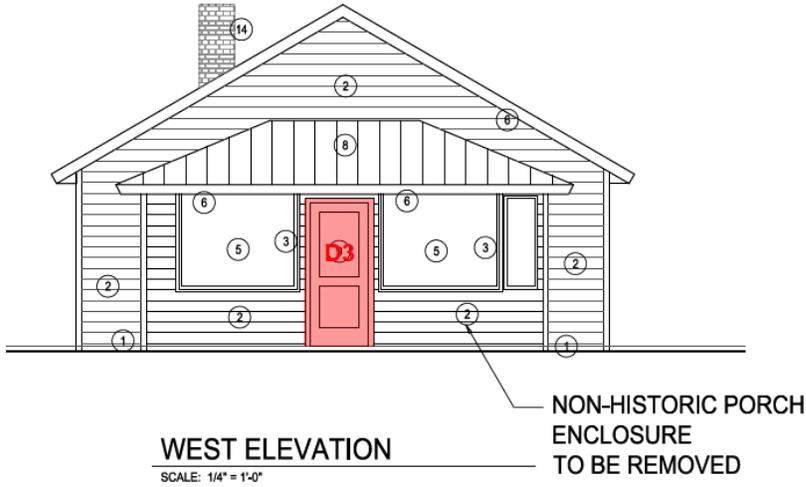
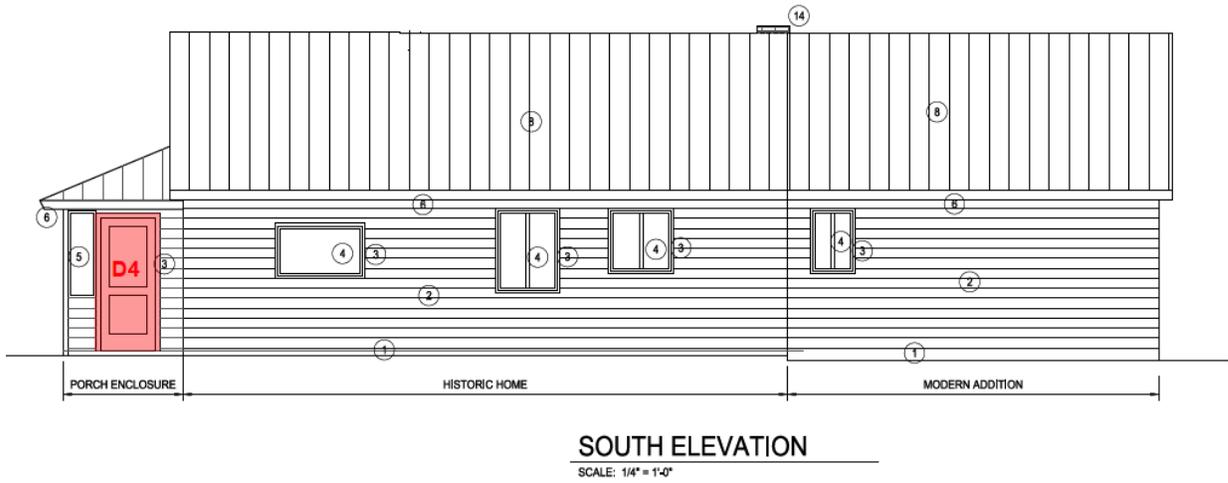
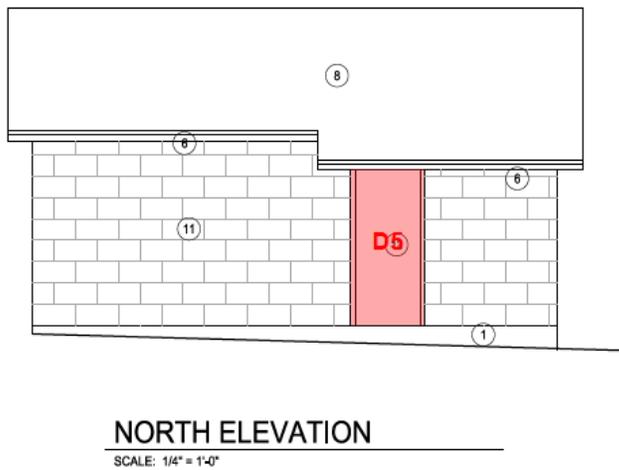
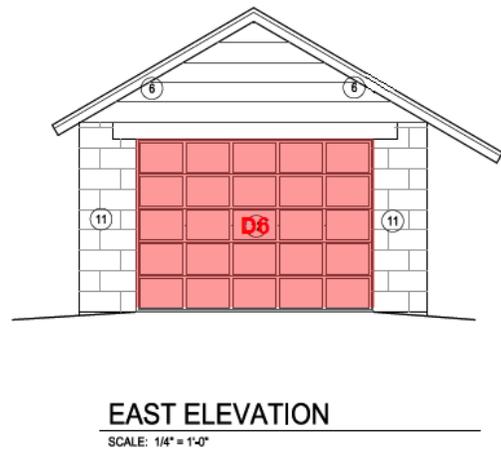
Diagram 6: Shaded doors with Door #'s are to be removed. The Door #'s correspond to the above Door Schedule.

The applicant intends to remove five (5) non-historic doors from the historic house and one (1) non-historic single-car garage door from the historic single-car garage accessory structure. None of the doors on the existing structure(s) are historic.

Door #:	Description:	Historic Status:
1	Wood half-glass (divided with muntins into nine [9] panes) with simple brass hardware and dog door.	Not historic
2	A set of two (2) sliding aluminum full-pane glass doors.	Not historic
3	Wood six-panel door with wood two-panel screen door.	Not historic
4	Wood half-glass door with a single wood panel below.	Not historic
5	Simple wood door, no paneling.	Not historic
6	Standard metal garage door with twenty-five panels arranged in a five by five pattern.	Not historic

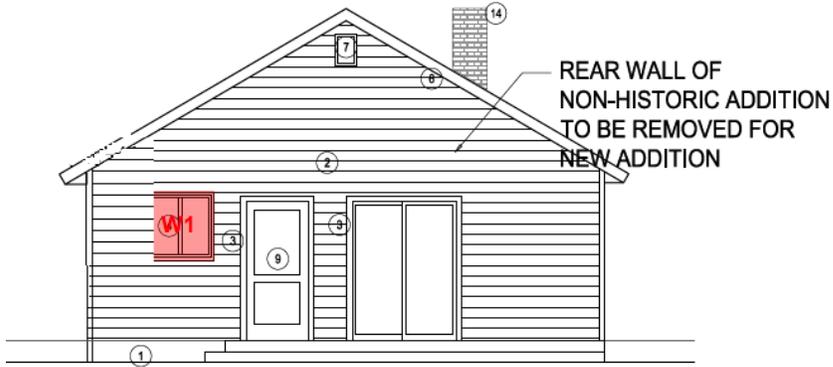
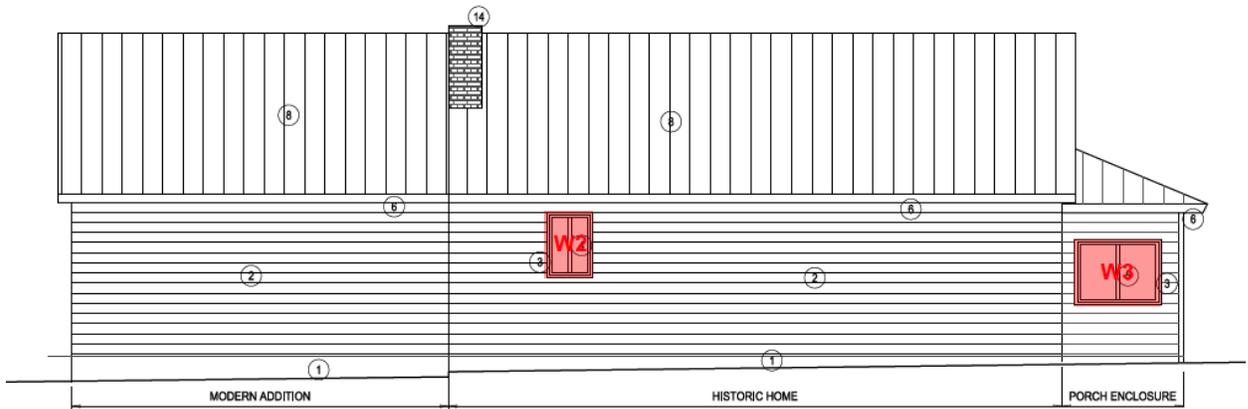
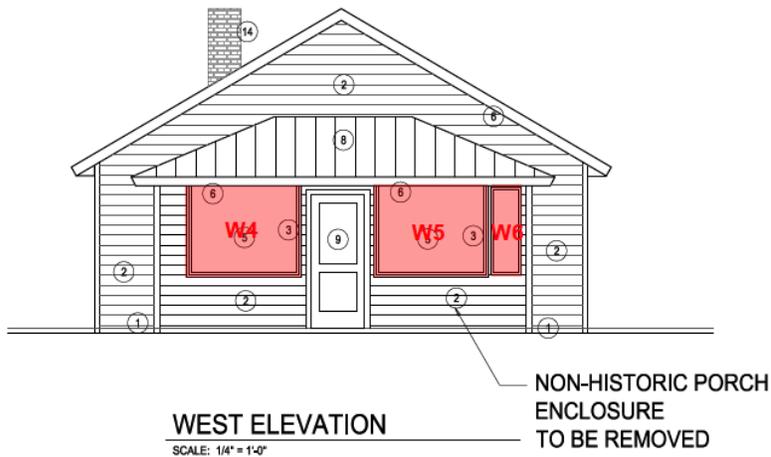
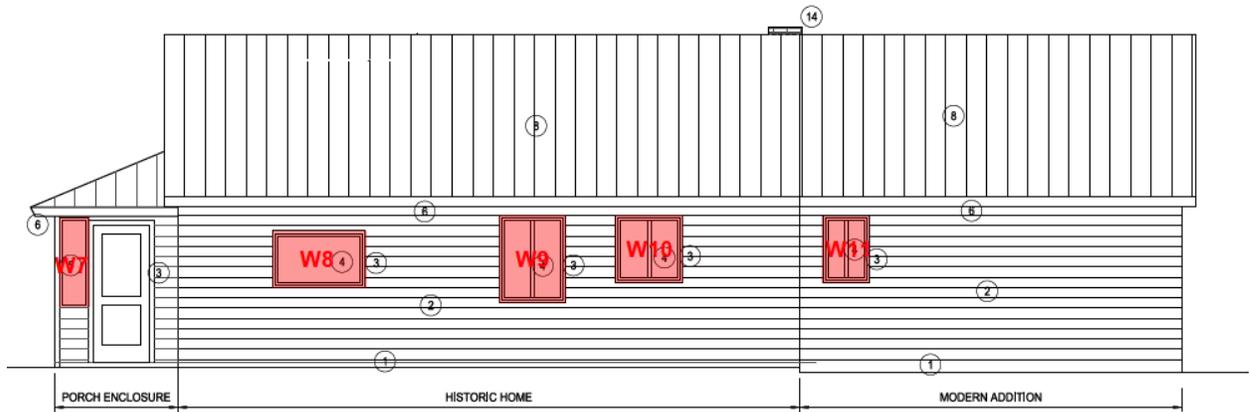
Diagram 7: Shaded windows with Window #'s are to be removed. The Window #'s correspond to the above Window Schedule.

The applicant intends to remove eleven (11) non-historic windows from the historic house and one (1) historic window from the historic single-car garage accessory structure. The eleven (11) windows on the historic house are not historic. Staff finds that the eleven (11) windows are non-historic because of incompatible materials, style, sizes, and location on the structure. The one (1) window on the historic single-car garage accessory structure is original to the garage, but in-kind replacement is proposed to allow for an operable window. Staff finds that the removal of all twelve (12) windows will have no adverse impact on the historic house or historic single-car garage accessory structure and will allow for more historically compatible windows as replacement. The non-historic and historic windows that are to be removed from the historic house and historic single-car garage accessory structure can be seen in Diagram 6.

Window #:	Description:	Historic Status:
1	Aluminum single-pane sliding window.	Not historic
2	Aluminum single-pane sliding window.	Not historic
3	Aluminum single-pane sliding window.	Not historic
4	Aluminum fixed two-pane window.	Not historic
5	Aluminum fixed two-pane window.	Not historic
6	Aluminum fixed single-pane window.	Not historic
7	Aluminum fixed single-pane window.	Not historic
8	Aluminum fixed single-pane window.	Not historic
9	Aluminum single-pane sliding window.	Not historic
10	Aluminum single-pane sliding window.	Not historic
11	Aluminum single-pane sliding window.	Not historic
12	Steel fixed twelve-pane window.	Historic

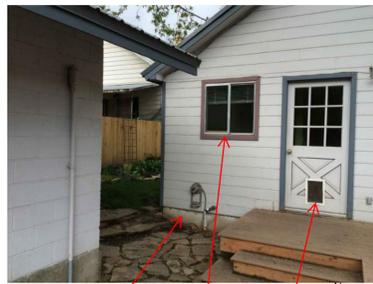
H2.01

HISTORIC PLAN

EAST ELEVATION

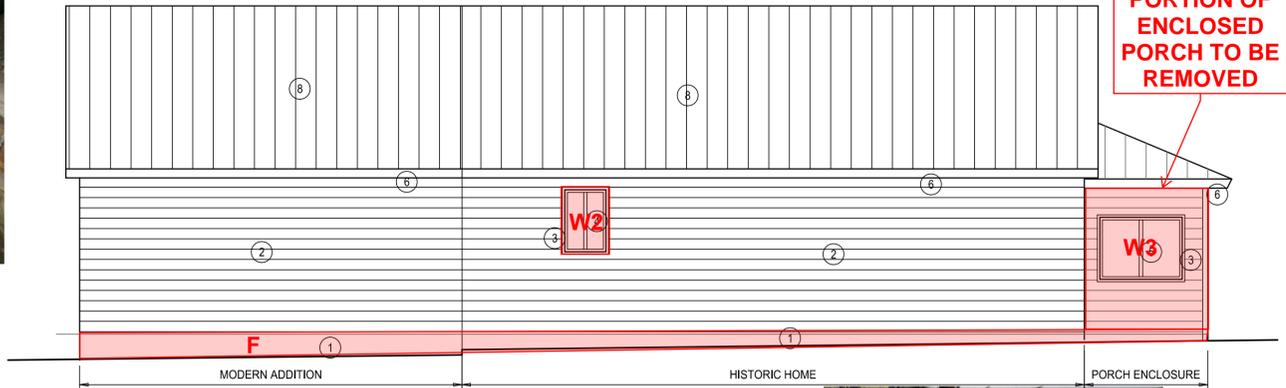
NORTH ELEVATION

SHADED PORTION OF ENCLOSED PORCH TO BE REMOVED

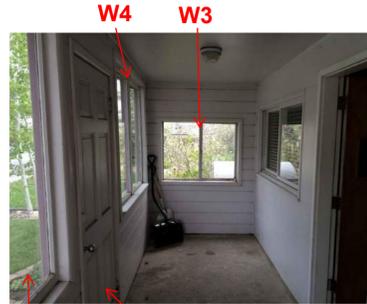
SHADED PORTION OF ENCLOSED PORCH TO BE REMOVED

1. Remove the existing north, south, and west non-historic walls of the non-historic enclosed porch.
2. Remove the entire (225.5 total square feet) non-historic east (rear) wall of the historic house.
3. Remove a portion (41.25 total square feet) of the north wall of the historic single-car garage accessory structure.
4. Remove a portion (6.75 total square feet) of the historic south wall on the historic house surrounding two (2) existing non-historic windows.
5. Lift the non-historic and historic portions of the house and the historic single-car garage accessory structure to replace the existing non-historic and historic portions of the concrete foundation for a new crawlspace and.
6. Remove five (5) non-historic doors and one (1) non-historic single-car garage door.
7. Remove one (1) historic and eleven (11) non-historic windows.

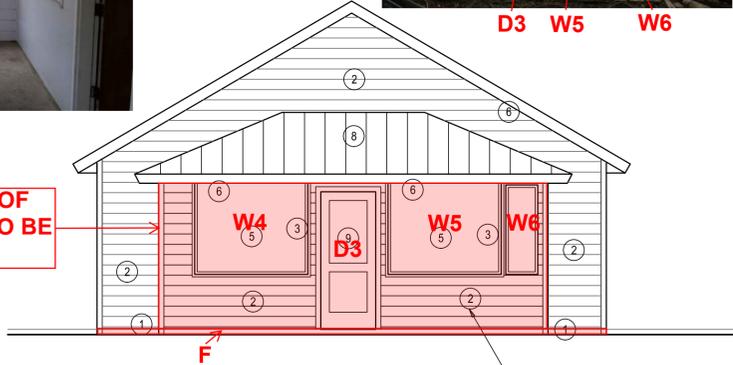
WEST ELEVATION

NON-HISTORIC PORCH ENCLOSURE TO BE REMOVED

SHADED PORTION OF GARAGE WALL TO BE REMOVED

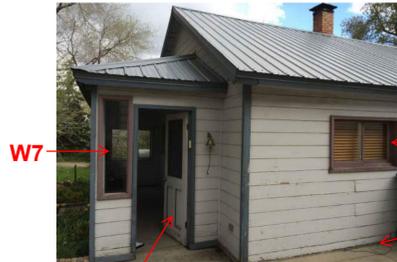
SHADED PORTION OF ENCLOSED PORCH TO BE REMOVED

SHADED PORTION OF SOUTH WALL TO BE REMOVED
