AGENDA

Historic Preservation Board Staff Report

Subject: LMC Amendment Park City Historic Sites Inventory Criteria & Demolition Permits
Author: Bruce Erickson, AICP, Interim Planning Director
Date: October 21, 2015
Type of Item: Legislative – LMC Amendment

Project Name: LMC Amendment regarding Historic Sites Inventory criteria and demolition permits in the Historic District
Applicant: Planning Department
Proposal: Revisions to the Land Management Code

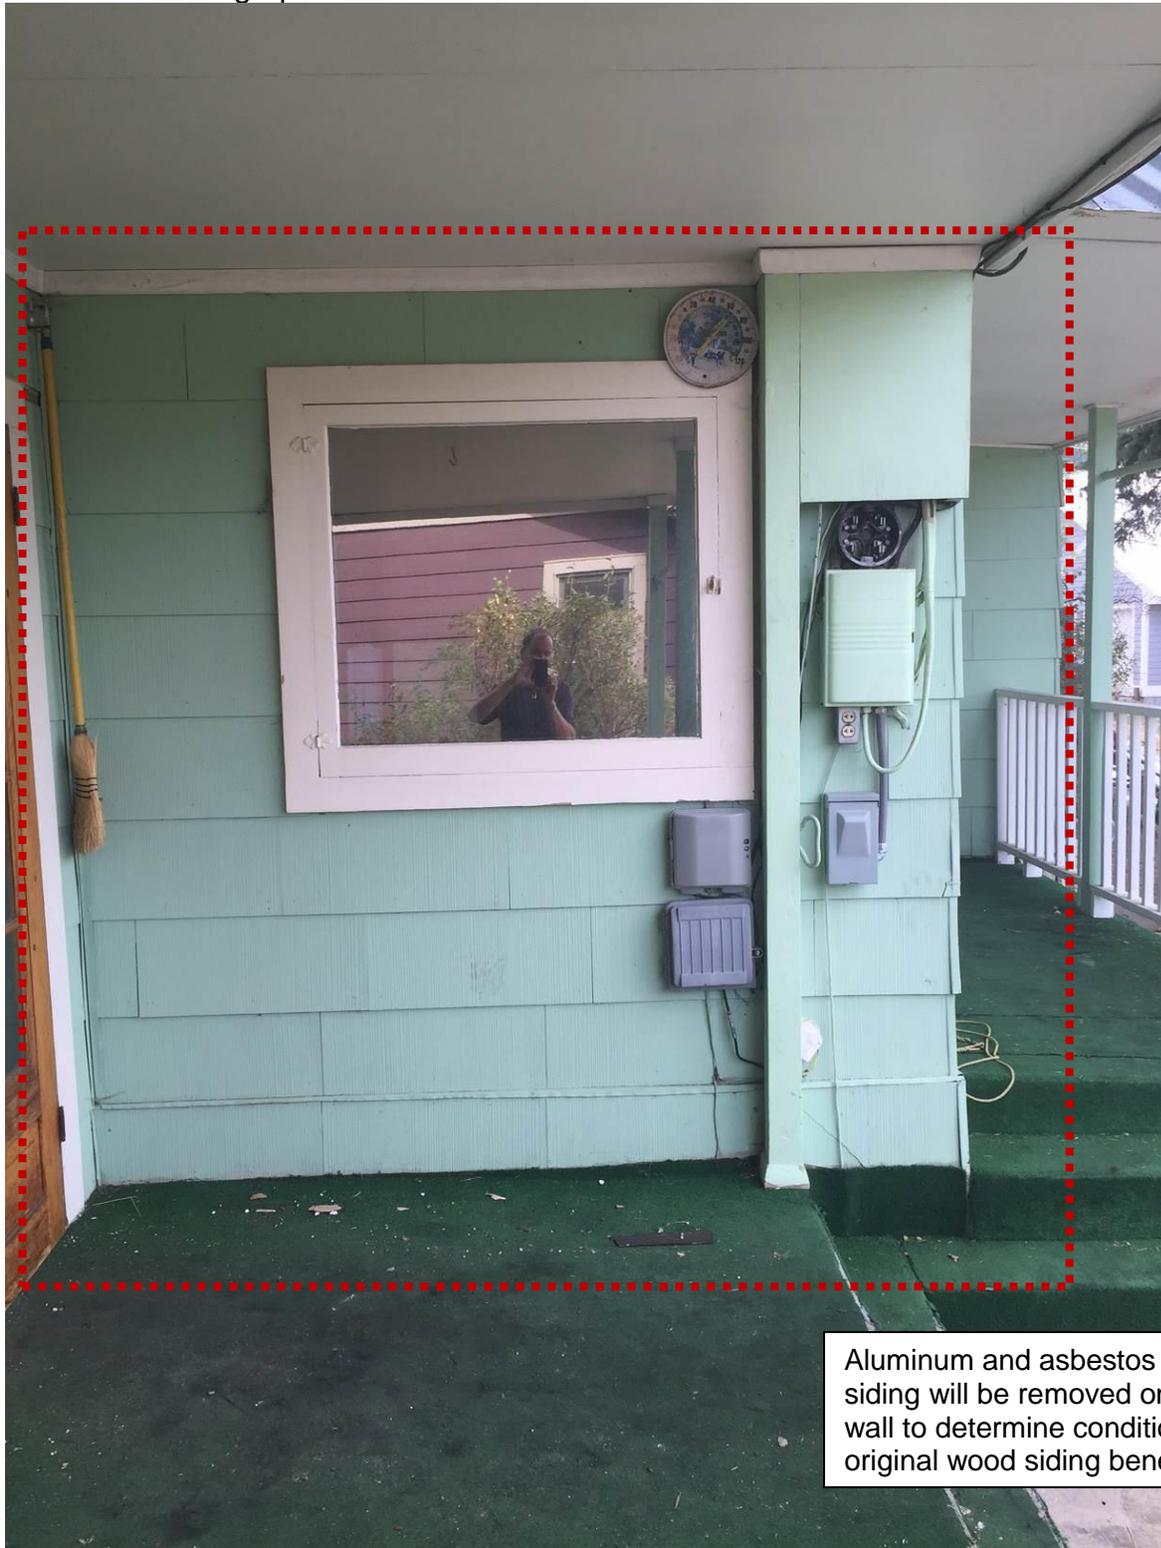
Aluminum and asbestos shingle siding will be removed on this north wall to determine condition of original wood siding beneath.

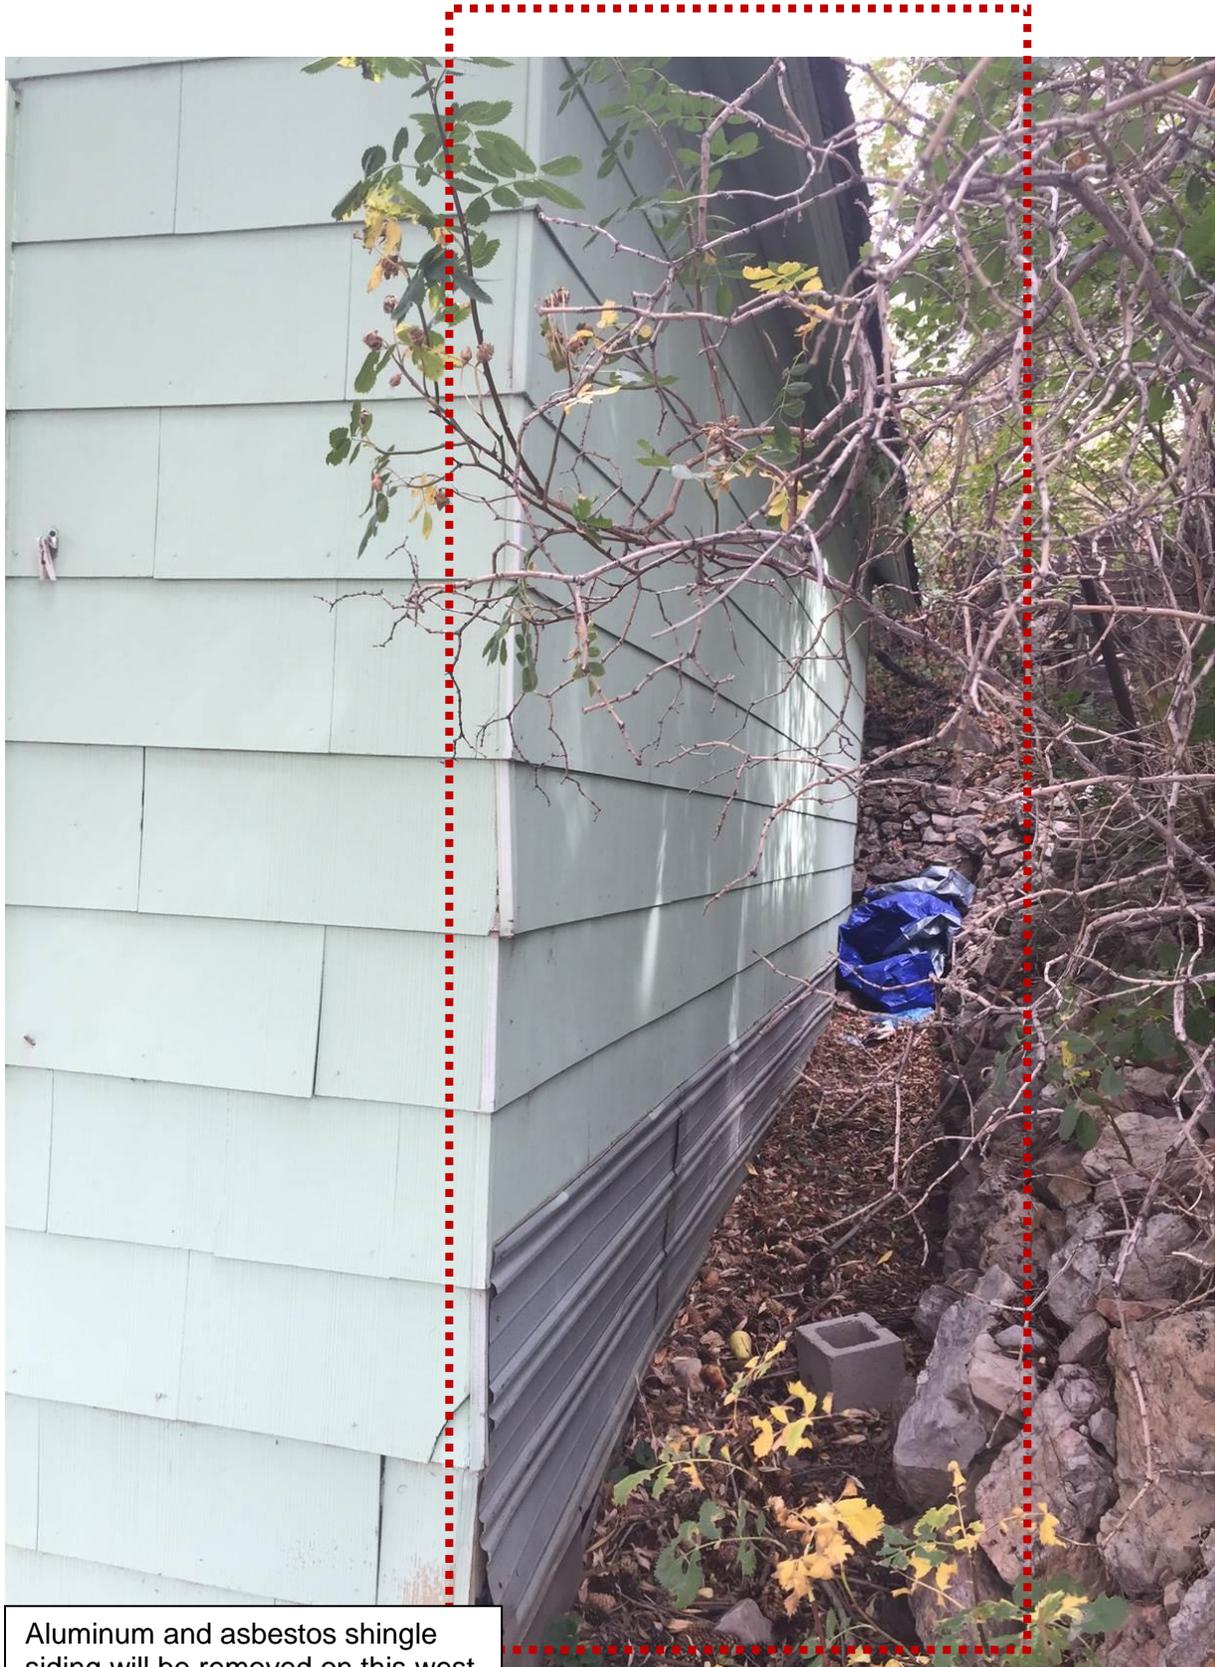
Aluminum and asbestos shingle siding will be removed on this west wall to determine condition of original wood siding beneath.
