HISTORIC SITE FORM - HISTORIC SITES INVENTORY

PARK CITY MUNICIPAL CORPORATION (10-08)

Address: 166 DALY AVE

Building Type and/or Style: Rectangular or "Hall-Parlor" House

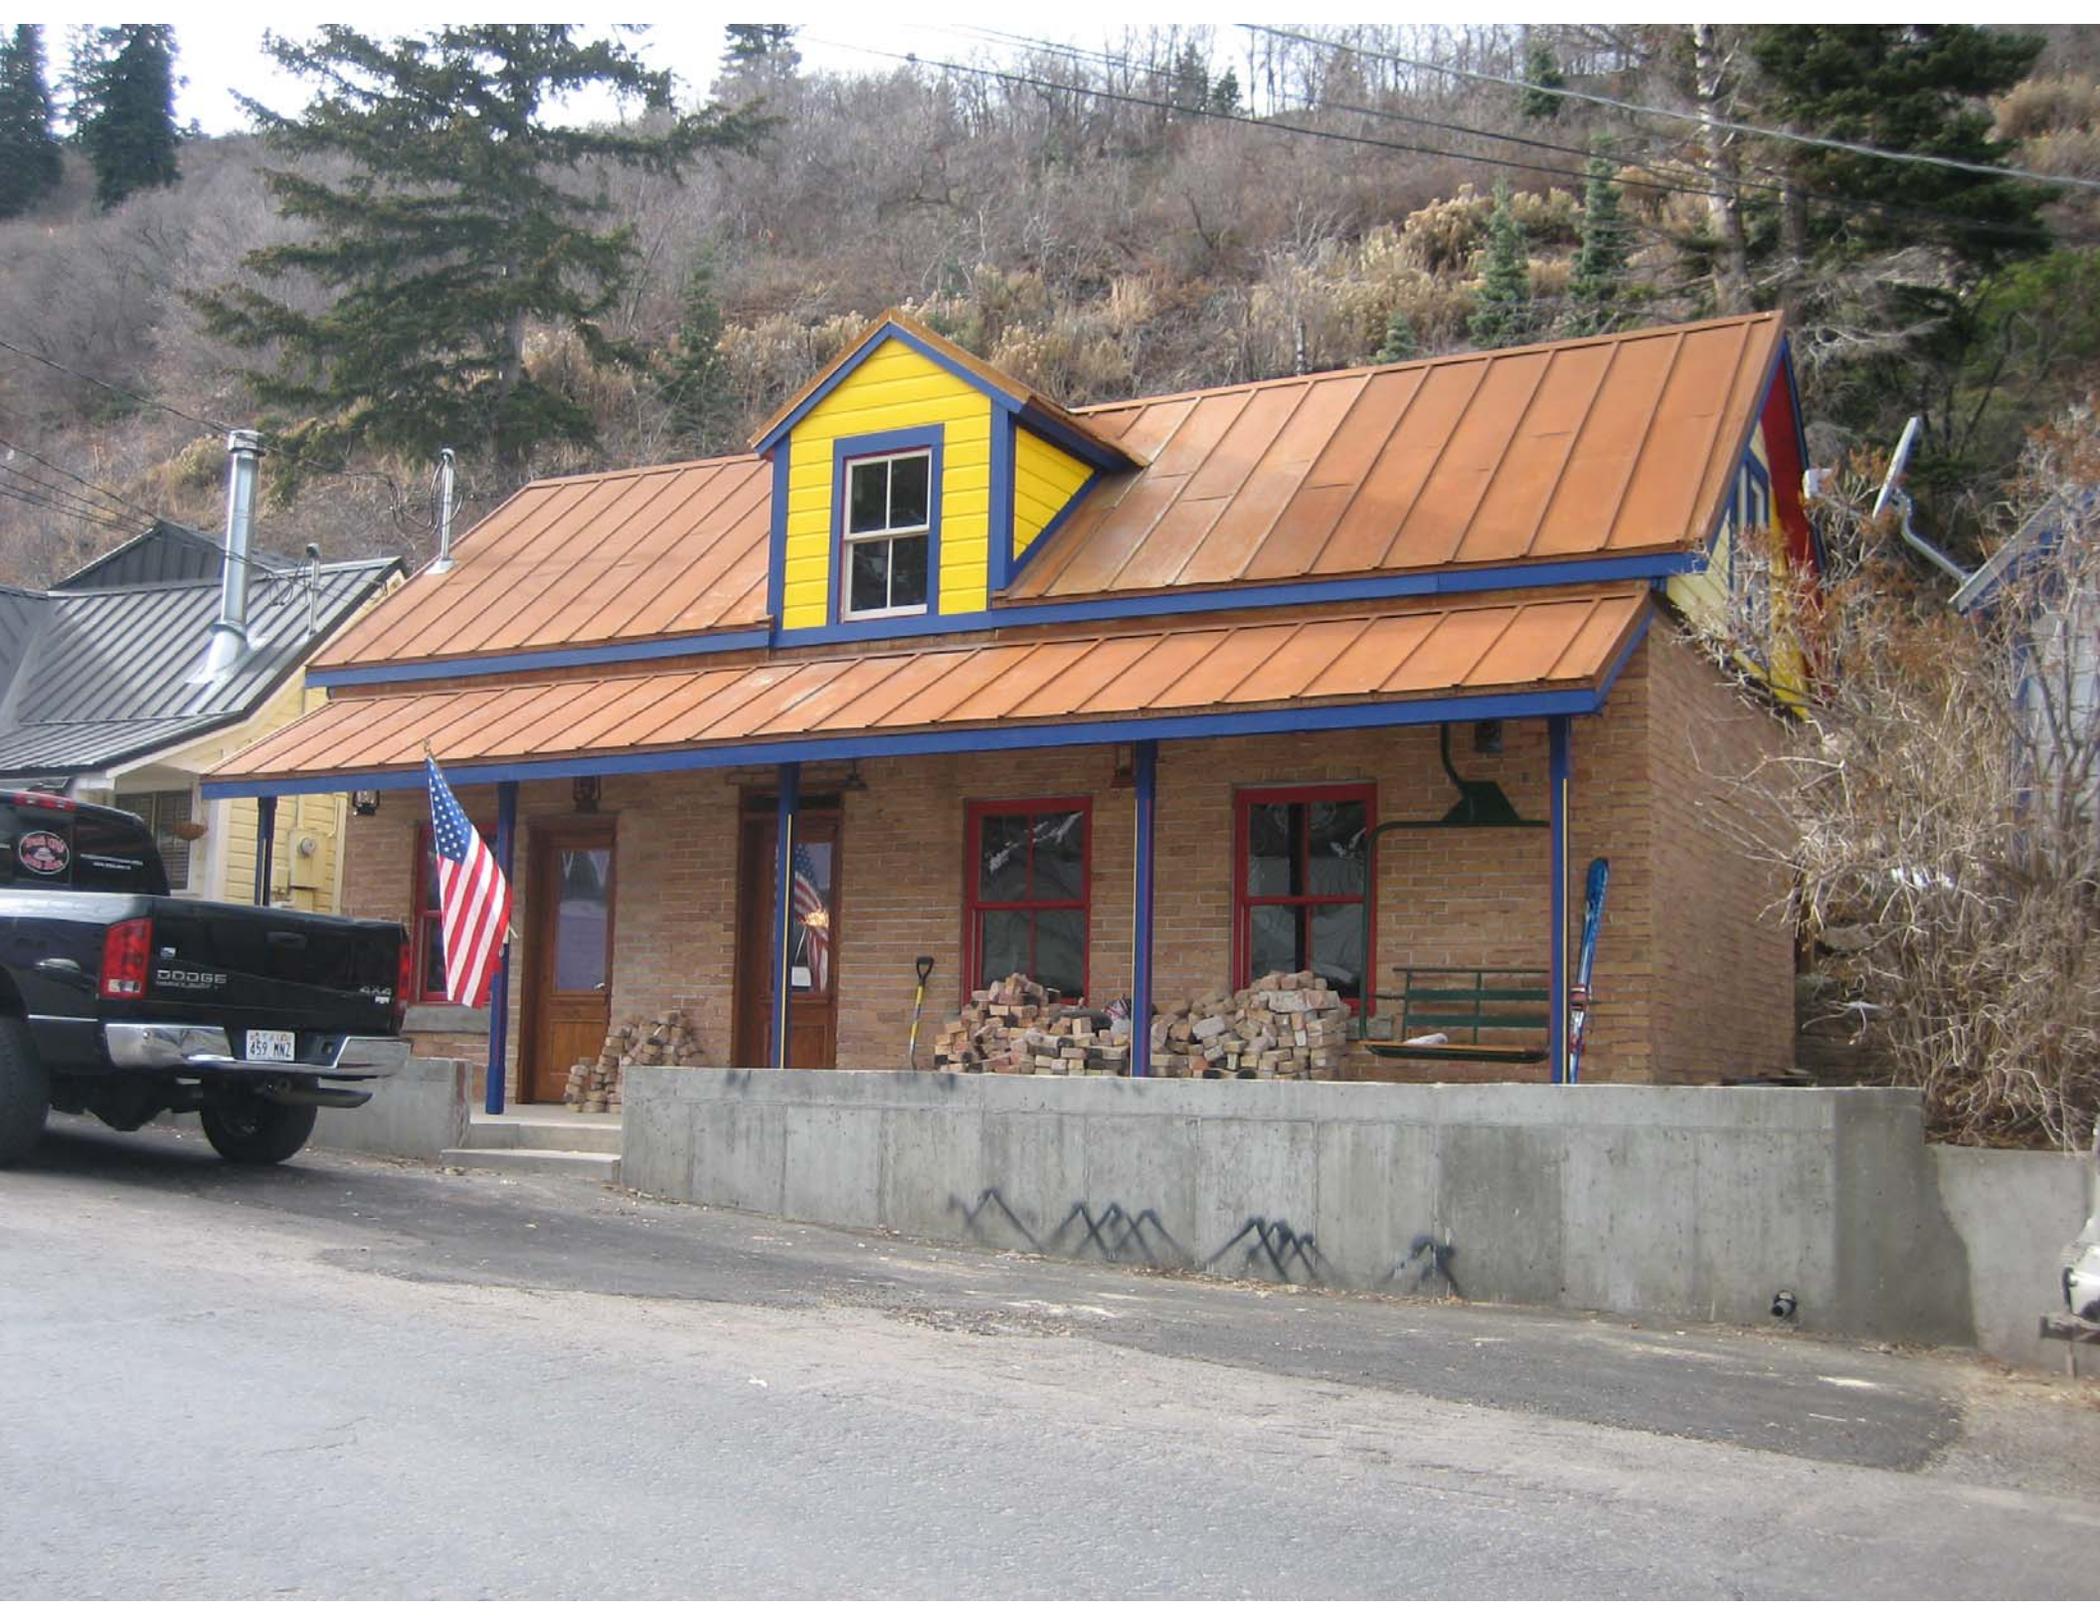
Photo No. 5: Southeast oblique. Camera facing northwest, 1995.

Design (The combination of physical elements that create the form, plan, space, structure, and style. Describe additions and/or alterations from the original design, including dates--known or estimated--when alterations were made): Building card indicates growing evolution of square footage, slowly expanding to the north side and rear of the front elevation, based on the assessment years of 1949, 1958, and 1968. 1940 photo shows evidence of 2nd addition already completed, which offers some discrepancy to when it was actually done. Regardless, the 2008 photos show efforts to restore earliest visual appearance of front elevation ground level, including adjacent front doors, and matching window styles to those found in 1940 tax photo. Central dormer is first seen in 1995 photo, but was not evident in photos prior to that time. Dormer size and scale is adjusted again by 2008 to match flush with ground level wall below, as is its window opening. Red brick color in 2006 photo appears painted as 2008 photo indicates a more natural brick coloration (likely a restorative effort between those two years). Drop-novelty siding appearance a likely restorative effort as well, as rear addition shows cinder block and aluminum siding in 1995 photo.
