HISTORIC SITE FORM - HISTORIC SITES INVENTORY

PARK CITY MUNICIPAL CORPORATION (10-08)

Address: 243 DALY AVE

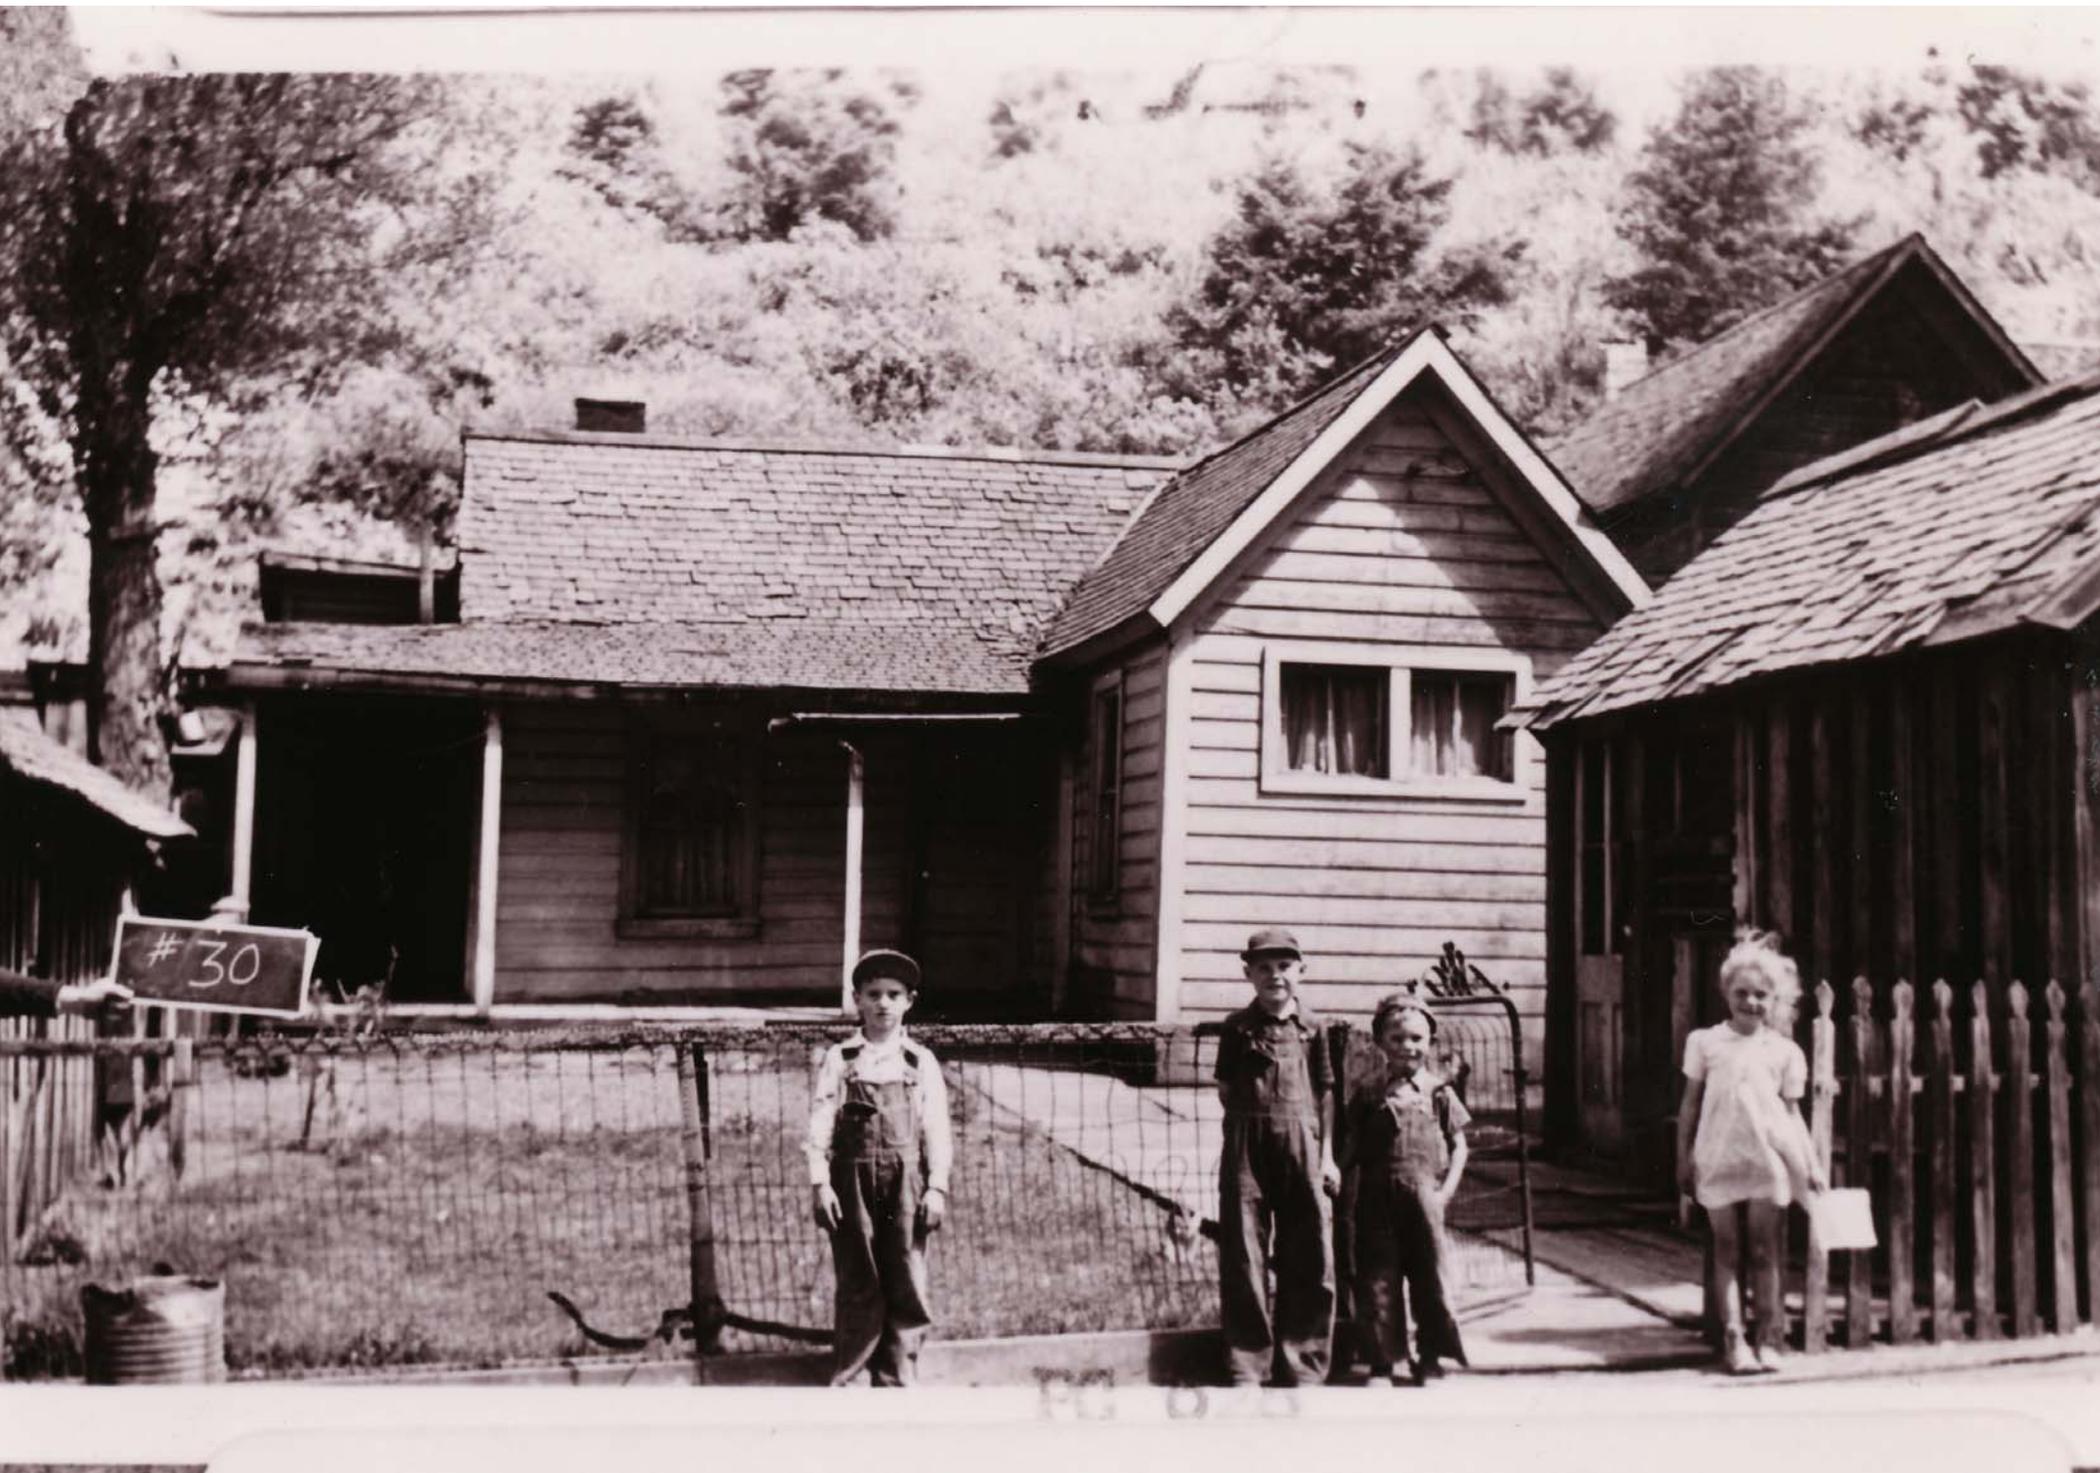
- Photo No. 1:** West elevation (primary façade). Camera facing east, 2006.
- Photo No. 2:** West elevation (primary façade). Camera facing east, 2006.
- Photo No. 3:** West elevation (primary façade). Camera facing east, 1995.
- Photo No. 4:** West elevation (primary façade). Camera facing east, tax photo.

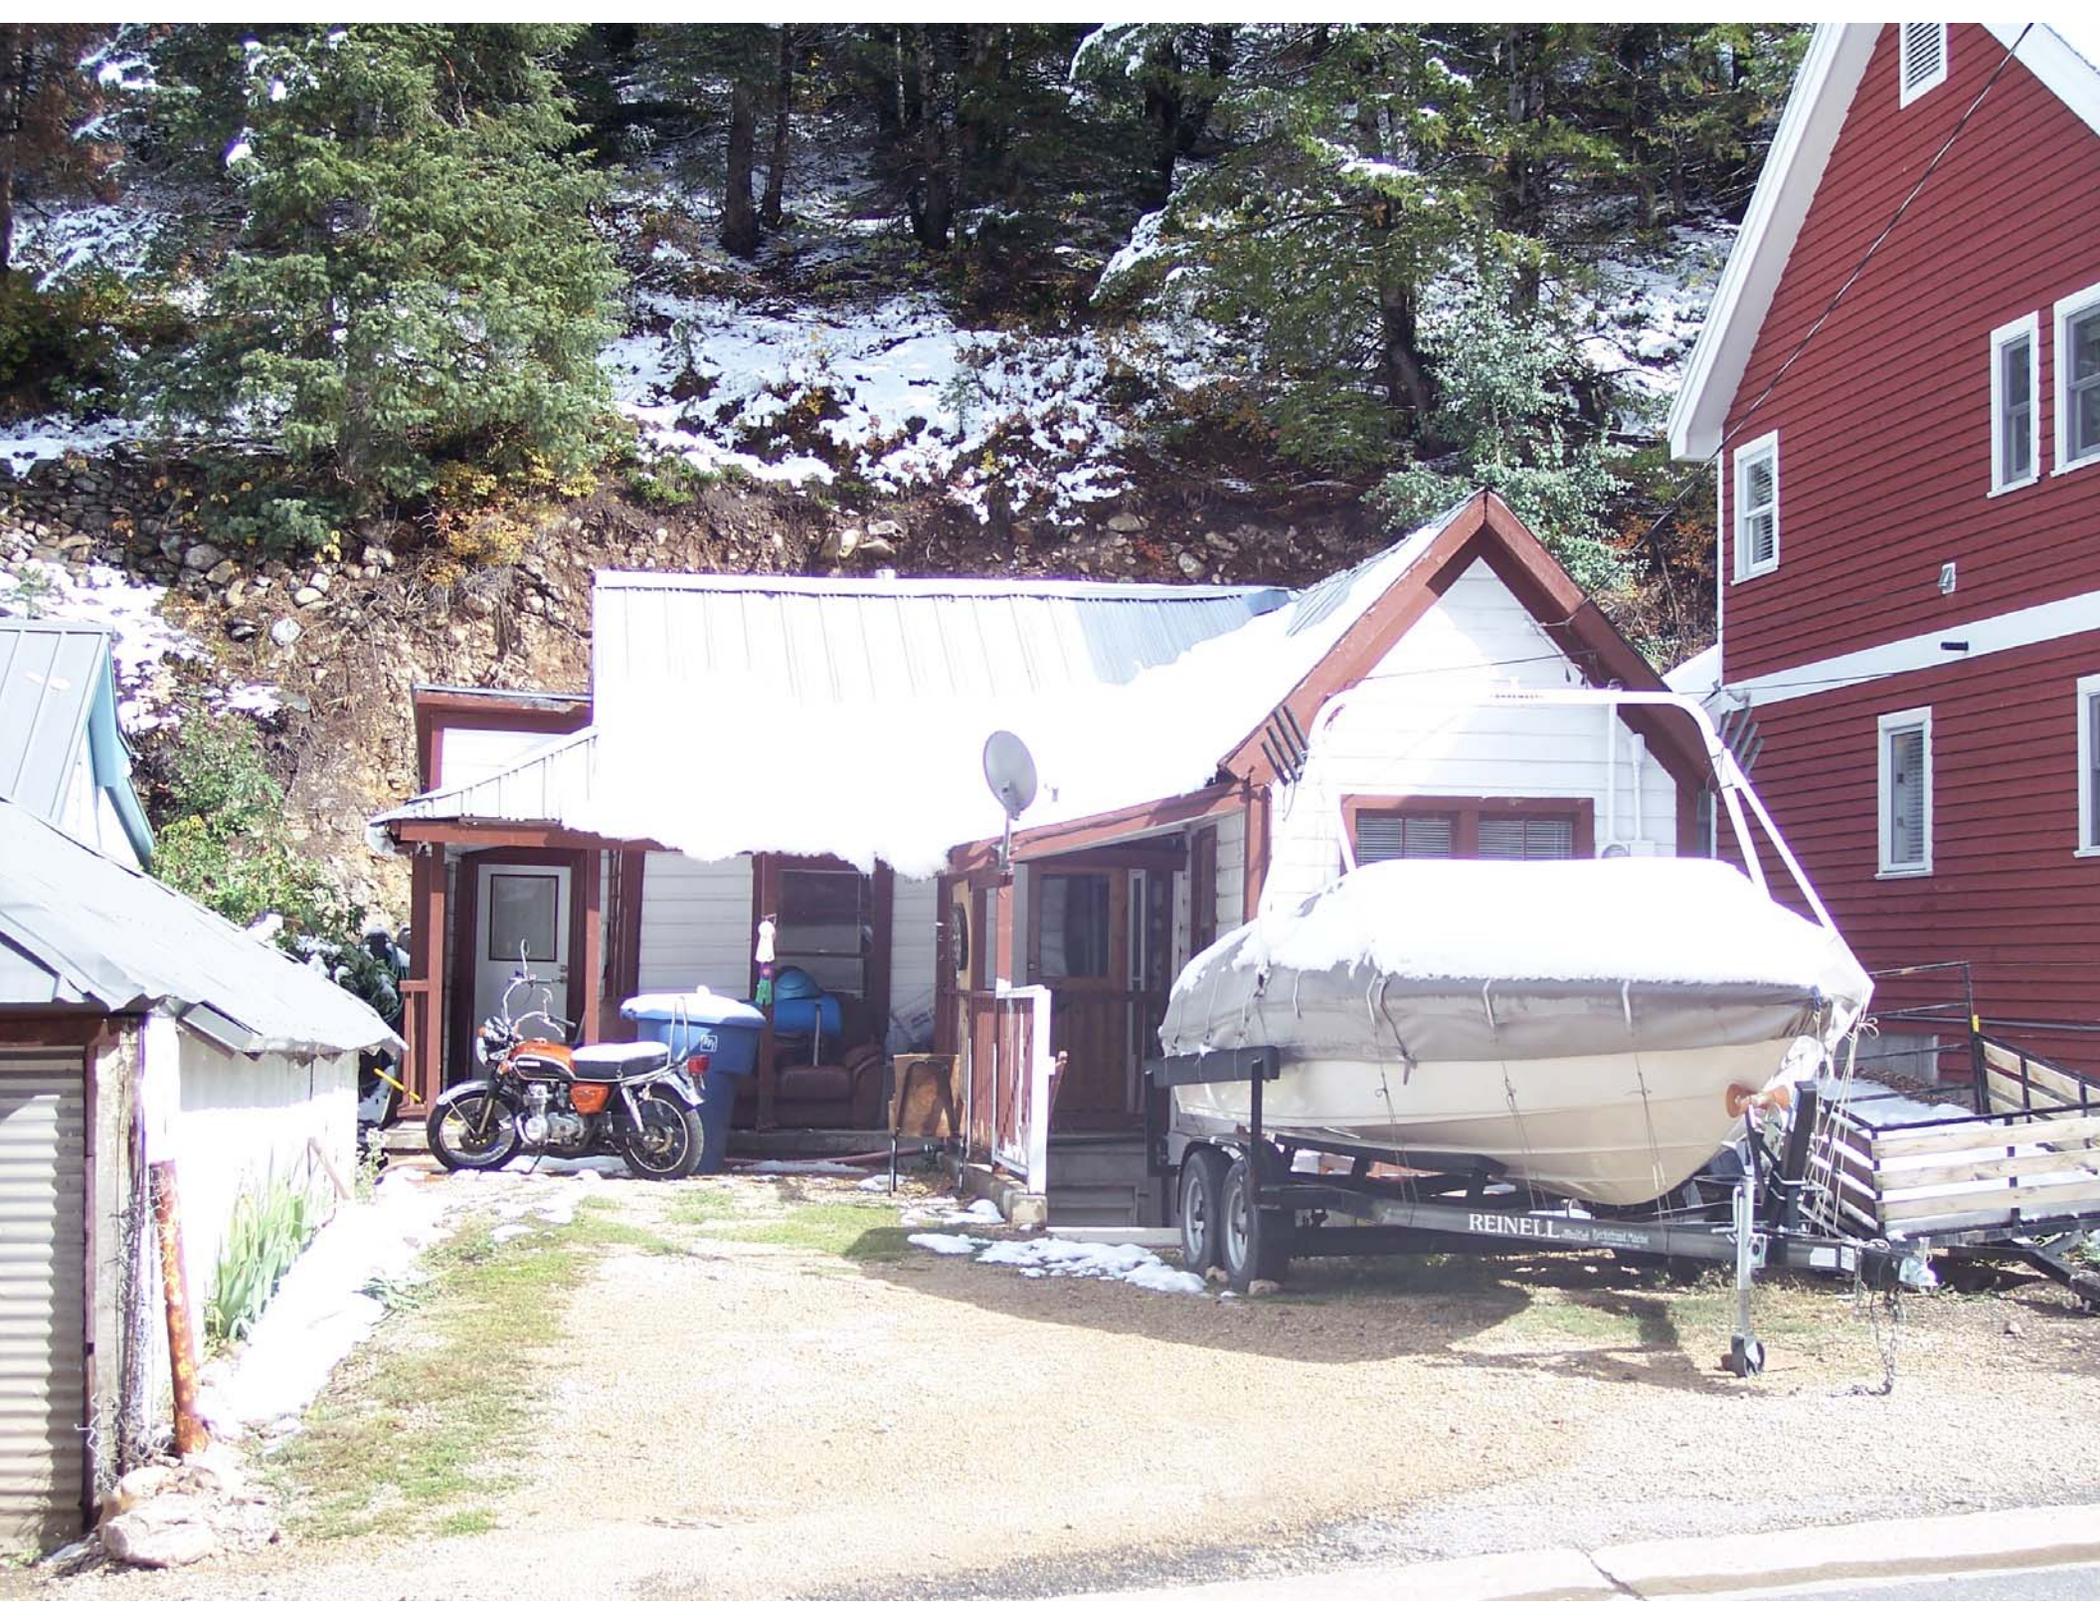
Narrow building lot on fairly flat terrain. A steep hilly slope rises directly behind the property line in back, covered in natural vegetation. Entire loss of front yard vegetation evident from 1995 photo to 2006 photo, where front yard fence separating property from city roadway has now been taken out completely and left as a gravel parking face. Evidence of a prior garage structure (seen in tax photo) has been removed from site by 1995 photo.
