HISTORIC SITE FORM - HISTORIC SITES INVENTORY

Address: 309 DALY AVE

Building Type and/or Style: Rectangular or "Hall-Parlor" House

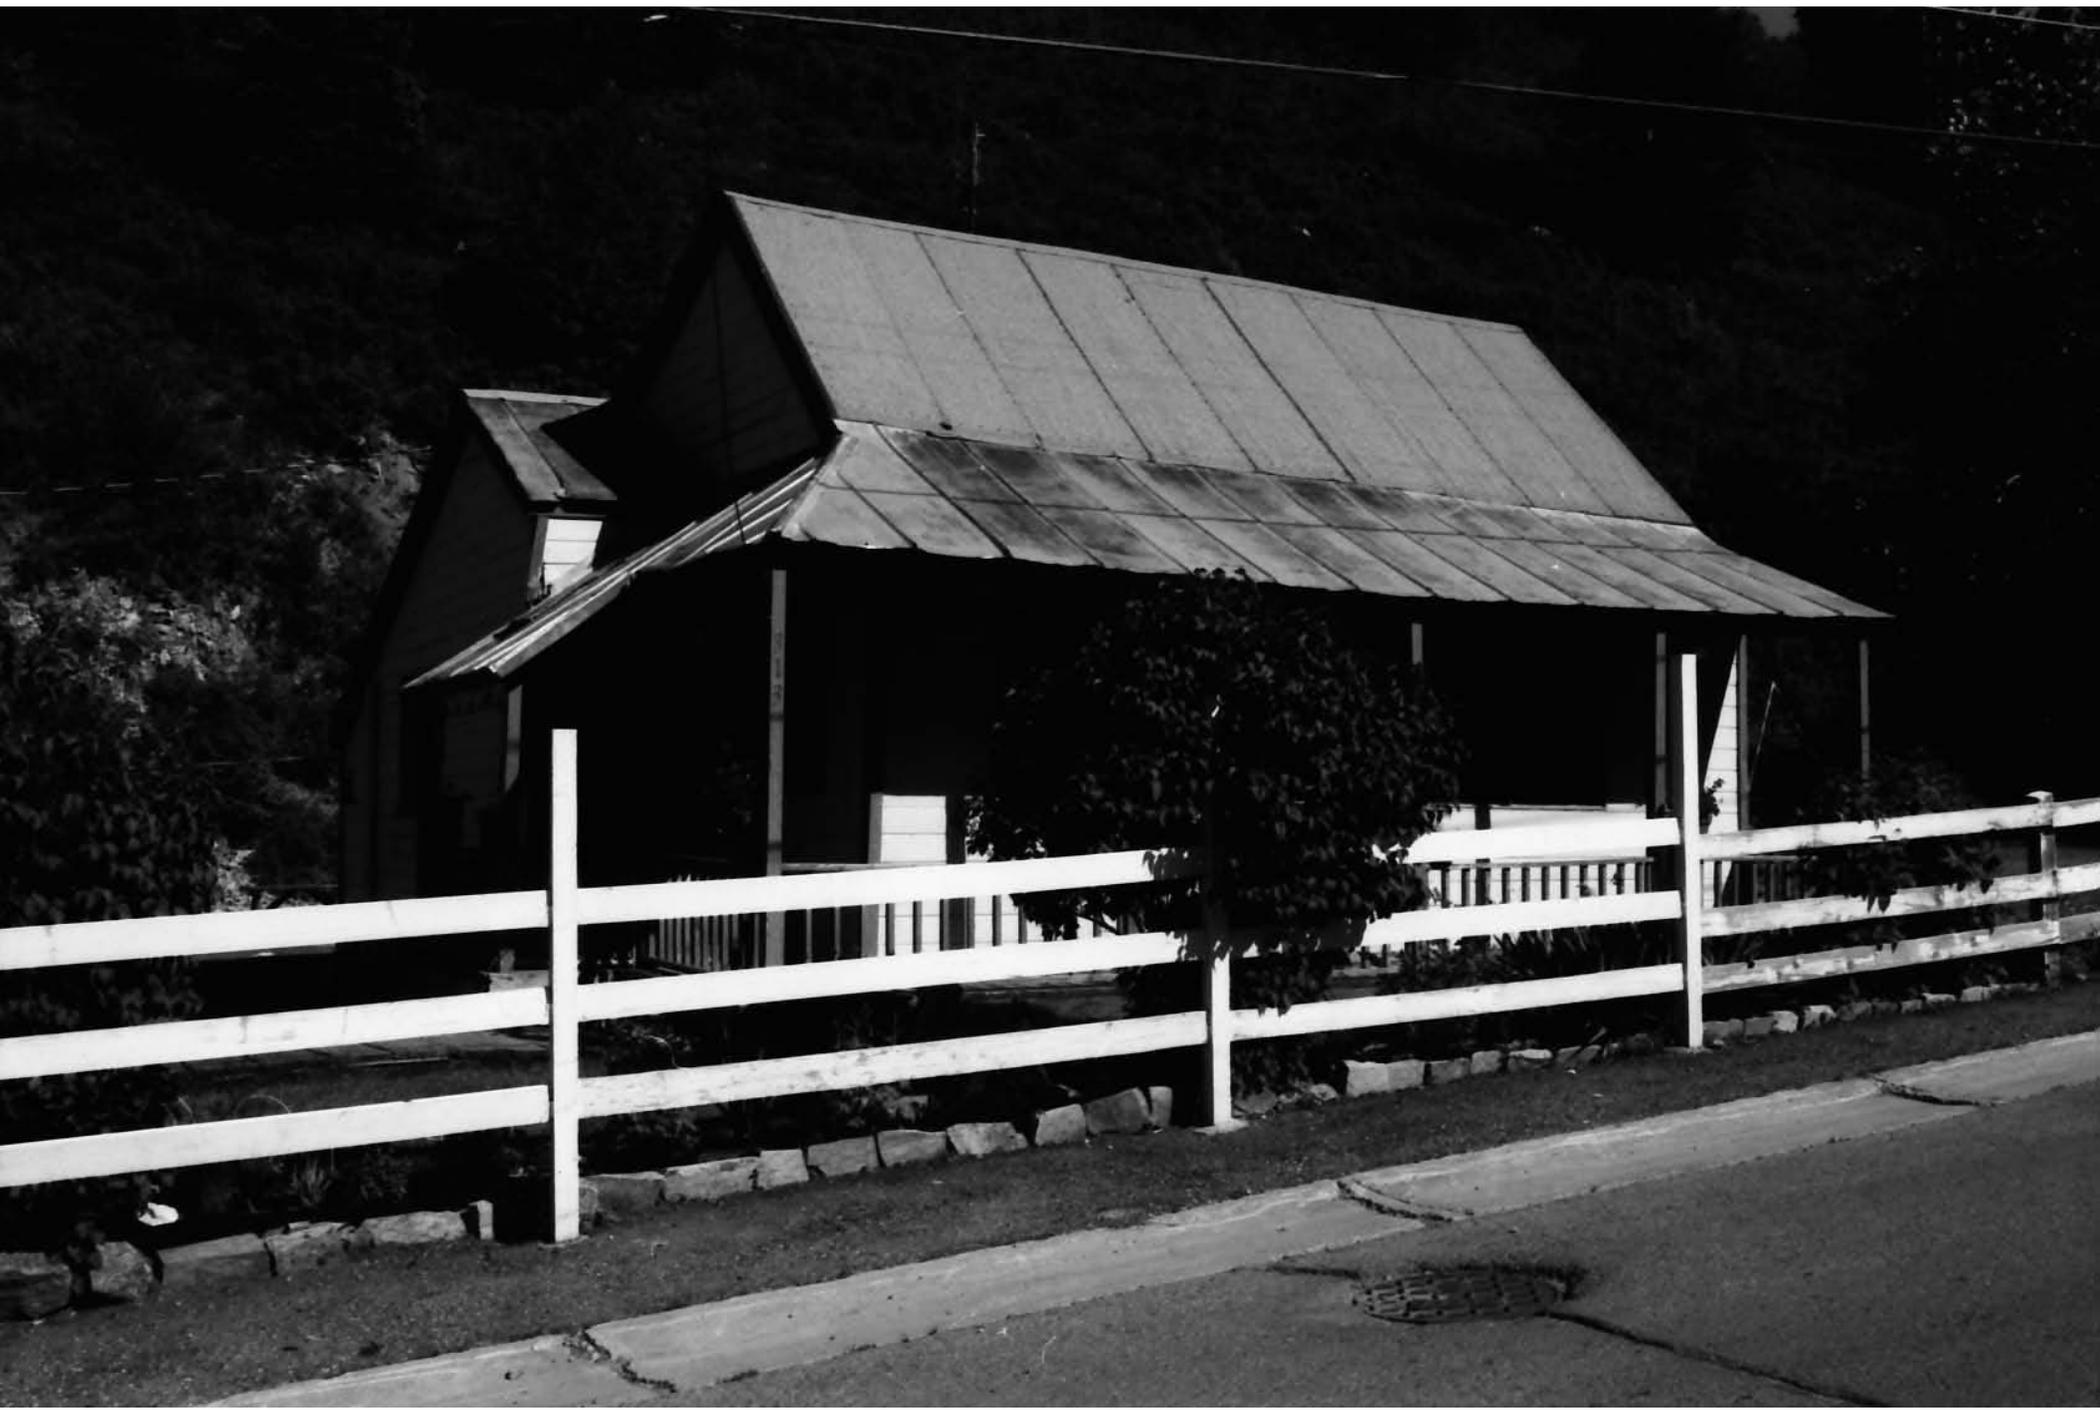
- Photo No. 1:** Southwest oblique. Camera facing northeast, 2006.
- Photo No. 2:** Northwest oblique. Camera facing southeast, 2006.
- Photo No. 3:** Accessory buildings. Camera facing east, 2006.
- Photo No. 4:** Northwest oblique. Camera facing southeast, 1995.
- Photo No. 5:** Northwest oblique. Camera facing southeast, tax photo.
