# HISTORIC SITE FORM - HISTORIC SITES INVENTORY

PARK CITY MUNICIPAL CORPORATION (10-08)

Address: 314 DALY AVE

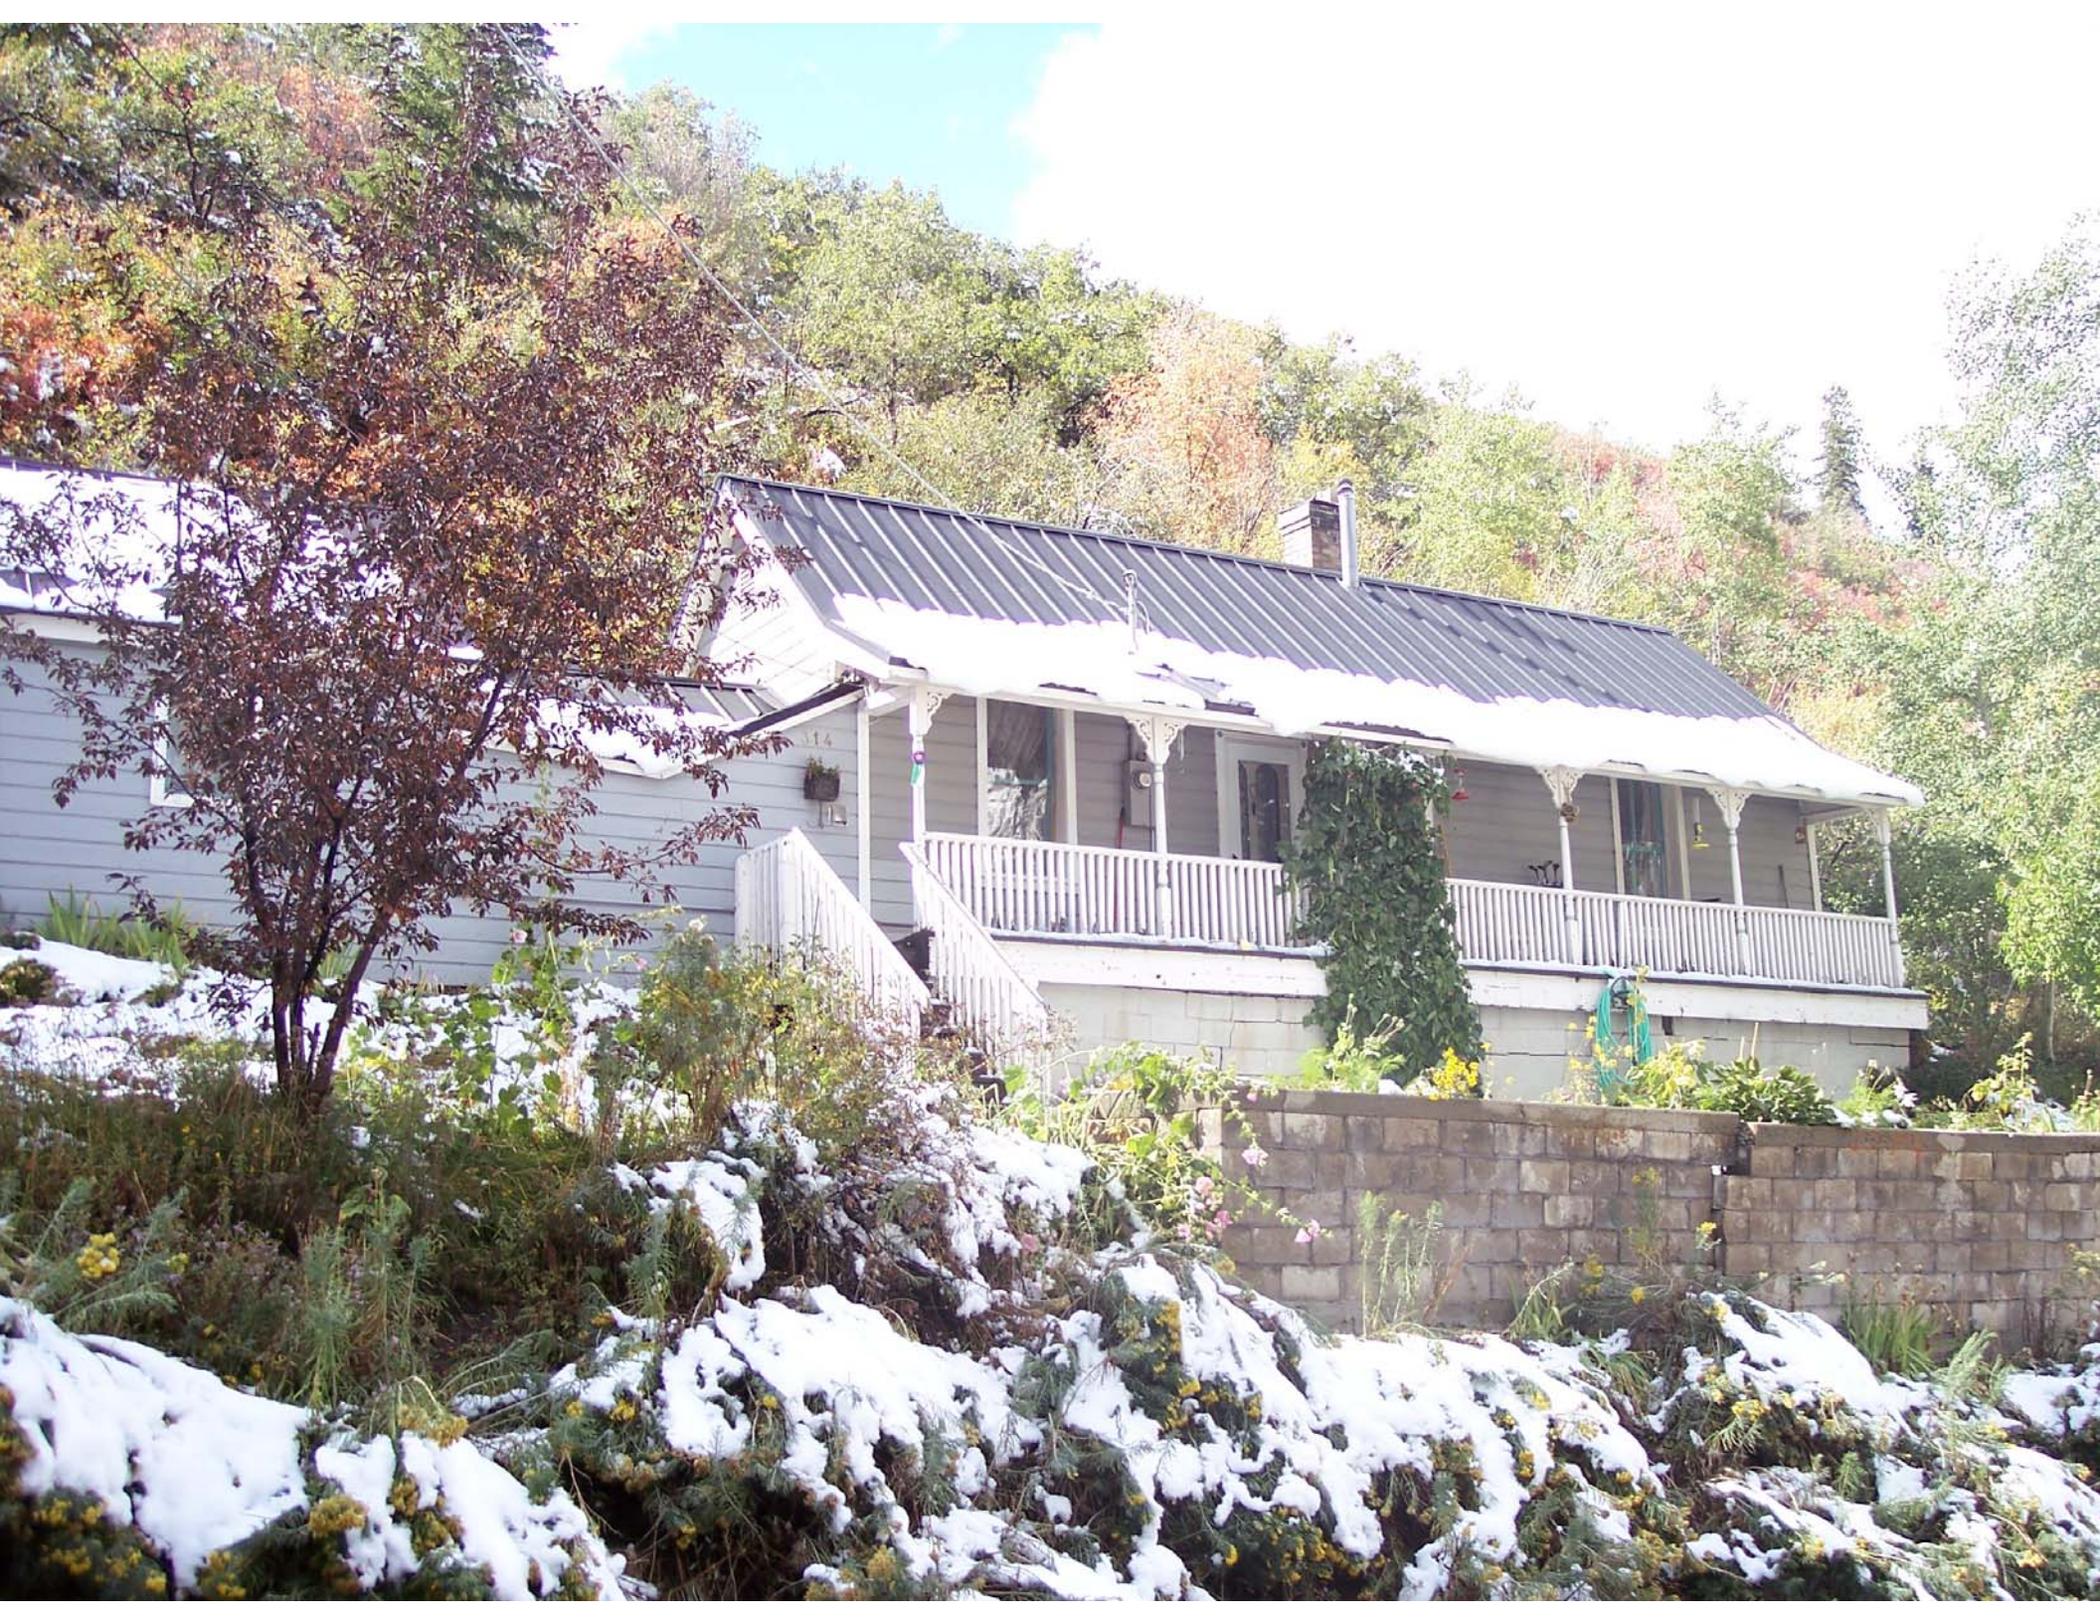
**Photo No. 1:** Southeast oblique. Camera facing northwest, 2006.

Site: Cement block retaining wall, looks to be settling and in some disrepair in 2006 photo

Foundation: Porch foundation is cement block- unable to determine foundation materials of the rest of the structure based on photos alone.

Walls: Drop-novelty wood siding

Roof: Metal

Windows: One casement window is visible from provided photos, unable to verify remaining window materials
