HISTORIC SITE FORM - HISTORIC SITES INVENTORY

Name of Property: **Samuel L. Raddon House**

Address: 325 Park Ave

Structure/Site Information Form

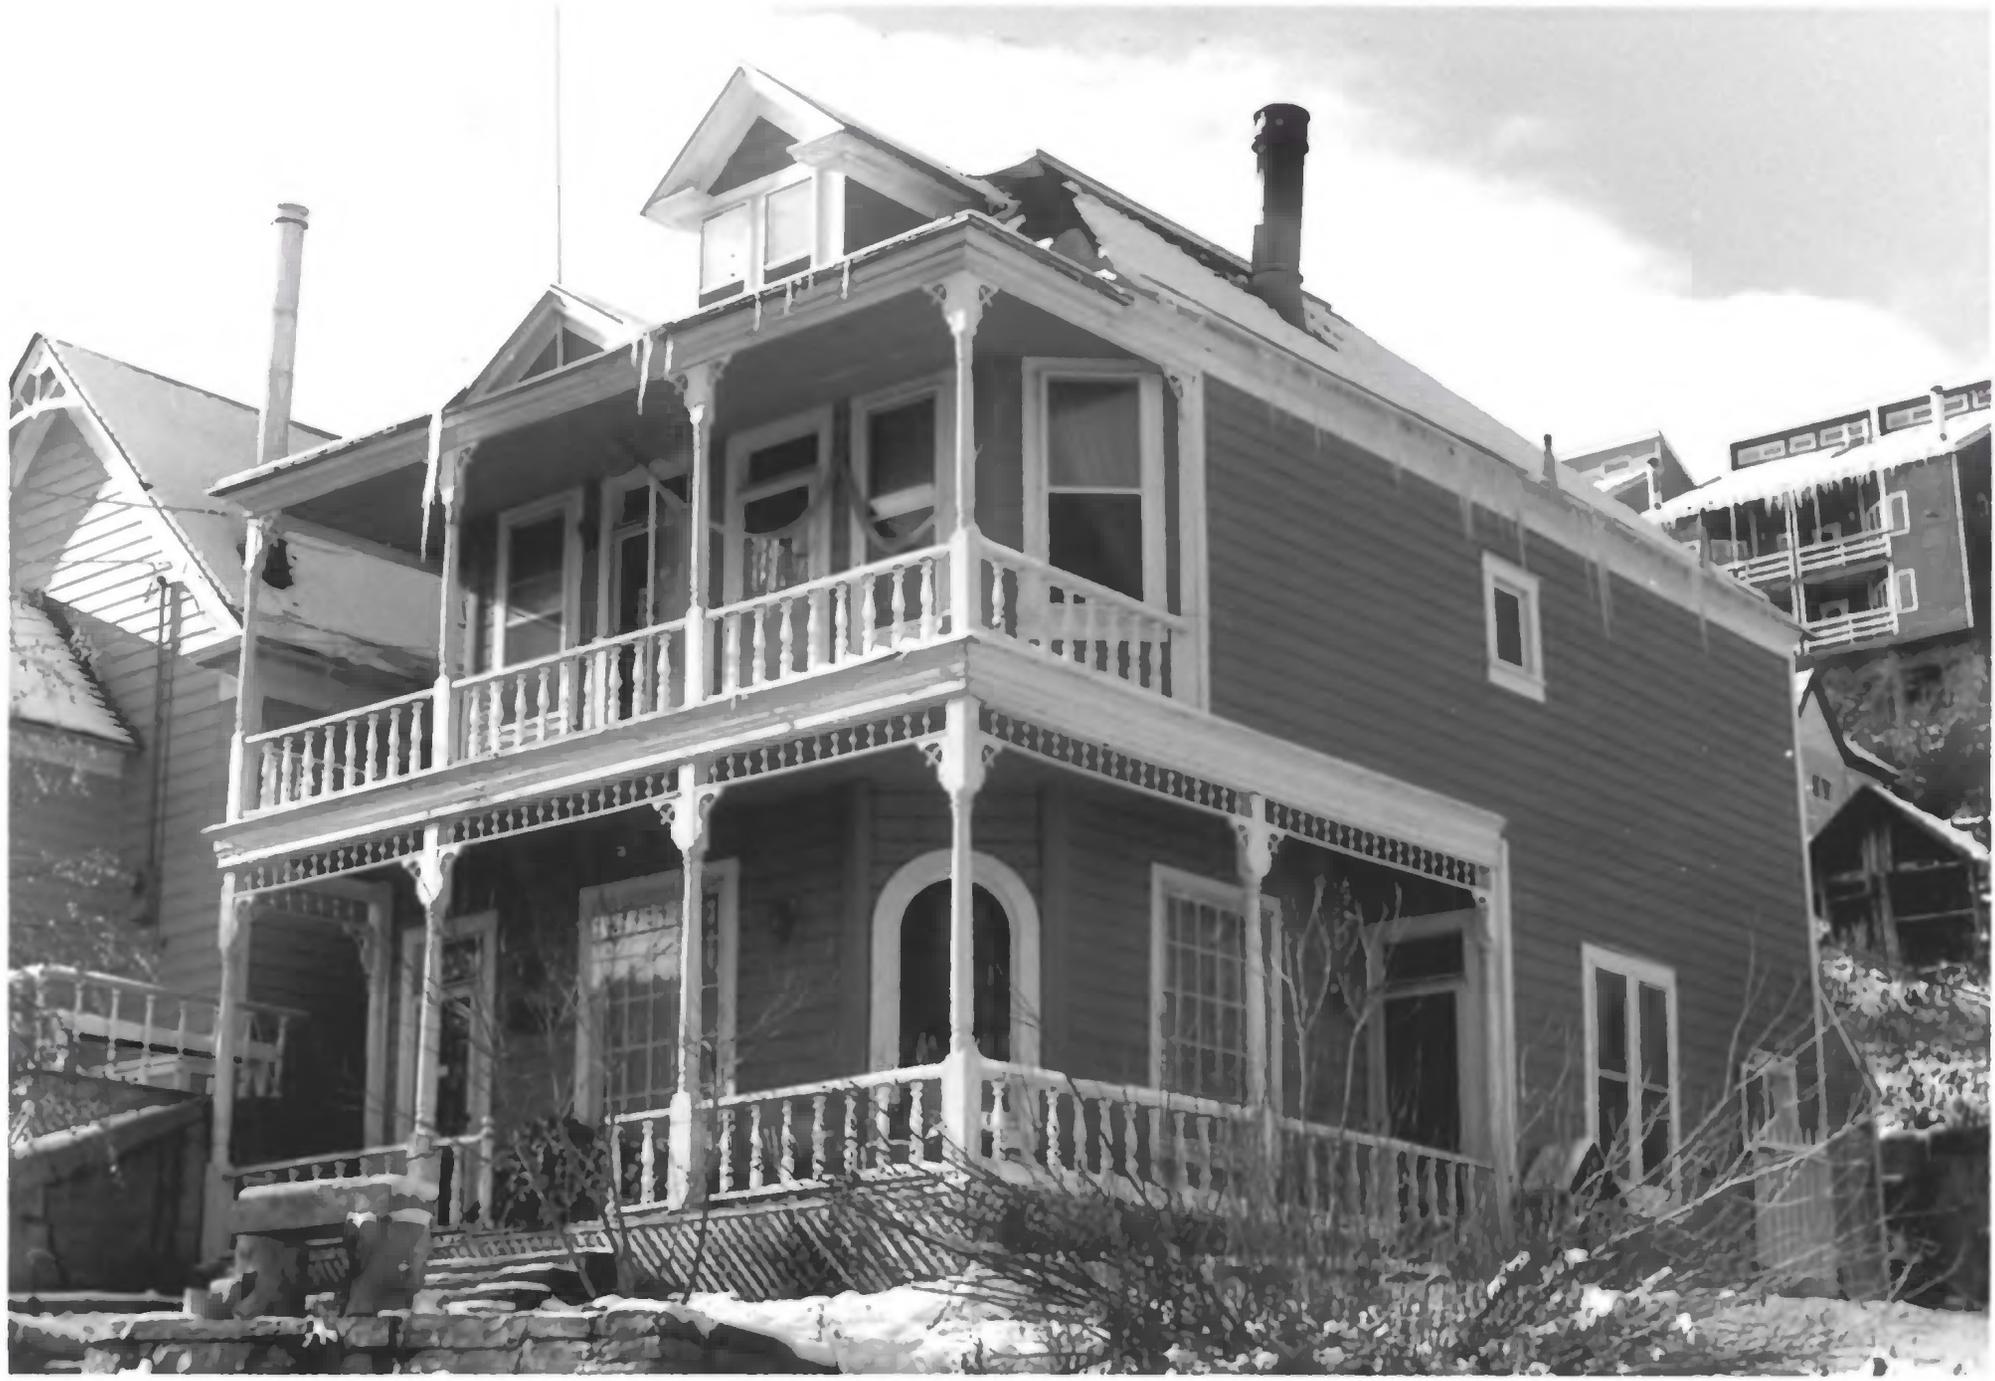
View from Northeast corner

This house is a two and one half story frame building with a truncated hip roof and an irregular rectangular form. It is Park City's premier example of the Victorian influence on residential architecture. Victorian influences were only superficially applied in Park City. This house, however, goes a step beyond the mere application of decorative features. A subtle attempt was made to create an irregular plan, characteristic of Victorian design, one which varies from the simple geometric form of most of Park City's residences. Other features characteristic of Victorian influences include: the impressive two story porch with lathe turned porch piers, balusters, spindles and decorative brackets, and the use of decorative glass windows.

The clipped northeast corner of the rectangle is recessed, allowing space for the first story of the two story porch that wraps around the corner to extend to a secondary entrance halfway down the north side of the building. The northeast and southeast corners of the second story are also clipped. The second story of the porch spans only the facade. Porch elements include: lathe turned piers topped by decorative brackets, lathe turned balusters, and a decorative spindle band. The balustrades on both floors may not be original, but they were designed to complement the style of the house, and are
(See continuation sheet)

comparable to the type that may have been original. There is a simple decorative pediment on the porch roof, centered between the central porch piers. A gable roof dormer projects from the east roof section directly behind the pediment. It may not be original, but was designed of materials in appropriate proportions so that it complements the design of the house. There are returns on the dormer's gable end, and it is pierced with a pair of double hung sash windows. The arrangement of openings on the first floor of the facade is asymmetrical, whereas it is symmetrical on the second floor. There are two large windows on the first floor, one on the east wall between the main door and the round arch corner window, and the other on the north wall between the round arch window and the second door at the west end of the porch. The windows are not original, but the size of the openings may be original. It is probable that a pair of double hung sash windows or a broad single pane with transom window once occupied the opening that now contains a large multi-pane window. The multi-pane windows are not in keeping with the character of the rest of the building, but, because they probably do not vary in proportion with the size of the original windows, they are unobtrusive and could easily be replaced. The front door and the round arch window both have leaded glass panes. Two doors are centered between pairs of windows on the second floor, one window on each side having been set into the clipped corner section. The doors are long and narrow with square leaded glass panes and plain transoms above. The windows are the one over one double hung sash type. There is a small square stained glass window set in the second story section of the north side of the building. Except for the probable replacement of the balusters, the possible addition of the dormer, and the change of window type on the first floor, the exterior of the house looks as it was originally designed. The changes that have been made, with the exception of the window change, are in keeping with the character of the building. Despite the changes that have been made, the Raddon house is the best extant example in Park City of a serious attempt to reflect Victorian influences. The Ferry-Kearns Mansion, the other excellent example of Victorian architecture in the Park City area, is not located in the town proper, and, due to its isolated location outside the town, it is not considered part of the general Park City housing stock.

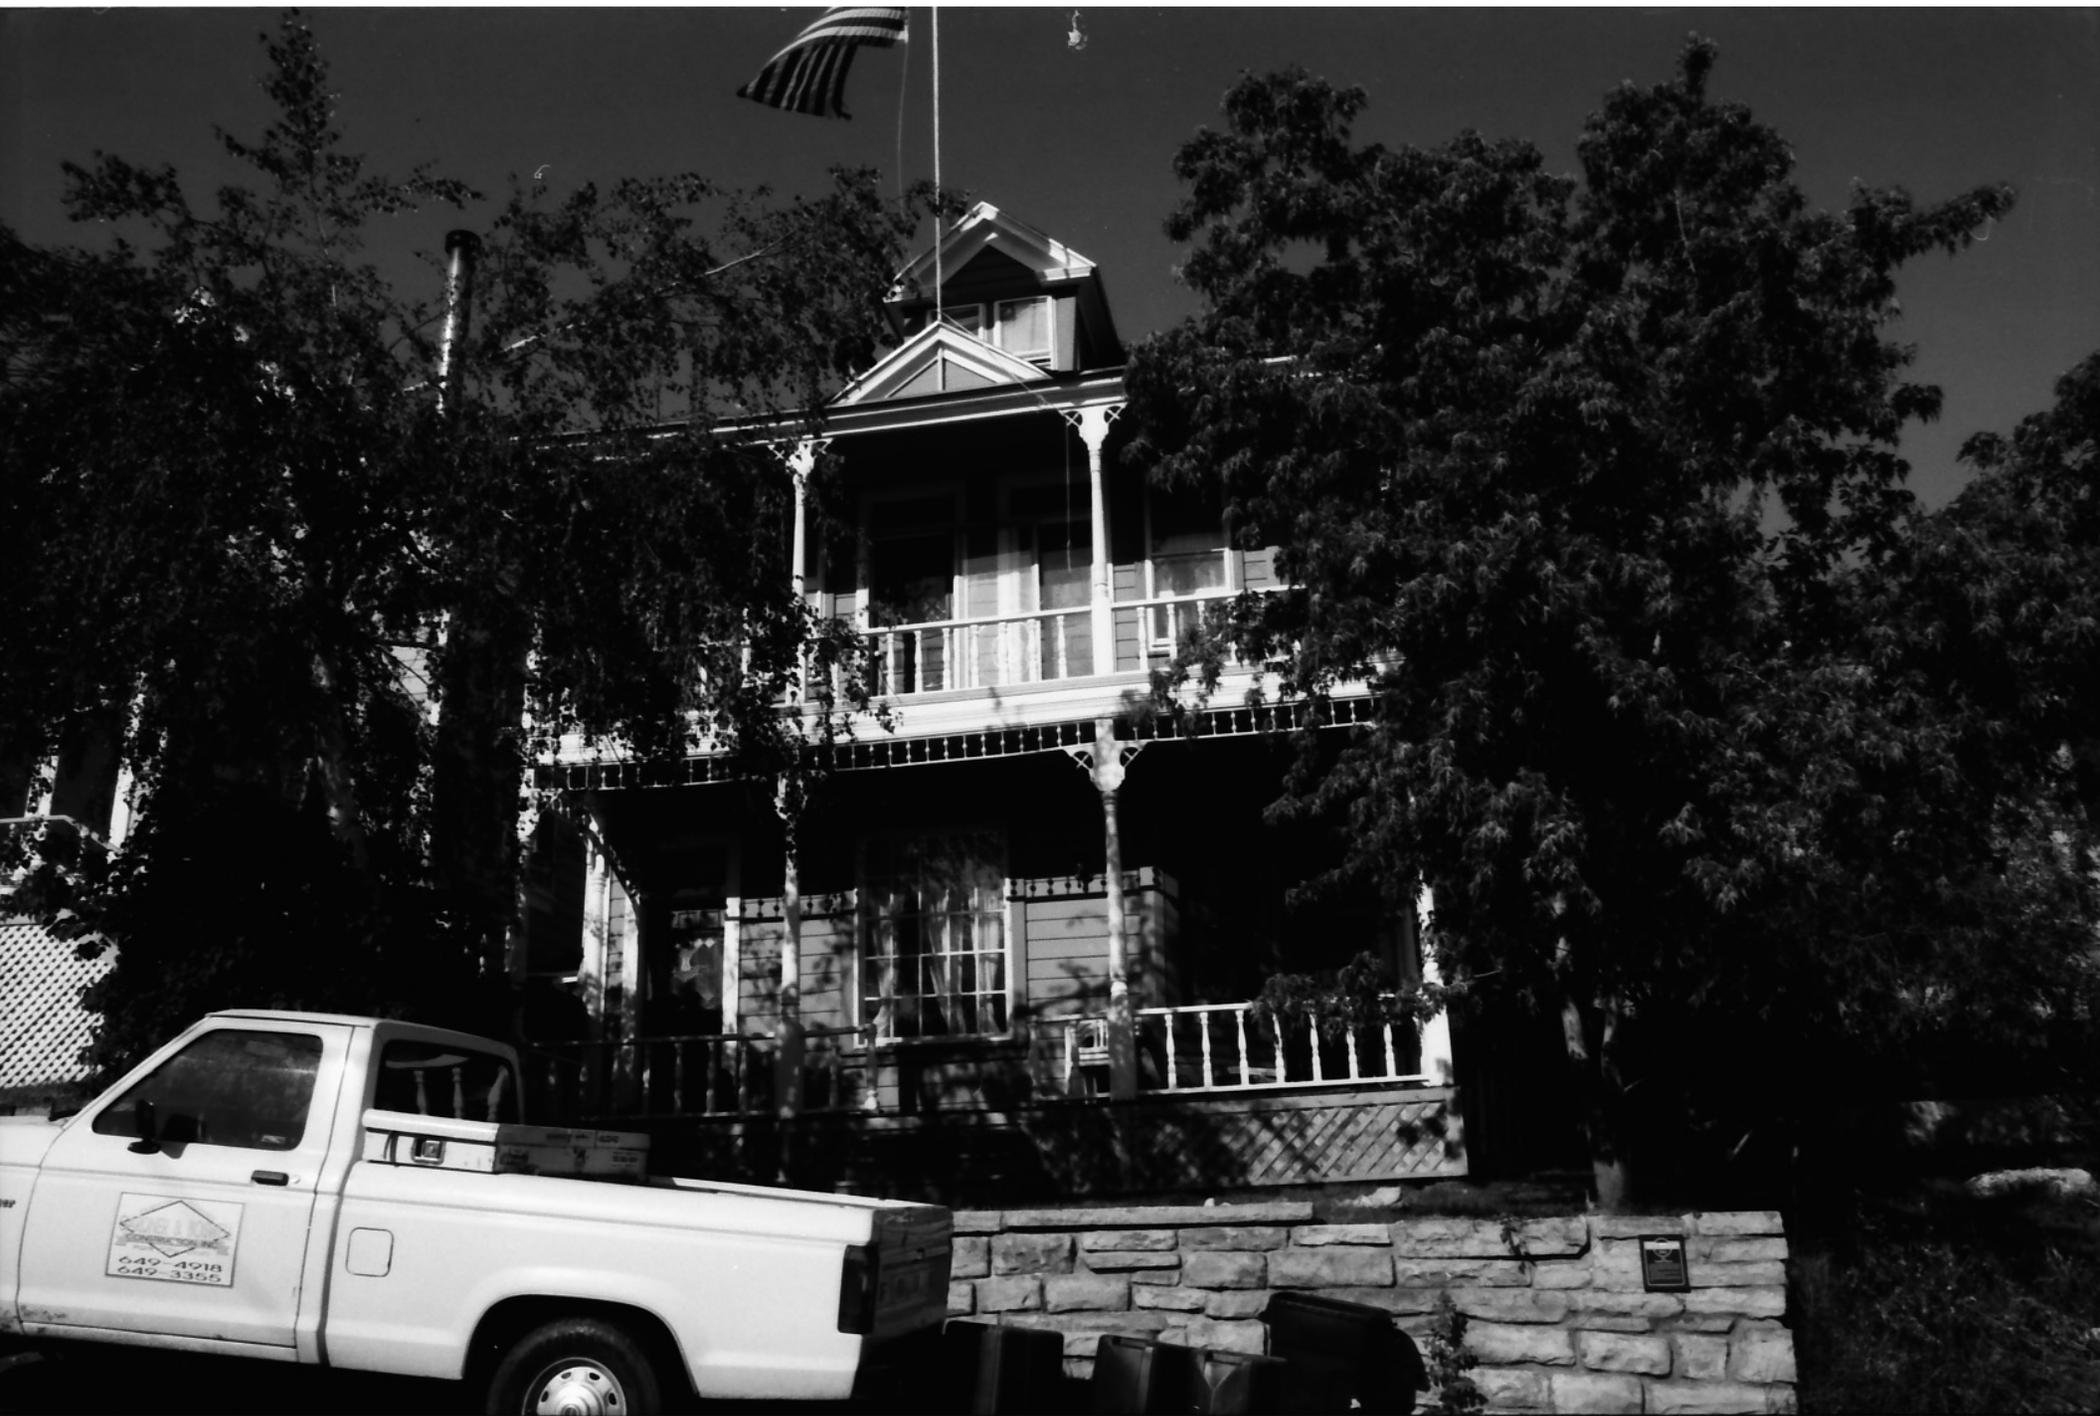
Photo No. 1: East elevation. Camera facing west, 2006.

Design (The combination of physical elements that create the form, plan, space, structure, and style. Describe additions and/or alterations from the original design, including dates--known or estimated--when alterations were made): The 1 1/2 -story frame foursquare remains unchanged from the description provided in the National Register nomination form (See Structure/Site Form, 1983).
