HISTORIC SITE FORM - HISTORIC SITES INVENTORY

Address: 343 Park Ave

Structure/Site Information Form

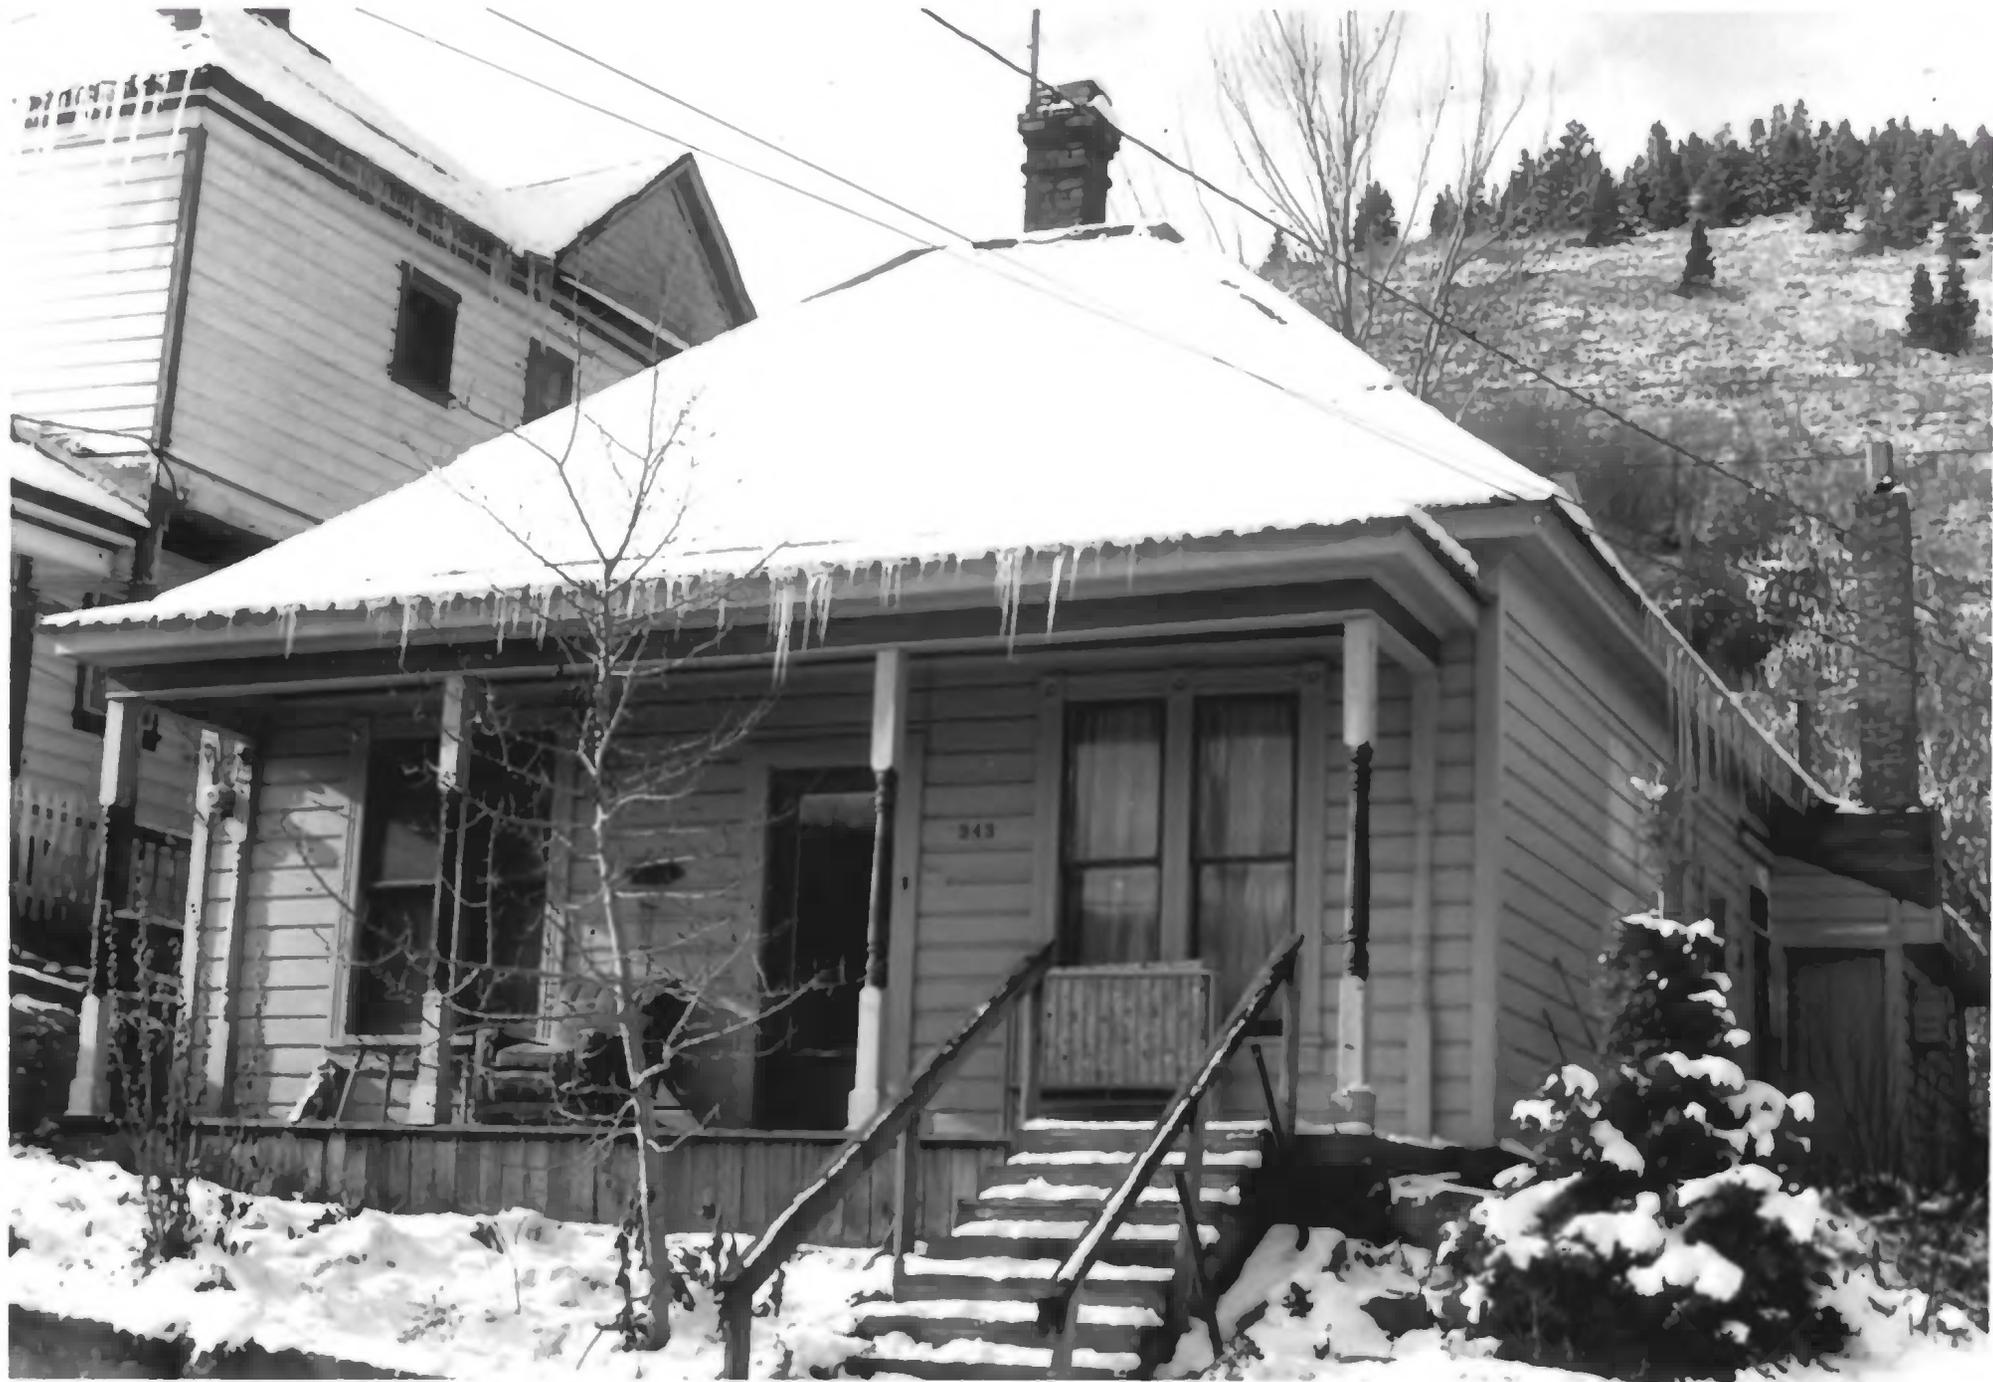
House at 343 Park
Park City, Summit County, Utah

View from Northeast corner

Photo by Roger Roper, October 1983
Negative: Utah State Historical Society
