HISTORIC SITE FORM - HISTORIC SITES INVENTORY

Name of Property: **Charles Heath House**

Address: 364 Park Ave

Building Type and/or Style: Pyramid House

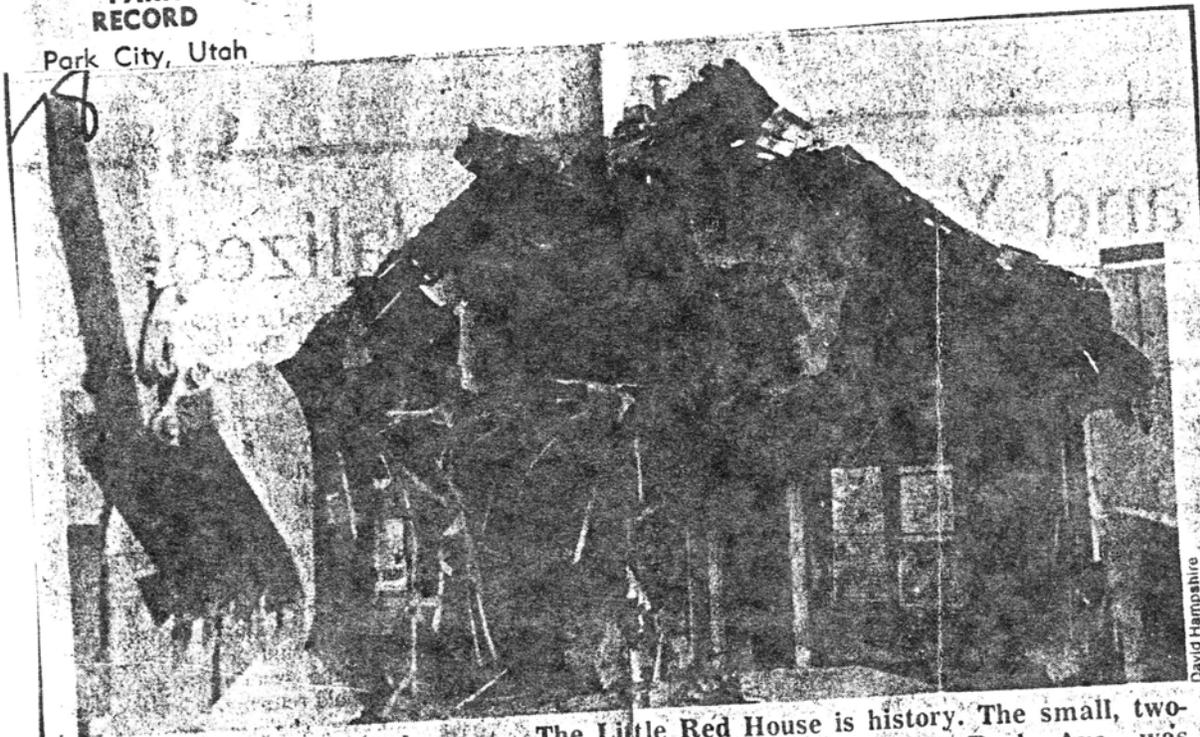
Red House is demolished

The Little Red House is history. The small, two-story wooden structure at 36 Park Ave. was demolished last week, ending a four-year debate involving the developers of the Main Street Mall, the city and local preservation advocates. Owner Randy Fields asked the city council for permission to replace the house with a replica. The council agreed after asking Fields to save as much of the original siding as possible. The contractors plan to begin work on the replica immediately.
