# HISTORIC SITE FORM - HISTORIC SITES INVENTORY

Name of Property: **John Diem House**

Address: 401 Park Ave

Structure/Site Information Form

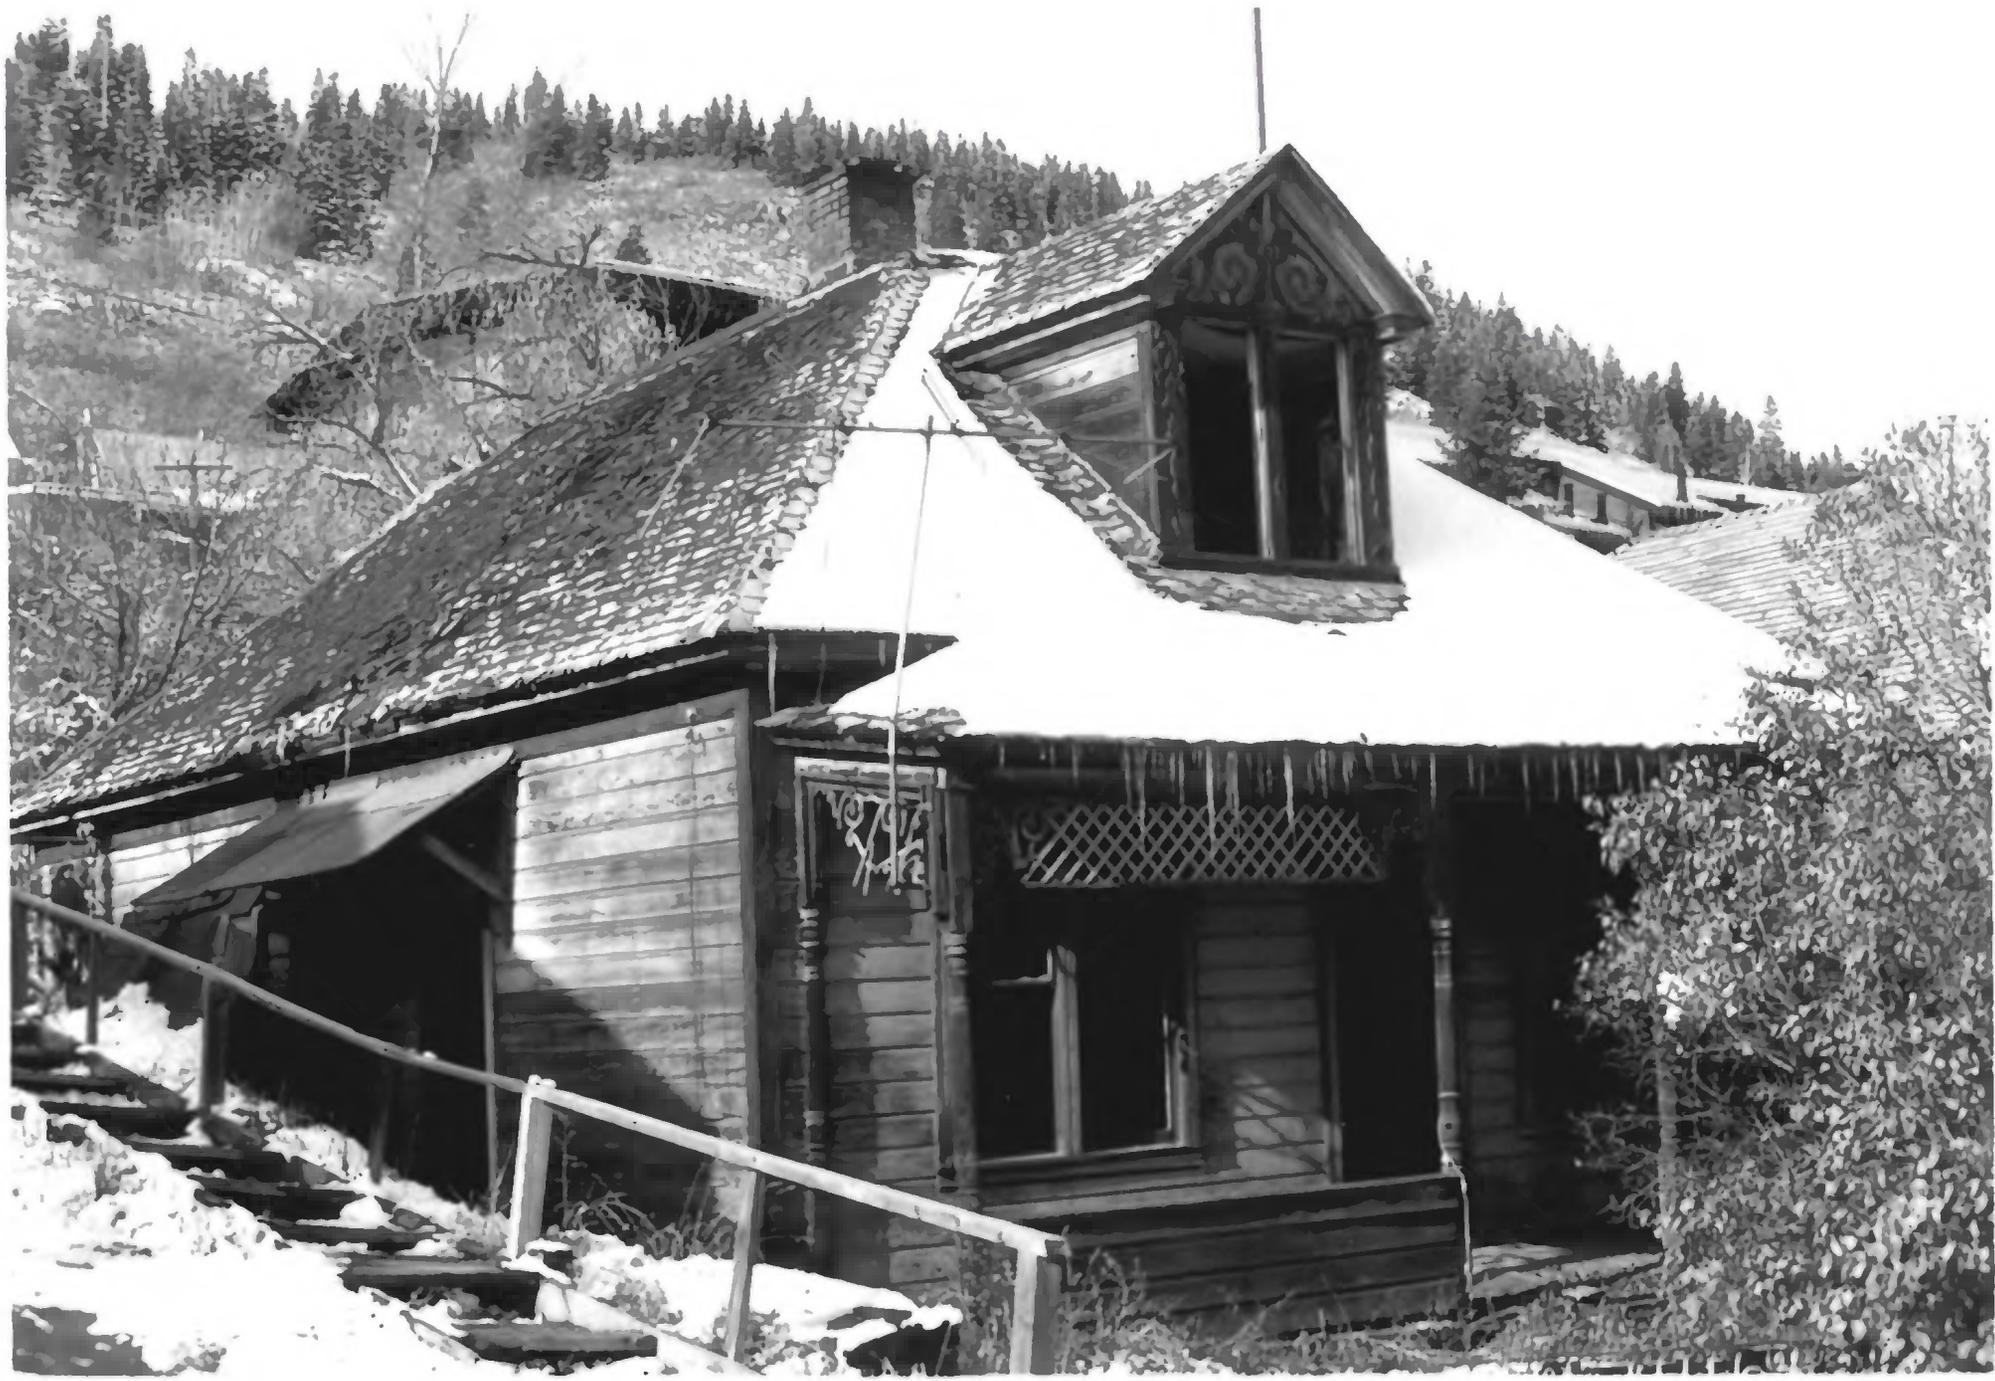
View from Southeast corner

Typical of the basic pyramid house is the generally symmetrical facade with a door set slightly off-center between pairs of windows and the low pitch hip roof porch spanning the facade. The porch is in a deteriorated condition, as is the rest of the house, but the original lathe turned piers and elaborate jigsaw cut brackets have survived to the present. Lattice bands span the spaces between the piers, except directly in front of the door. The original balustrade was probably replaced by the existing low wall of drop siding. The  
(See continuation sheet)

The house has been vacant for a few years and shows signs of neglect on both the interior and exterior. Because the windows and doors of the John Diem House are no longer intact, and the building is in need of some porch repair and a paint job, it appears to be more deteriorated than it actually is. The roof is intact, as are all four walls, and the building is quite stable. The original plan and a majority of the window and door moldings and decorative features which distinguish this type of pyramid house variant are also intact.

John Diem House

401 Park
