HISTORIC SITE FORM - HISTORIC SITES INVENTORY

Name of Property: **Dr. William Bardsley House**

Address: 517 Park Ave

Bardsley, Dr. William, House
Name of Property

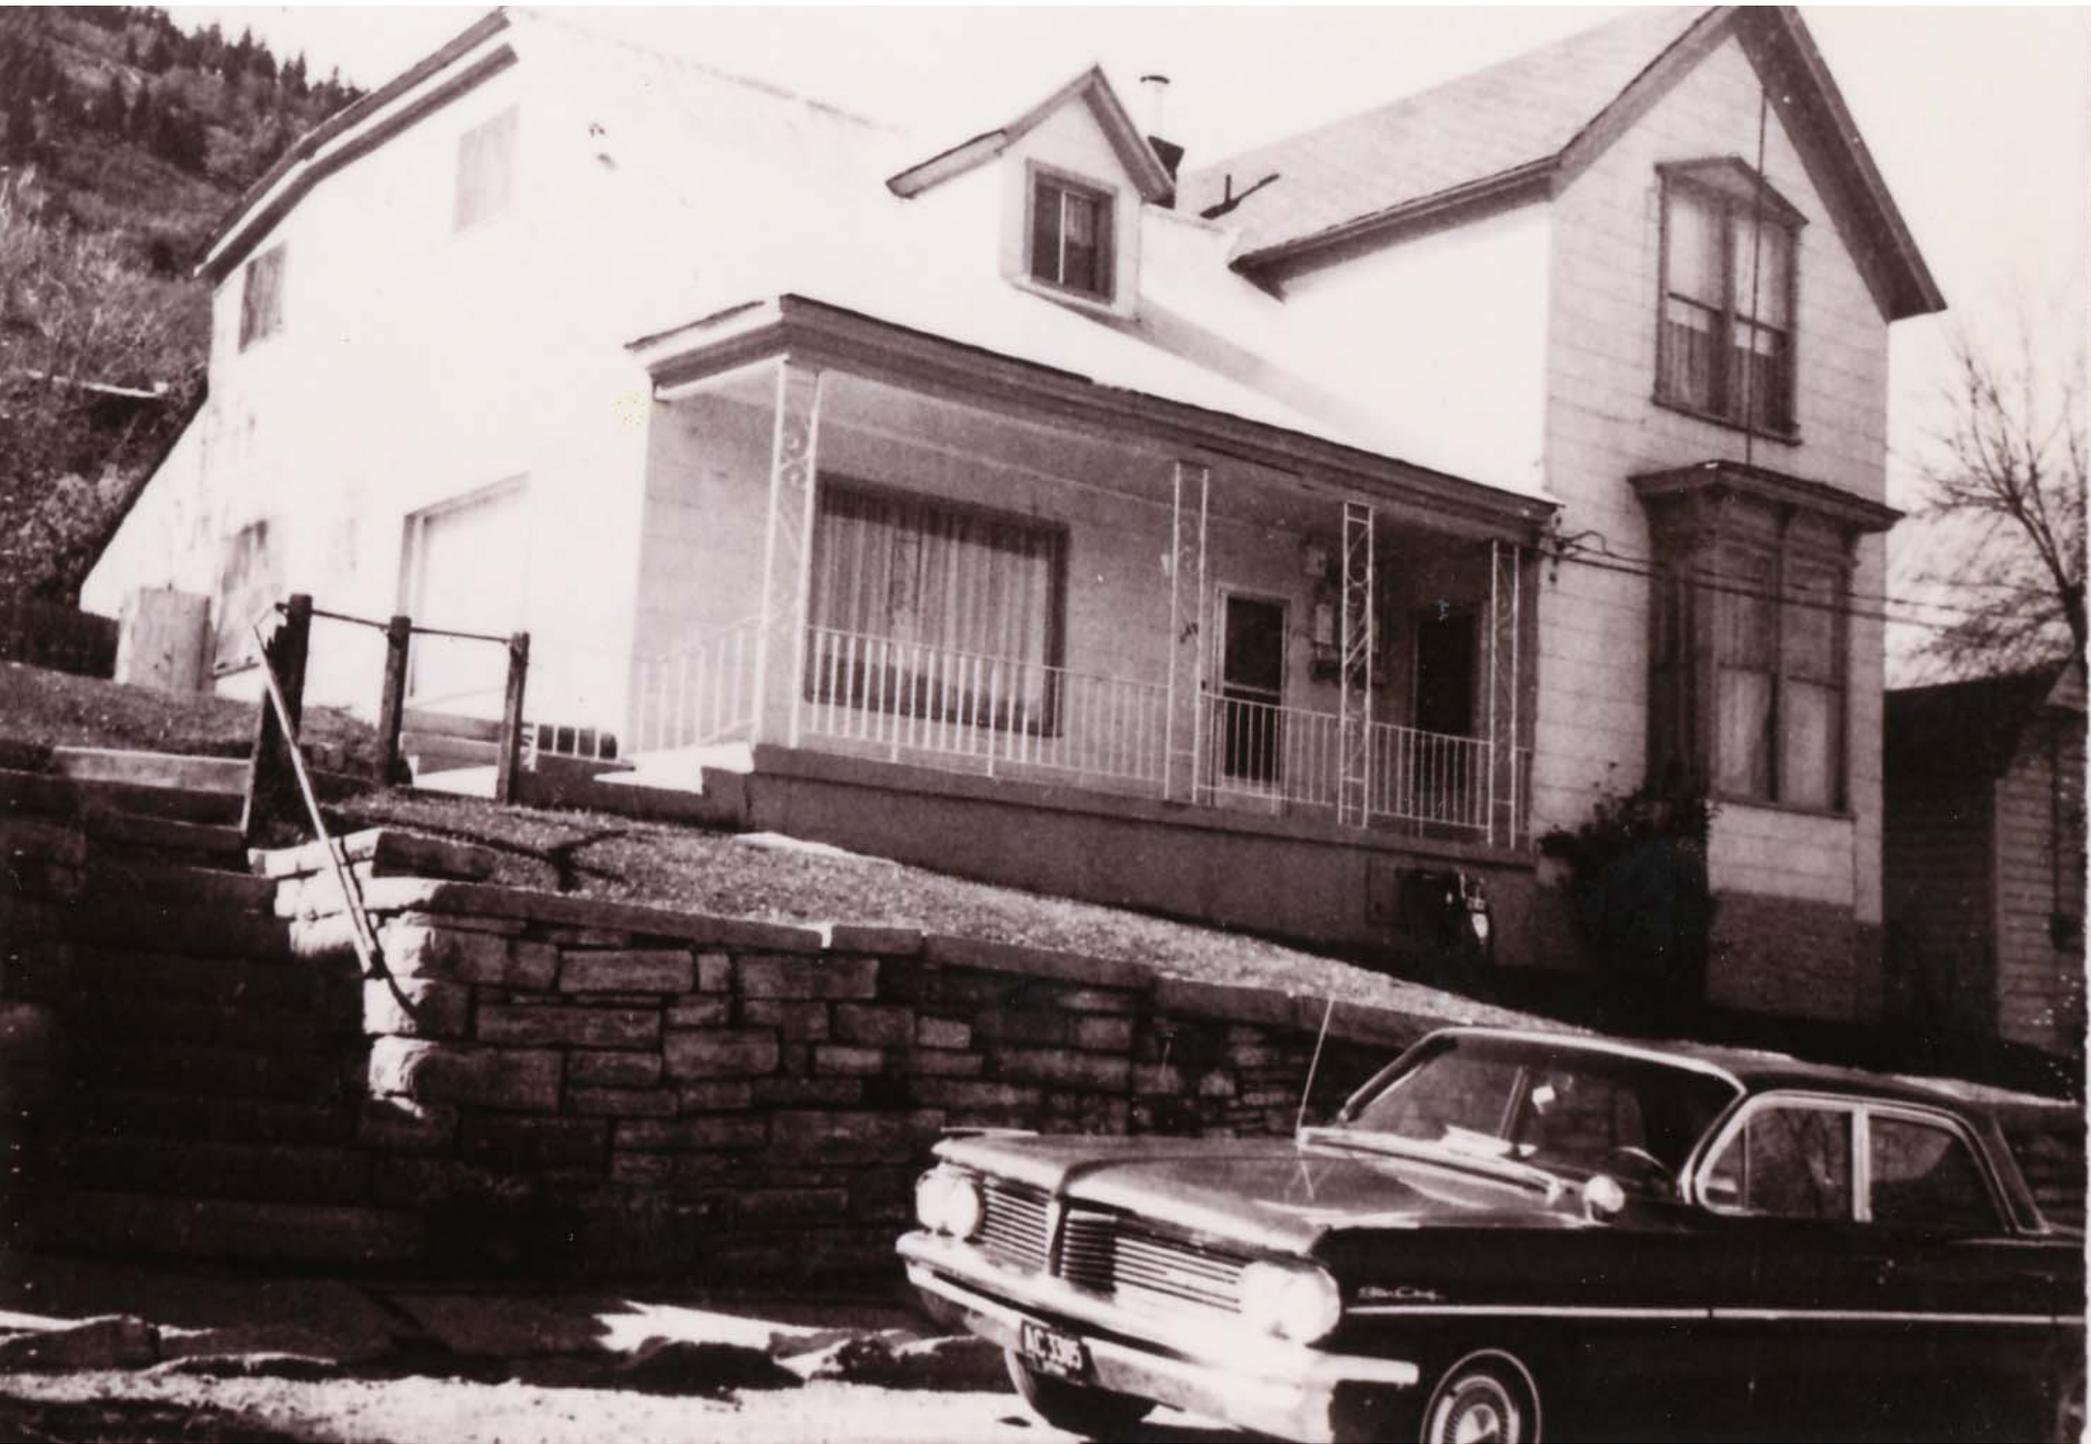
This frame dwelling has basically two sections, a two story portion to the north, and a one story portion to the south, with attic, having a small dormer facing east. The roof construction is of the gable type. A decorative bay window is located on the two story gable section below two-side-by-side double-hung frame windows with a Greek pediment added to the window detailing. The front windows, and doors have been altered (the latter to accomodate apartments), and the front porch now has an ornamental iron railing.

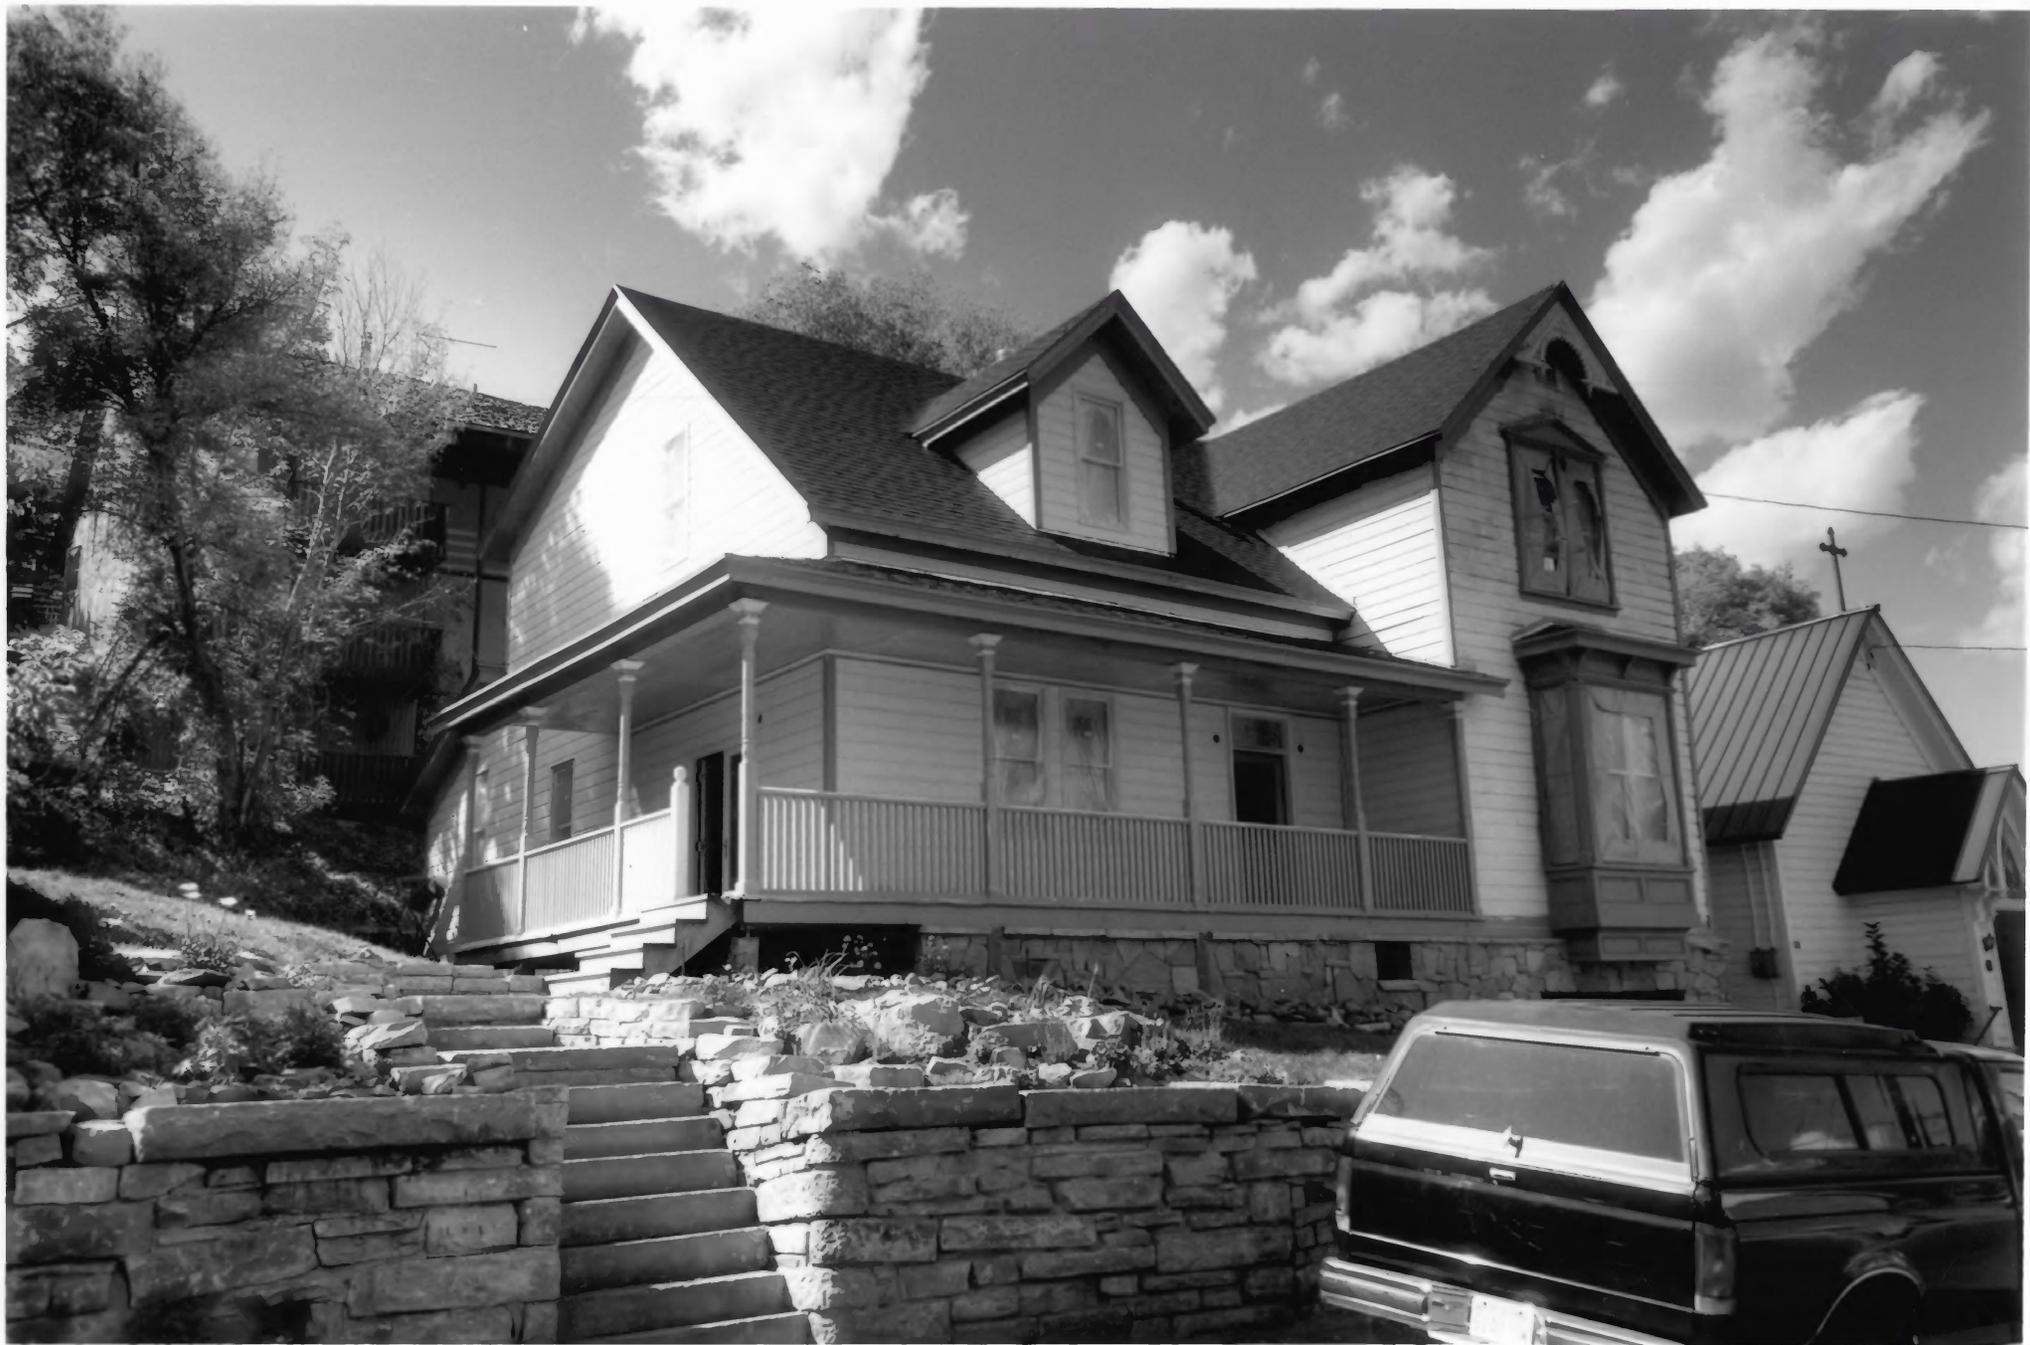
BARDSLEY, DR. WILLIAM, HOUSE
PARK CITY, SUMMIT CO., UTAH PHOTO#1

1. Bardsley, Dr. William, House
2. Park City, Summit County, Utah
3. Photographer: unknown
4. Date: c.1965
5. Negative (copy) on file at Utah SHPO.
6. Tax record photo of south and east elevations of building showing pre-rehabilitation condition. Note roof and porch alterations. Camera facing northwest.

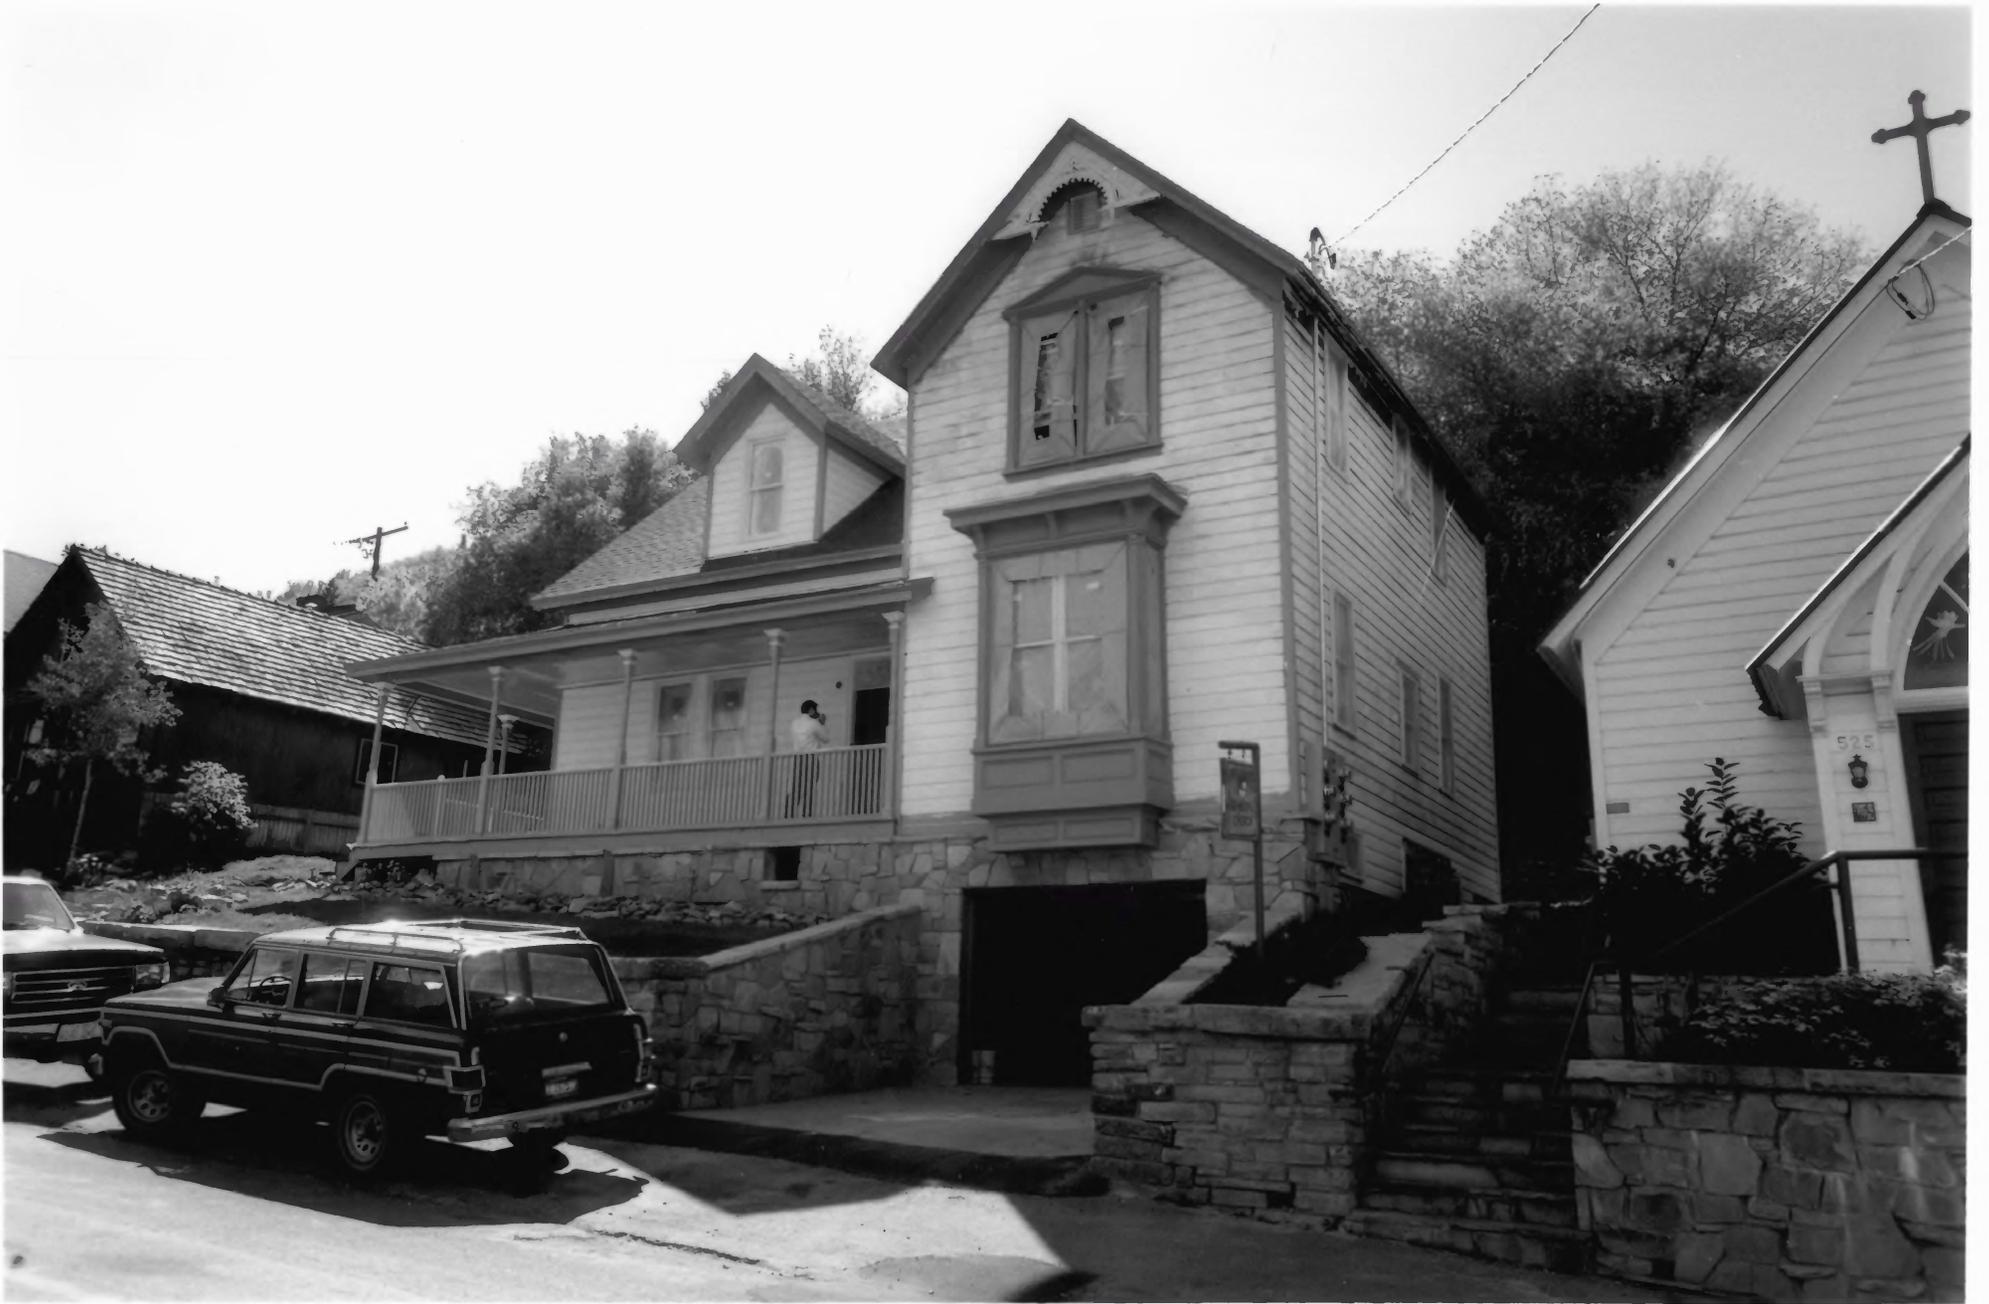
PARK CITY, SUMMIT CO., UTAH PHOTO #2

Perhaps thirty or forty years ago (definitely outside the period of significance), in an effort to create additional rental units, the roof over the southern wing was reconfigured to a near flat slope to the rear (see Photo No. 2). The other major alterations to the building were likely made at this time.

by the installation of synthetic siding and alterations to the roof, windows and porch. The 1993 rehabilitation has removed or reversed these problems and the historic architectural character and integrity of the house is once again apparent. While the house now contains four separate apartments, a garage that was carefully added beneath the cross-wing (off-street parking is a rarity in Park City) and a slightly raised ridge line of the south portion (to correct deficiencies in the modified portion), the numerous restorative aspects of the recent project have greatly enhanced the historic character of the building. The historic wood siding was revealed and restored. Non-historic window openings were reconfigured to their historic size and compatible double-hung windows installed. The porch was rebuilt returning the roof to the historic slope and installing compatible columns and balustrade. (The porch was also extended slightly to the south to provide better weather protection. This type of extended, wrap-around porch was a common historic feature on several of the miners' cottages in Park City.) The repair/reconstruction of the roof over the southern wing also returned this roof to a historically-correct gable configuration.
