# HISTORIC SITE FORM - HISTORIC SITES INVENTORY

PARK CITY MUNICIPAL CORPORATION (10-08)

Address: 527 Park Ave

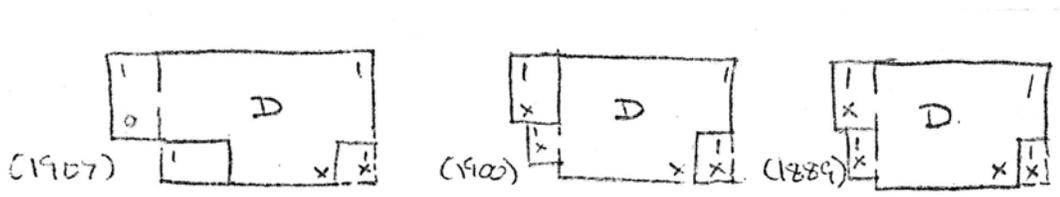
## Sketches from Sanborn Maps:

One-story frame dwelling with a gable roof. Basically a "T" shaped building, it has a porch to the south; and fine wood frame two-over-two windows on the gable end of the north section. The porch has wood posts, and the home has white siding (wood) with re-red-painted trim.
