HISTORIC SITE FORM -- HISTORIC SITE INVENTORY

PARK CITY MUNICIPAL CORPORATION (06-09)

Address: 575 Park Ave

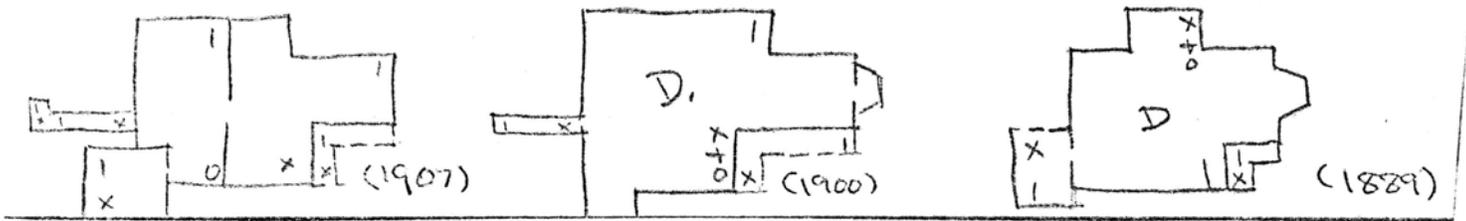
One-story frame home with a gable roof; asbestos shake siding. Tax records indicate that a bay window existed, but has been removed.

Sanborn Maps showed the bay window in 1889 and 1900, but not in 1907. The speculation is that the building could have been remodeled after 1907 to include the bay window, then altered again; thus, its removal. Or possibly, the present structure was built between 1900 and 1907.
