HISTORIC SITE FORM - HISTORIC SITES INVENTORY

PARK CITY MUNICIPAL CORPORATION (10-08)

Name of Property: **Kimball Double Dweling House #2**

Address: 698 Park Ave

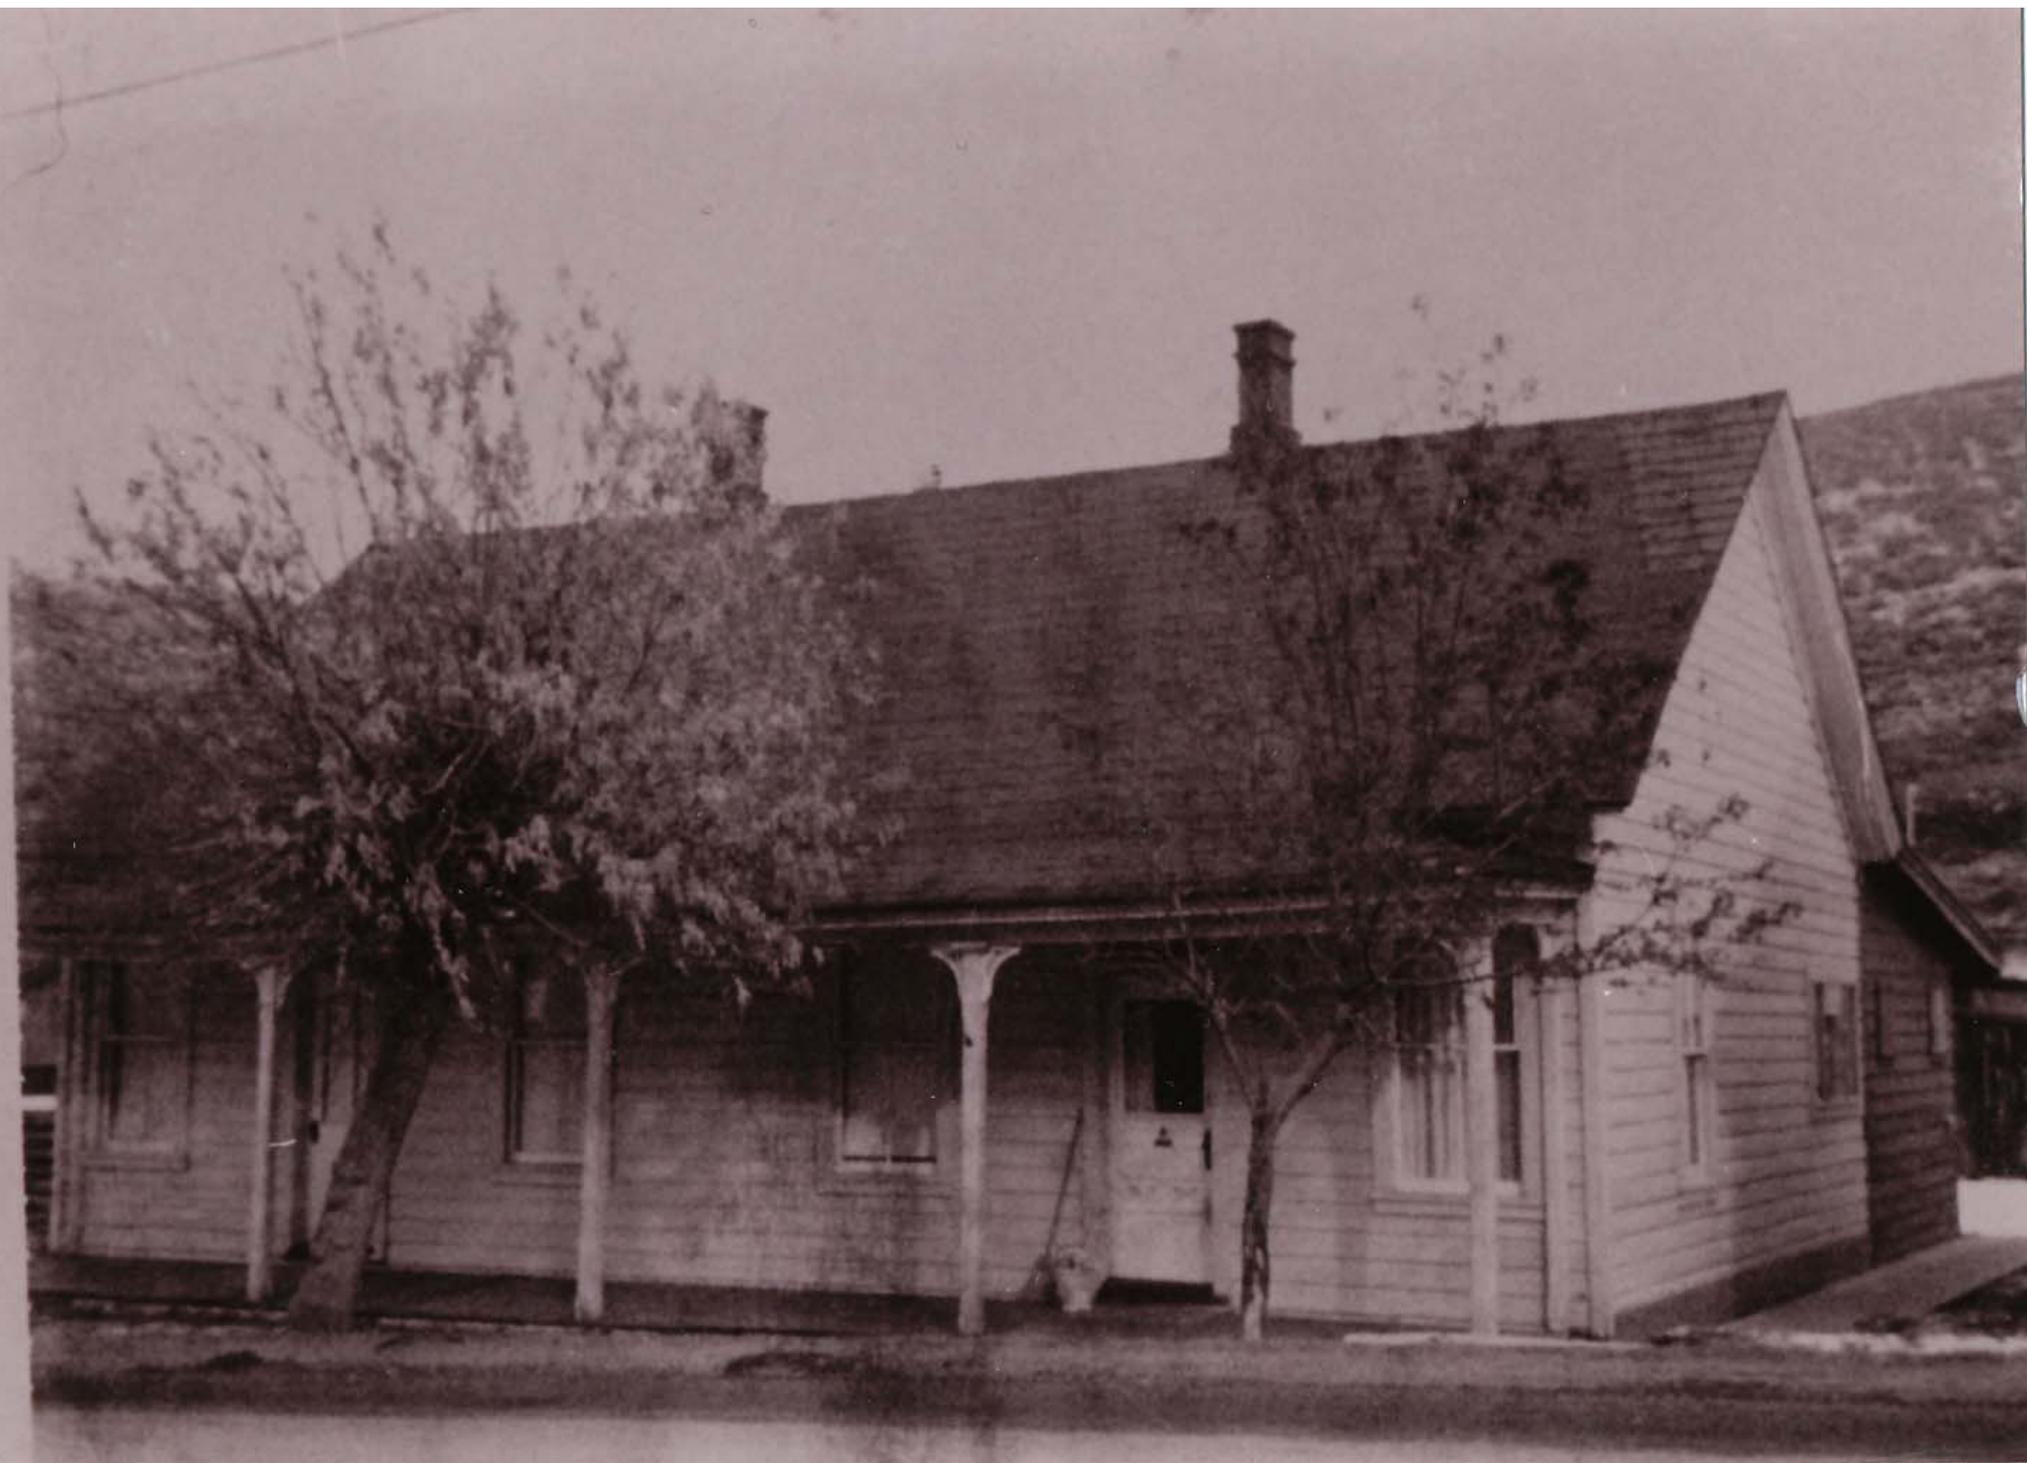
- Photo No. 1:** West elevation (primary façade). Camera facing east, 2006.
- Photo No. 2:** West elevation (primary façade). Camera facing east, 1995.
- Photo No. 3:** West elevation (primary façade). Camera facing east, tax photo.
