# HISTORIC SITE FORM - HISTORIC SITES INVENTORY

Name of Property: **Kimball Boarding House**

Address: 801 Park Avenue

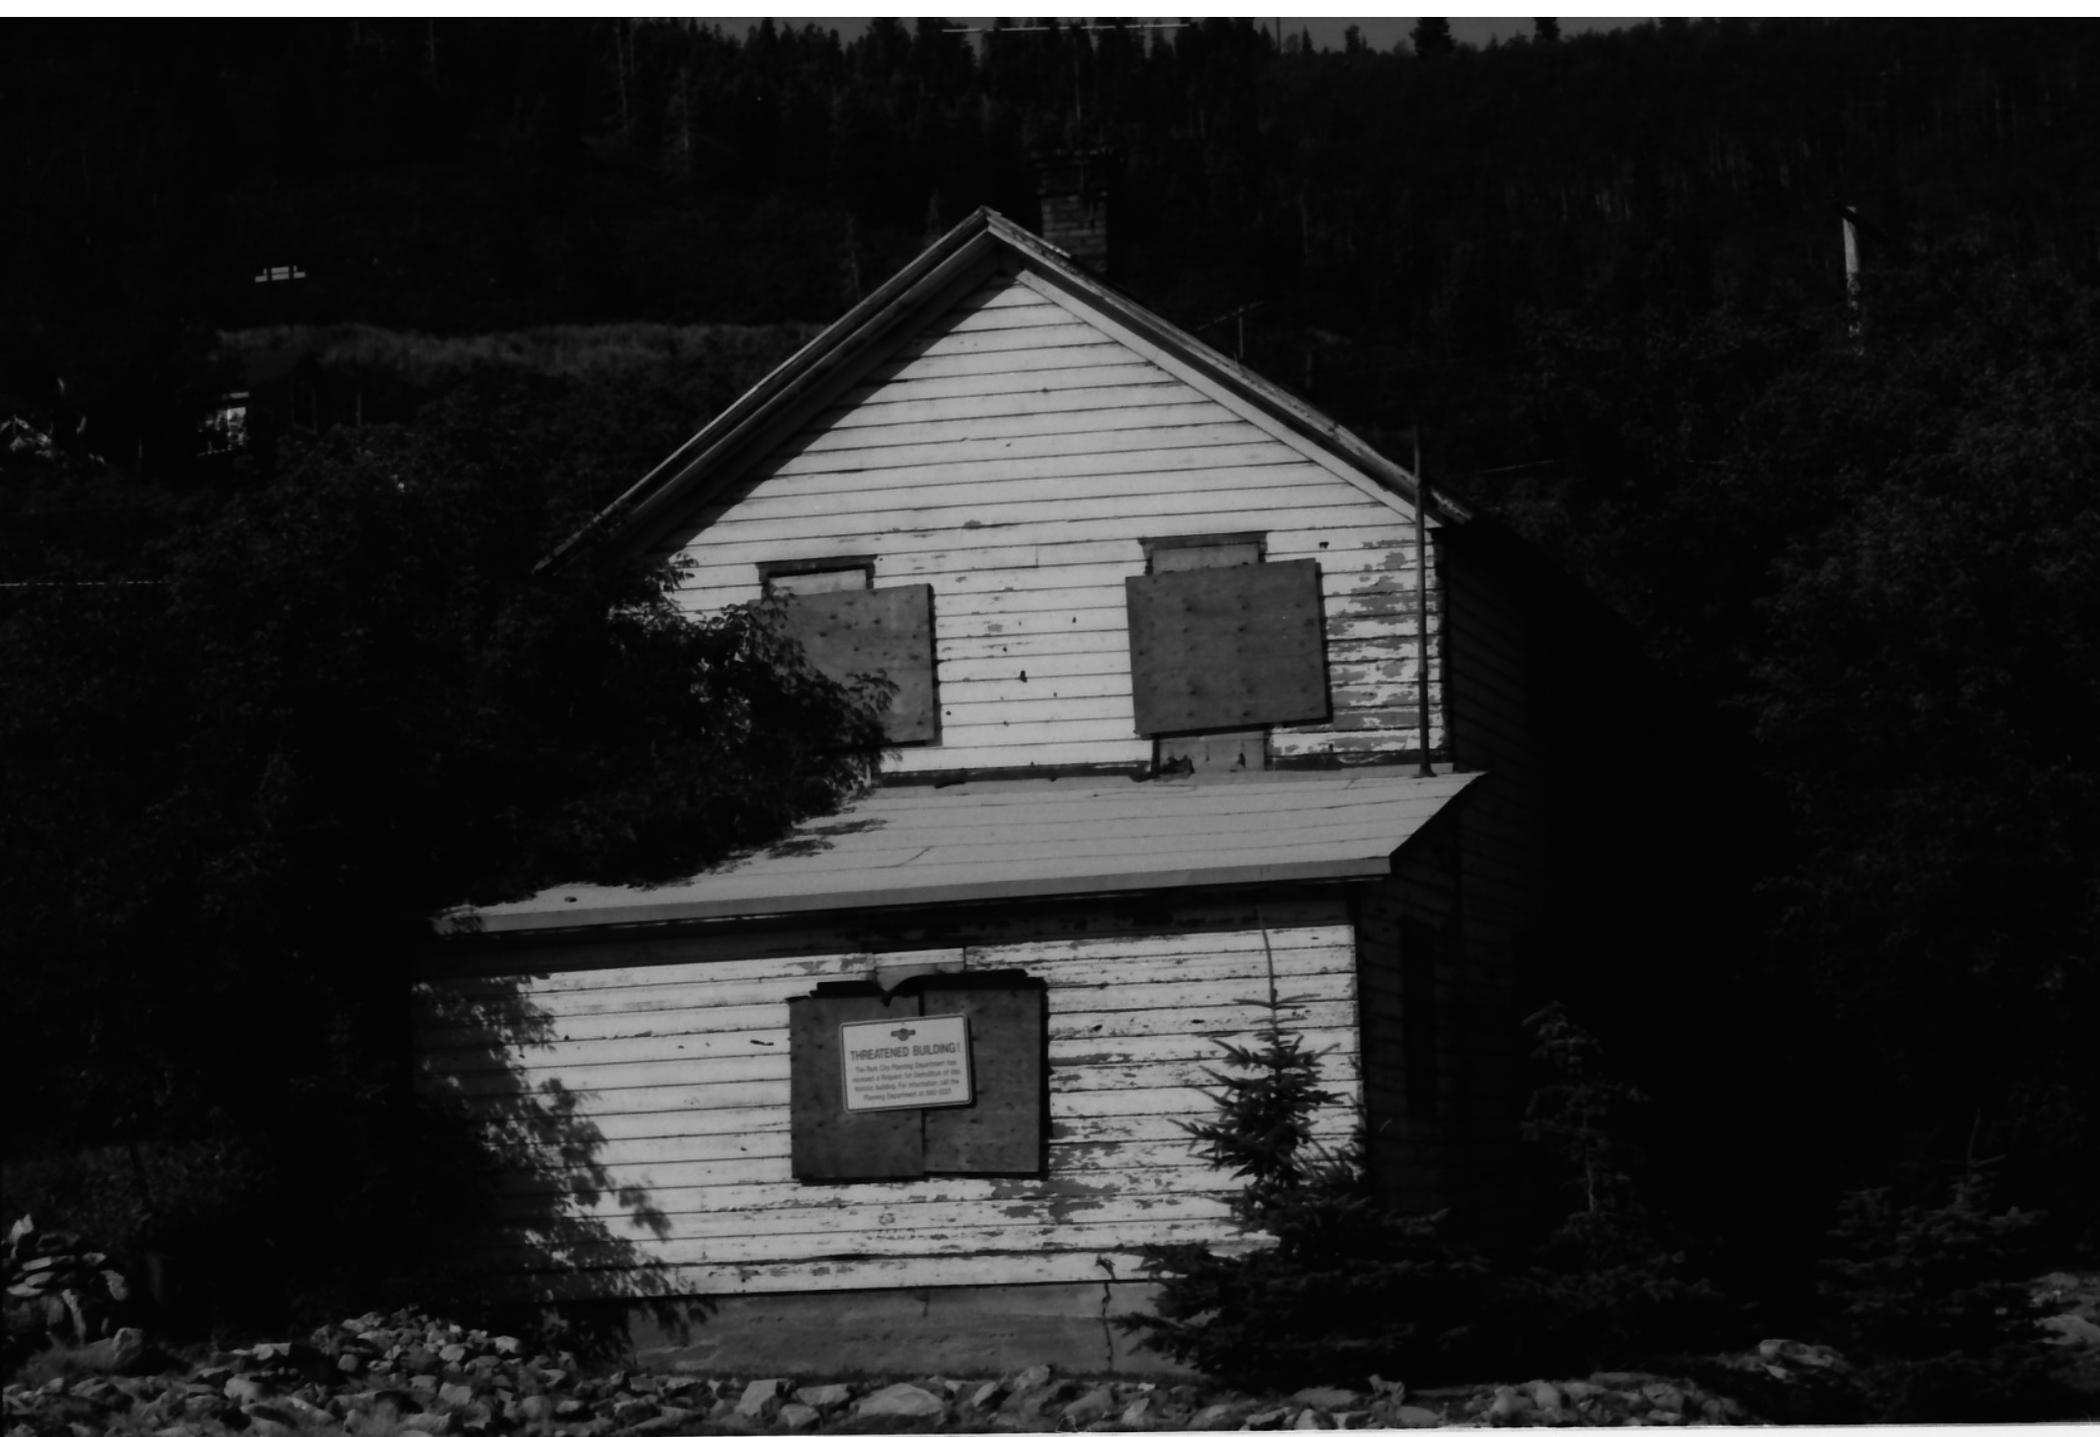
**Photo No. 1:** Southeast oblique. Camera facing northwest, 2008.

**Design** (The combination of physical elements that create the form, plan, space, structure, and style. Describe additions and/or alterations from the original design, including dates--known or estimated--when alterations were made): The two-story frame rectangular block boarding house has been significantly altered. The 1889, 1900 and 1907 Sanborn Insurance maps show the structure set back from Park Avenue with various additions changing with each map. According to the tax cards, additions continued to be changed and added over the years, but the central two-story element remained. The two-story element was, in 2006, incorporated into a larger development on the block. The structure was turned 90 degrees and moved to the southeast corner of the lot rather than its original location of the southwest section of the parcel. The changes are significant and diminish the site's original design integrity.

**Setting** (The physical environment--natural or manmade--of a historic site. Describe the setting and how it has changed over time.): the setting has been altered by moving the structure east toward the roadway (Park Avenue) and turning the structure 90 degrees. Also, the extensive site work for the comprehensive development plan for 801-817 Park Avenue substantially alters the site's original setting and character.
