# HISTORIC SITE FORM - HISTORIC SITES INVENTORY

PARK CITY MUNICIPAL CORPORATION (10-08)

Address: 909 Park Avenue

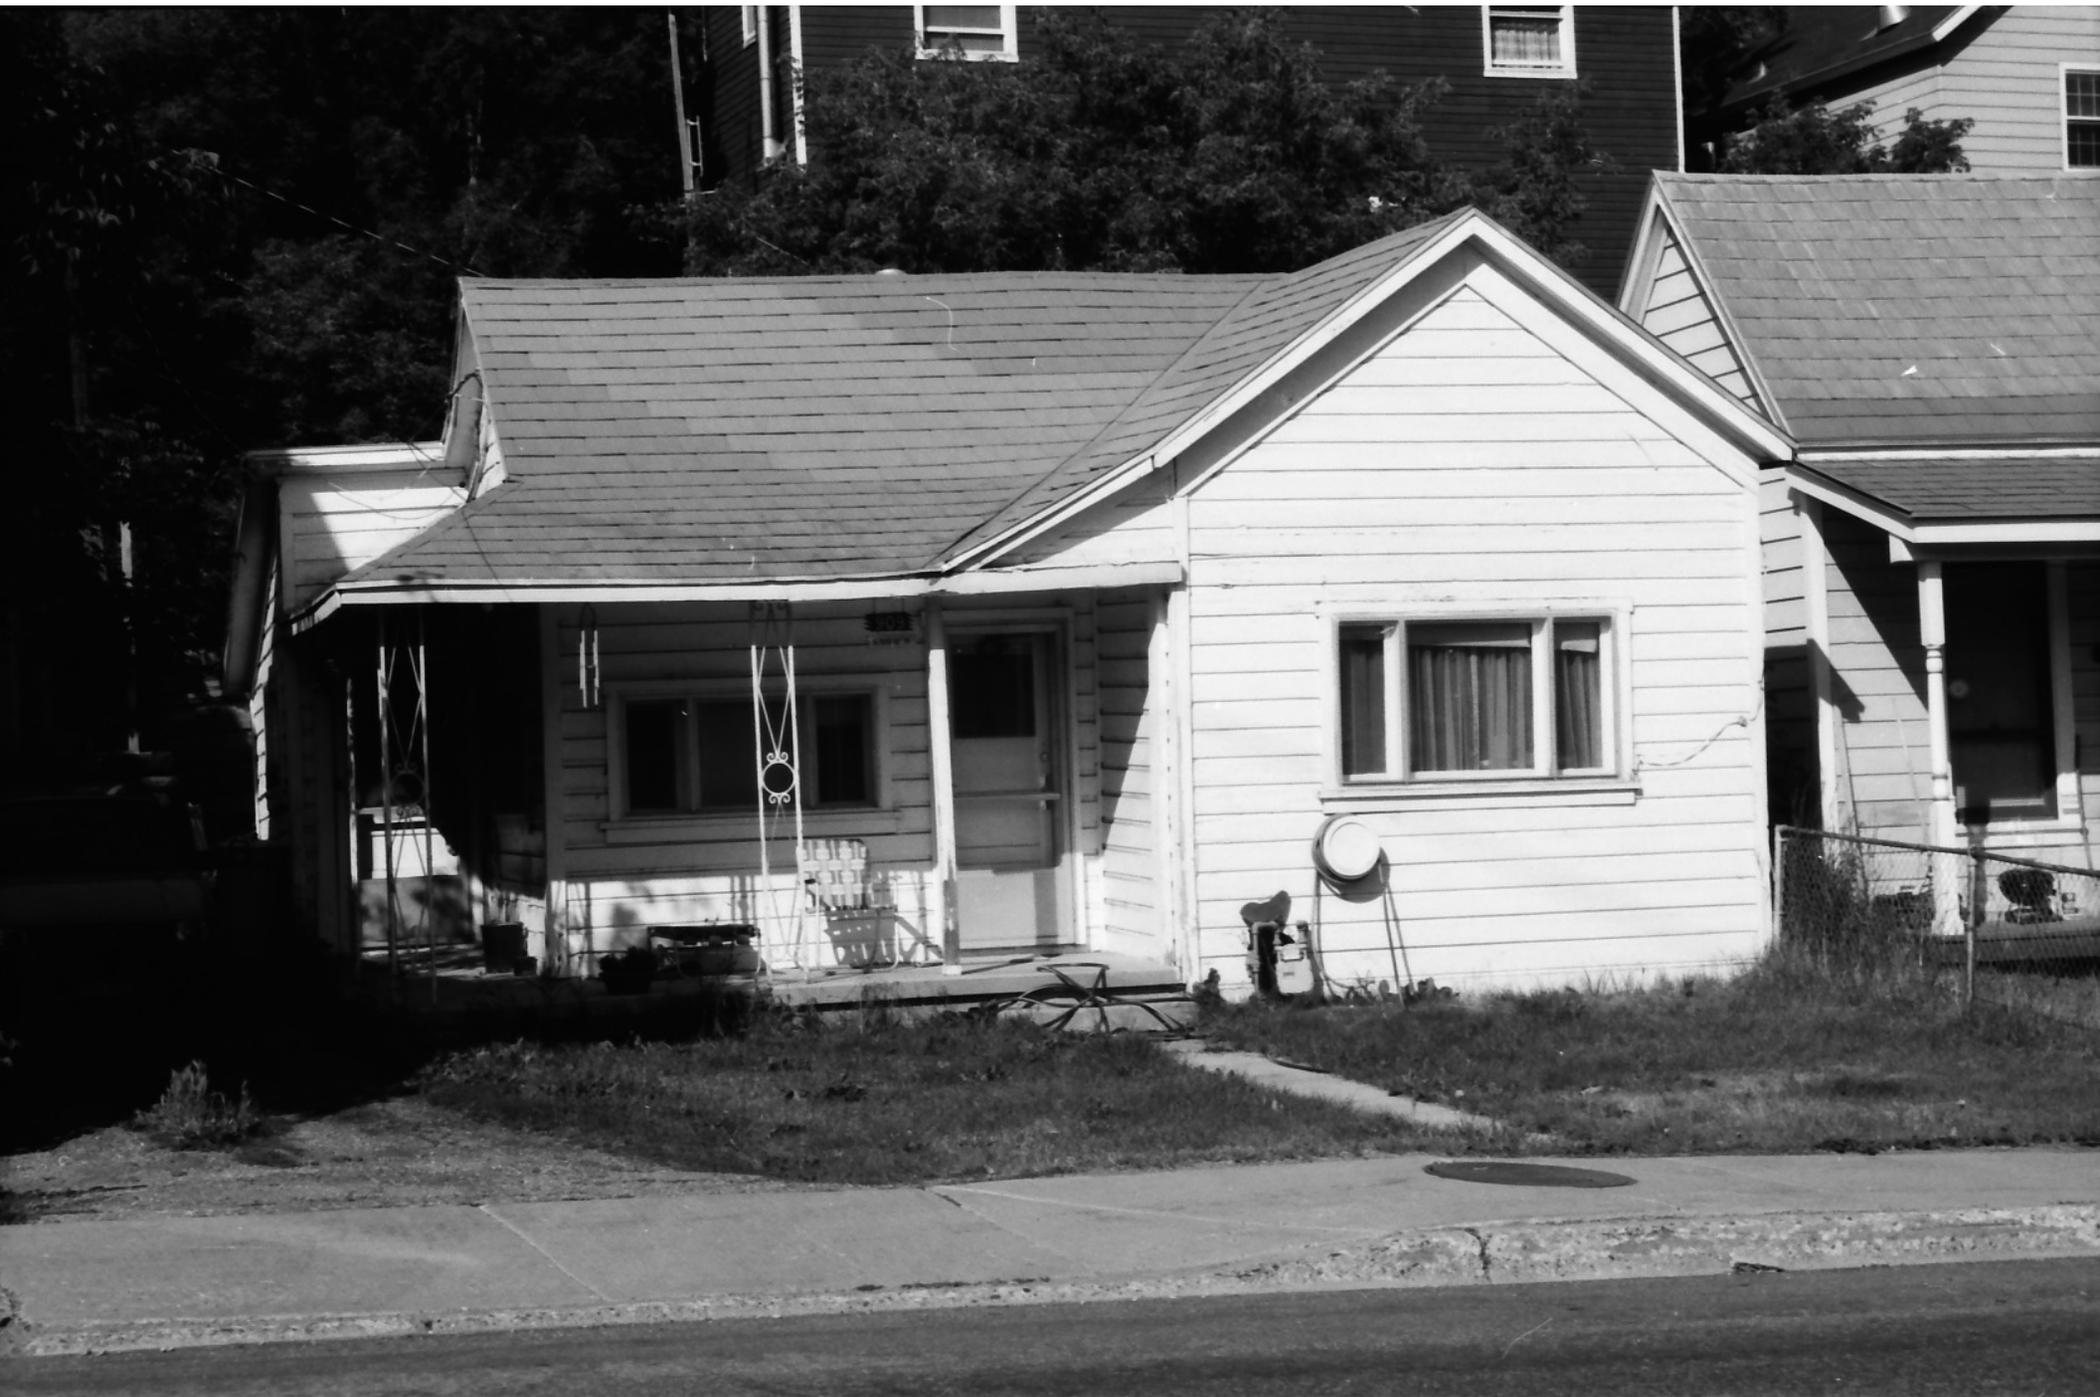
**Photo No. 1:** Southeast oblique. Camera facing northwest, 2007.

Additions:  none  minor  major (describe below) Alterations:  none  minor  major (describe below) Large two-storey addition to the rear of the lot is in the process of completion in the 2007 photo.

Walls: Drop-novelty wood siding (unable to verify if materials are new, original, or mix of both as 2007 shows an unfinished addition in the rear)

Roof: Unable to verify based on 2007 photo which shows an unfinished remodeling
