HISTORIC SITE FORM - HISTORIC SITES INVENTORY

PARK CITY MUNICIPAL CORPORATION (10-08)

Address: 1450 Park Avenue

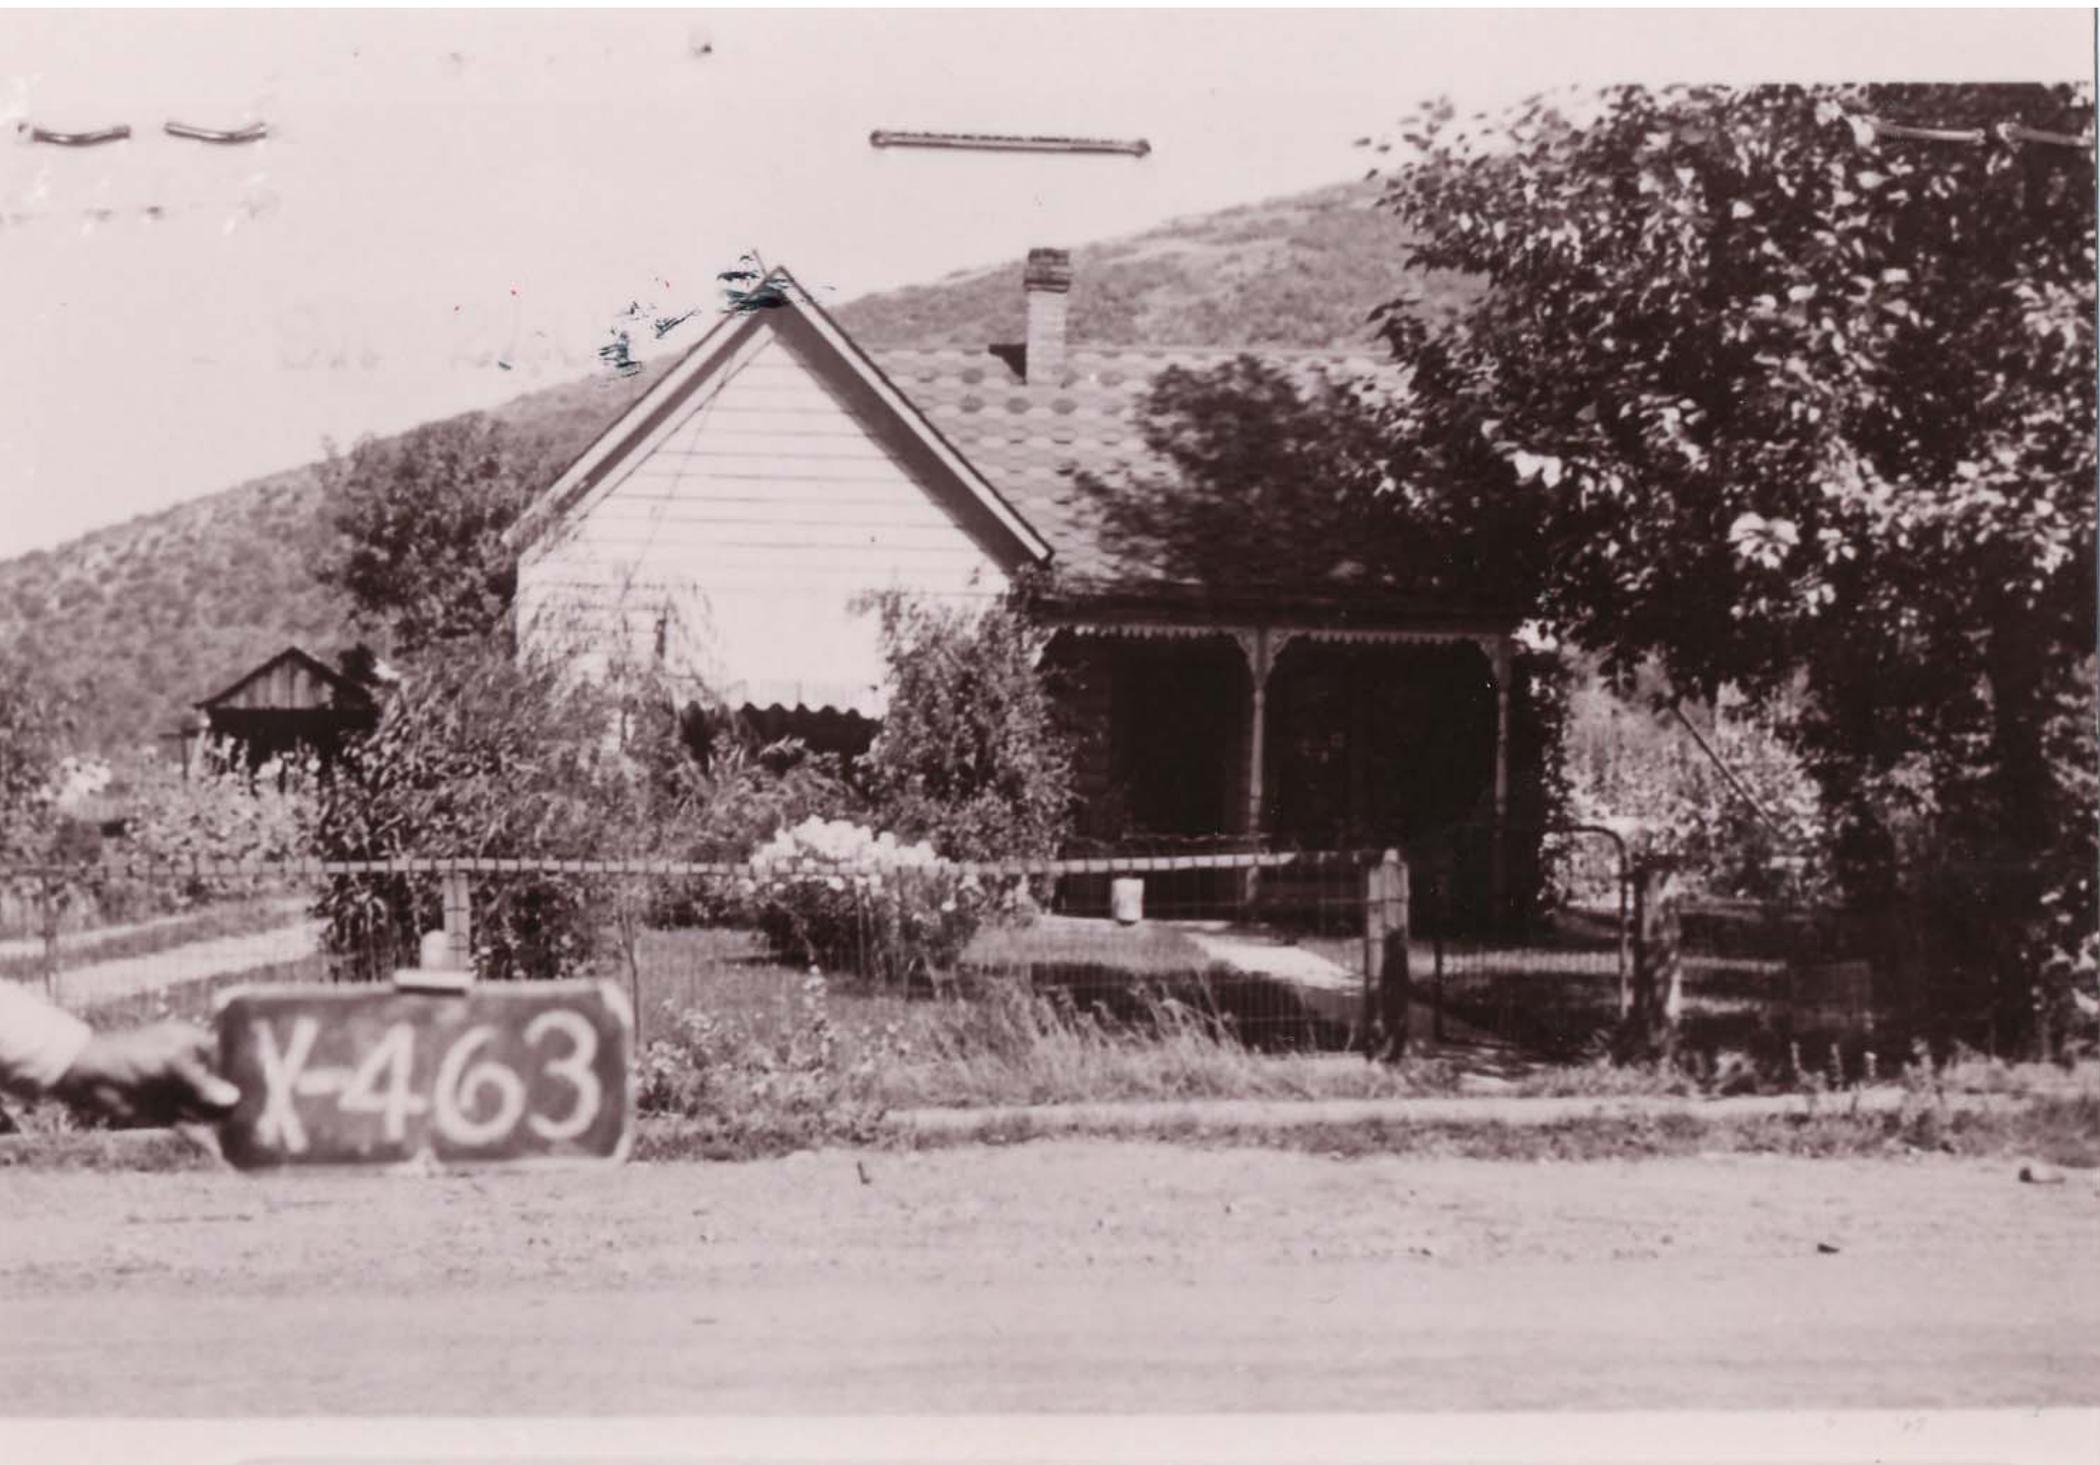
- Photo No. 1:** West elevation (primary façade). Camera facing east, 2006.
- Photo No. 2:** West elevation (primary façade). Camera facing east, 1995.
- Photo No. 3:** West elevation (primary façade). Camera facing east, date unknown.
- Photo No. 4:** West elevation (primary façade). Camera facing east, tax photo.
