# HISTORIC SITE FORM -- HISTORIC SITE INVENTORY

PARK CITY MUNICIPAL CORPORATION (06-09)

Name of Property: Thaynes Mine Conveyor Gallery

Name of Property: Thaynes Mine Hoist House

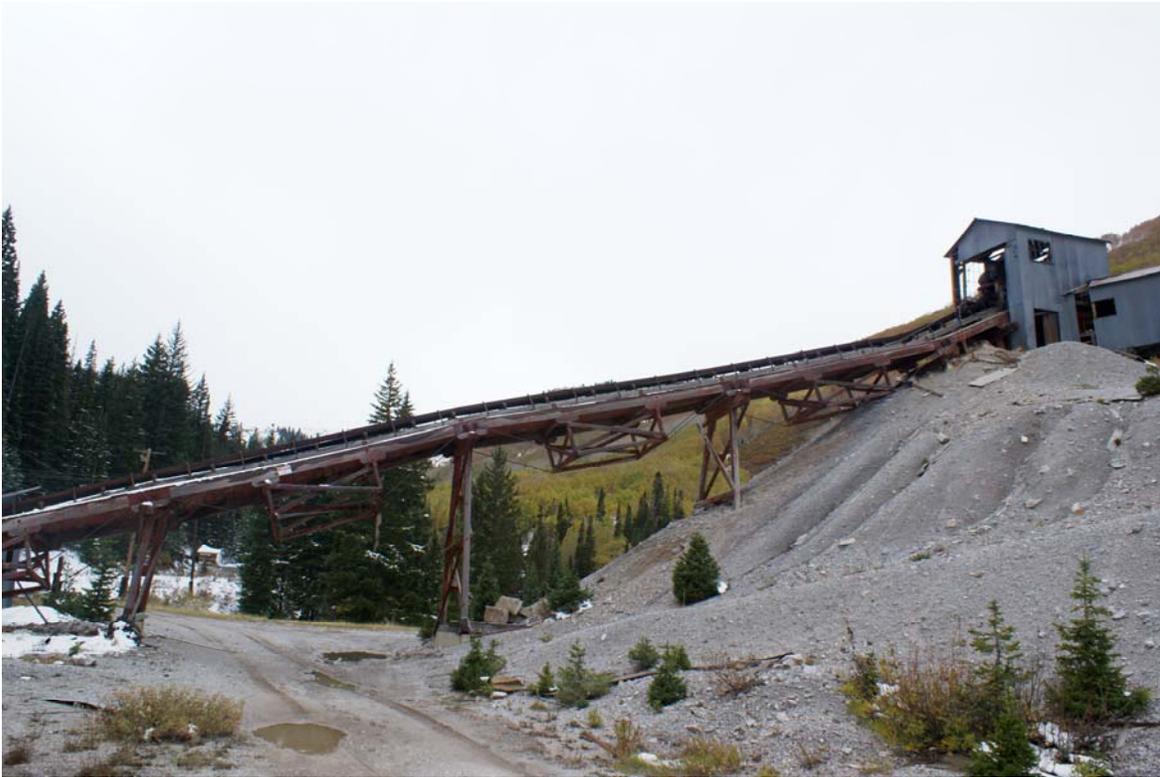
**Photo No. 1:** Northeast elevation. Camera facing southwest, 2009.

Poor (Major problems are apparent and constitute an imminent threat. Describe the problems.): **General deterioration, unsecured structure, collapsing in several places.**

Conveyor Gallery (northeast elevation), 2009

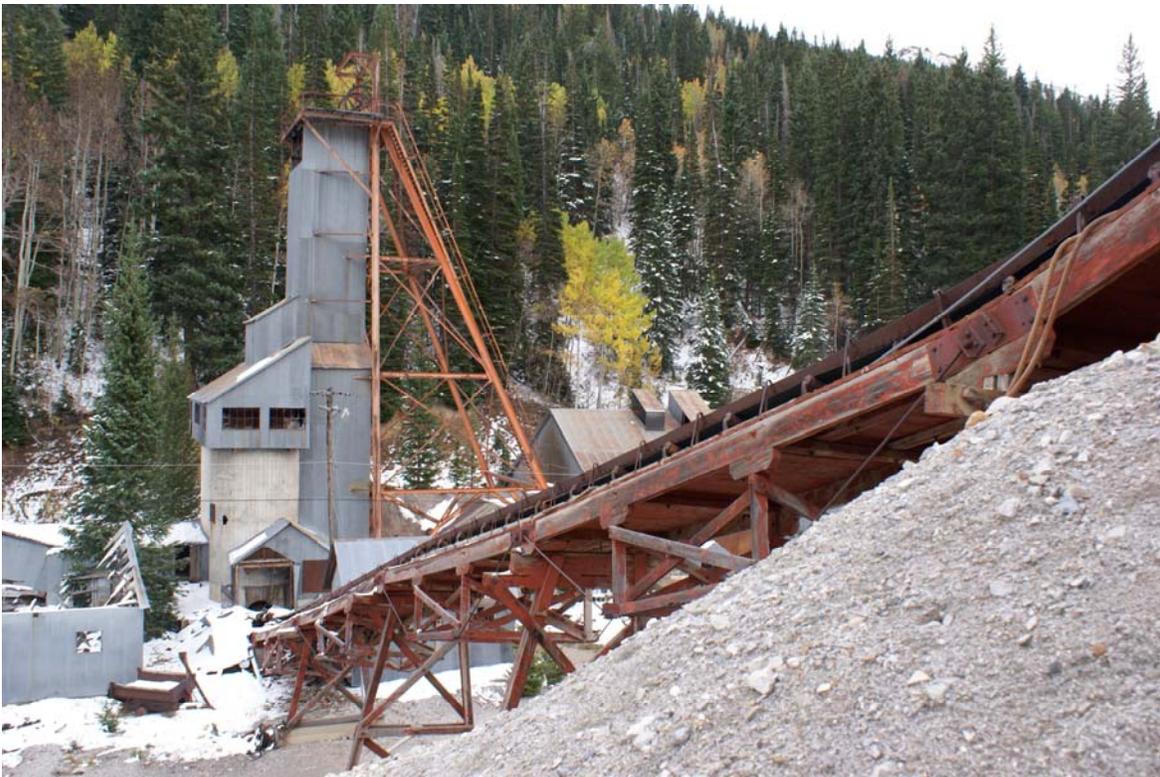
**Photo No. 2:** Northwest elevation. Camera facing southeast, 2009.

Conveyor Gallery detail (northwest elevation), 2009

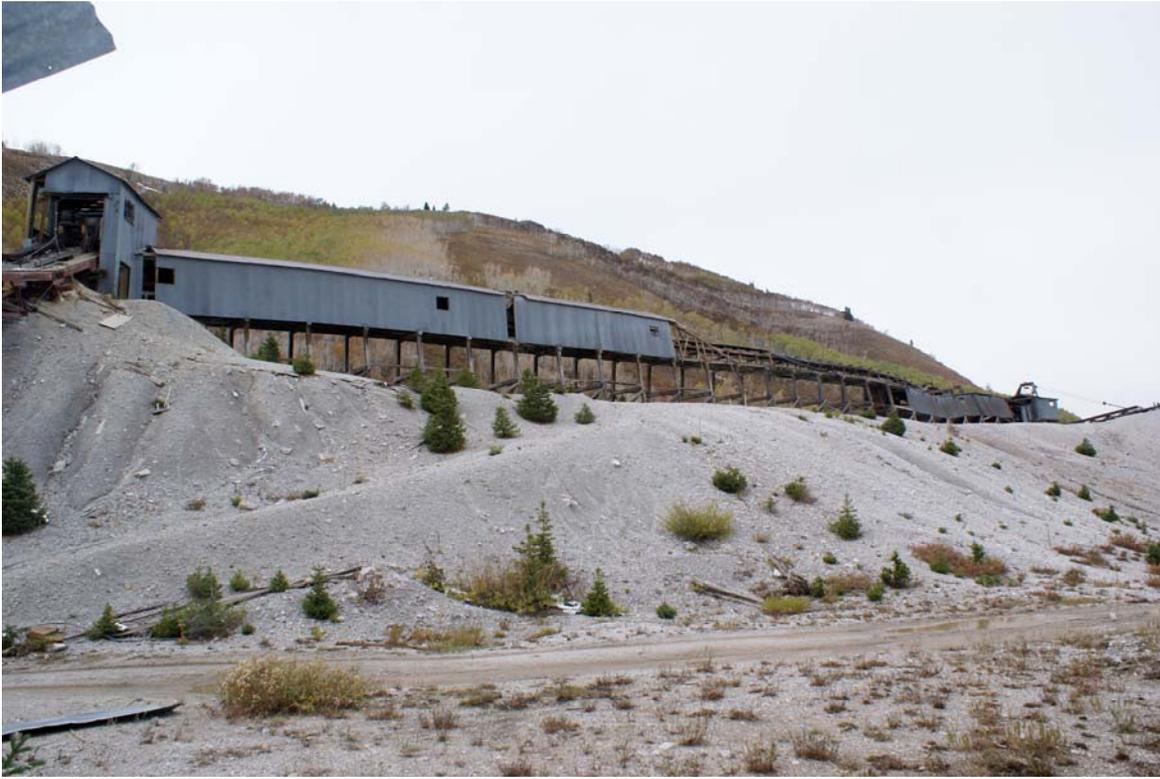
Conveyor Gallery extension, 2009

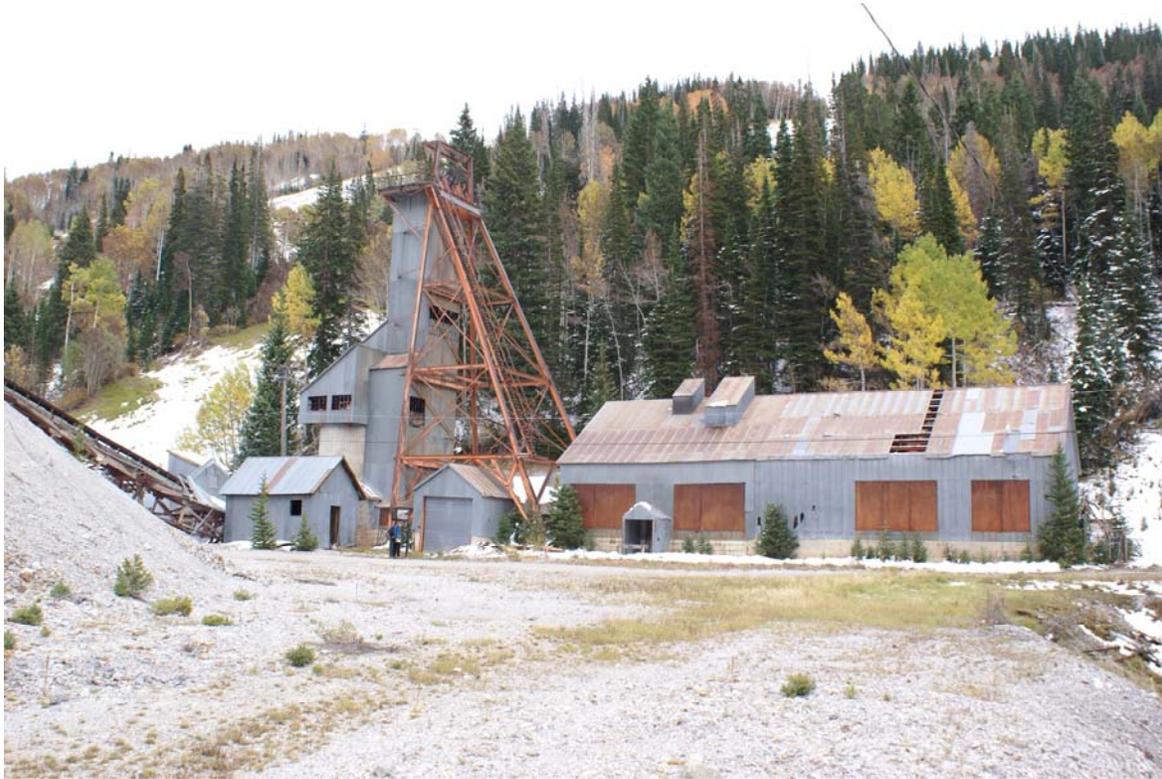
**Photo No. 1:** West oblique. Camera facing east, 2009.

Poor (Major problems are apparent and constitute an imminent threat. Describe the problems.): **General deterioration, unsecured building, broken windows, parts in various states of collapse.**

Hoist House (west oblique), 2009

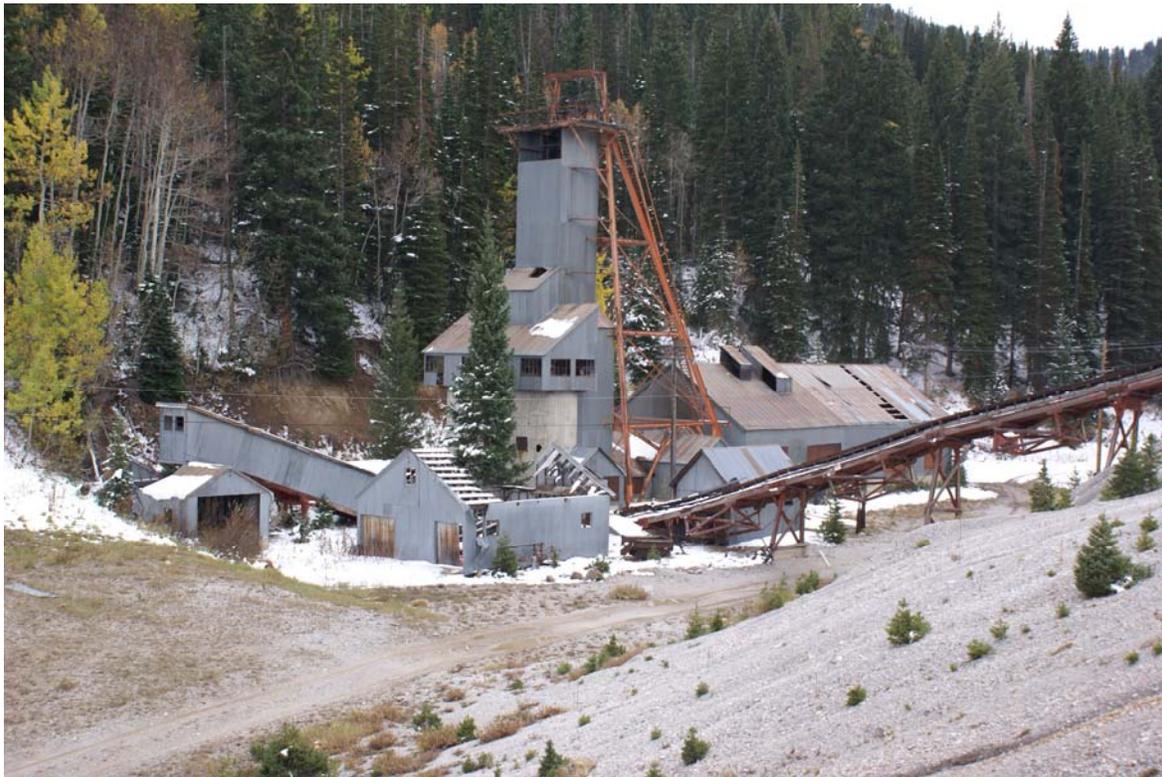
**Photo No. 2:** North oblique. Camera facing south, 2009.

Hoist House (north oblique), 2009

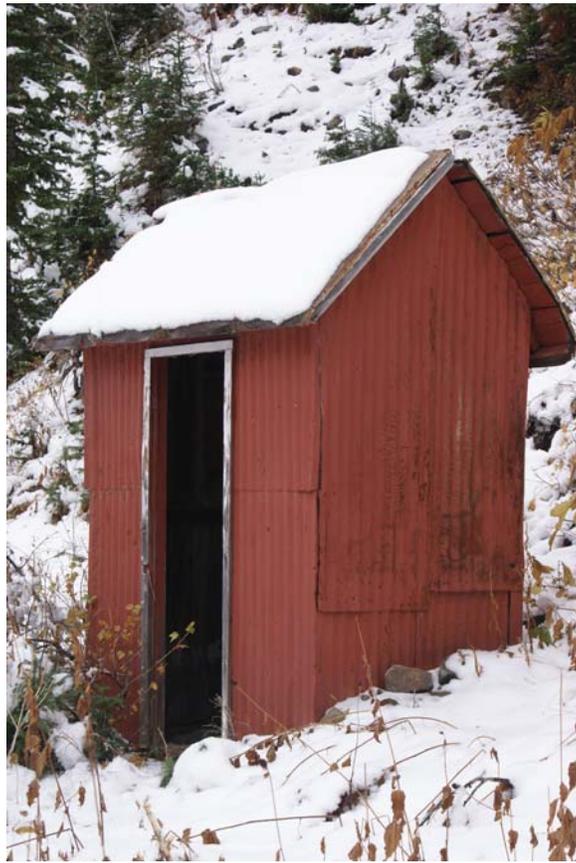
**Photo No. 1:** West oblique. Camera facing east, 2009.

Poor (Major problems are apparent and constitute an imminent threat. Describe the problems.): General deterioration, unsecured structure.

Fire Hydrant Shack (west oblique), 2009

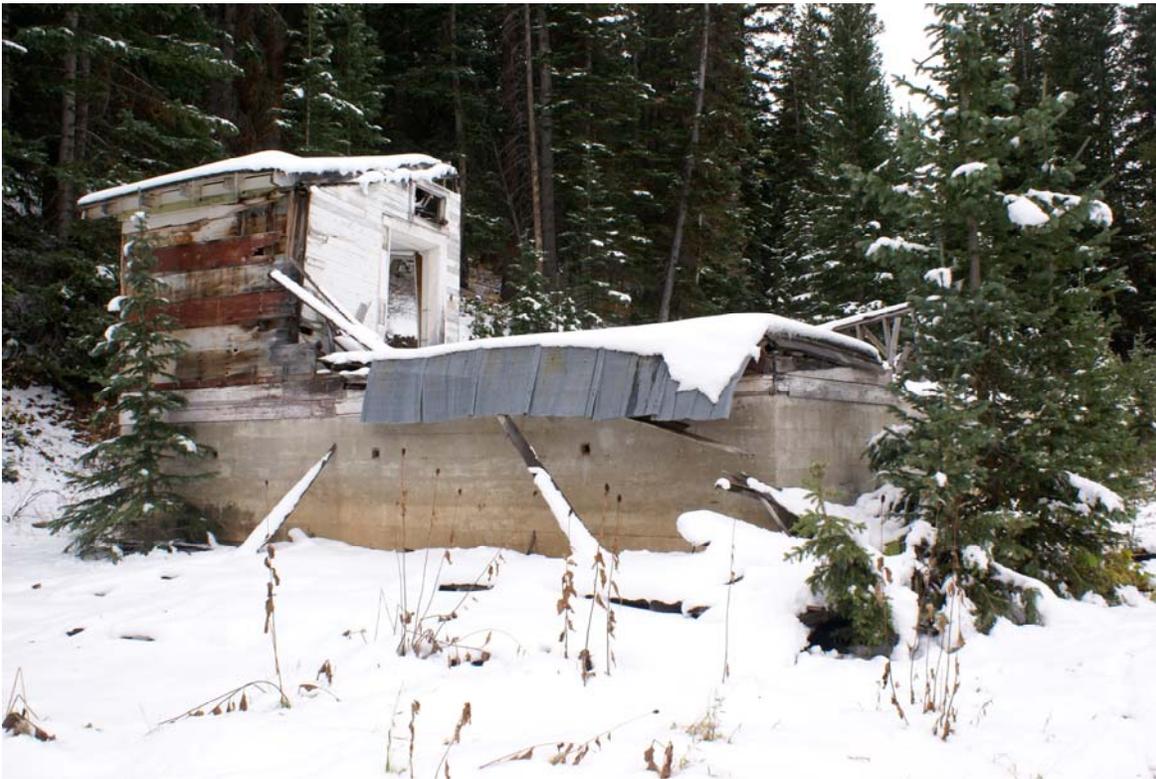
Boarding House ruins, 2009

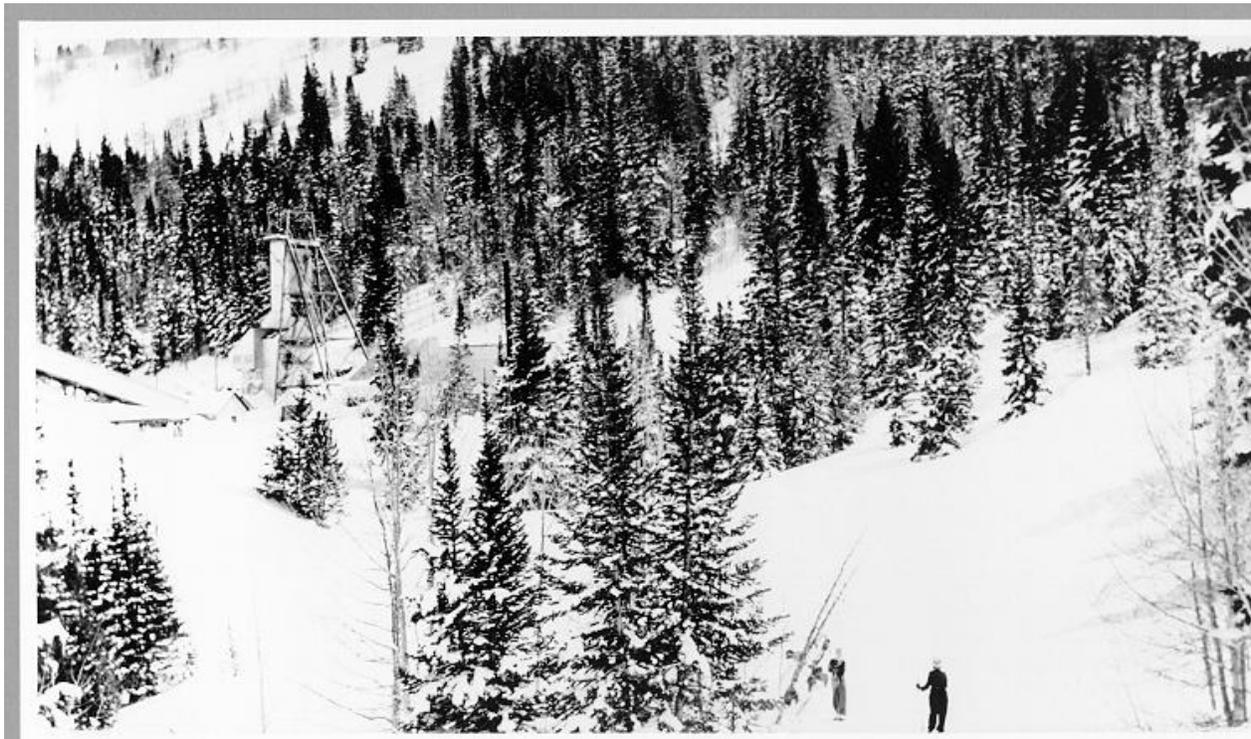
Thaynes Shaft Surface Plant - Silver King Coalition Mines Company. N.d. *George Barben Collection.* Hal Compton Research Library. Park City Historical Society & Museum. 10 Oct. 2009. Photo #1986.5.2. Electronic.

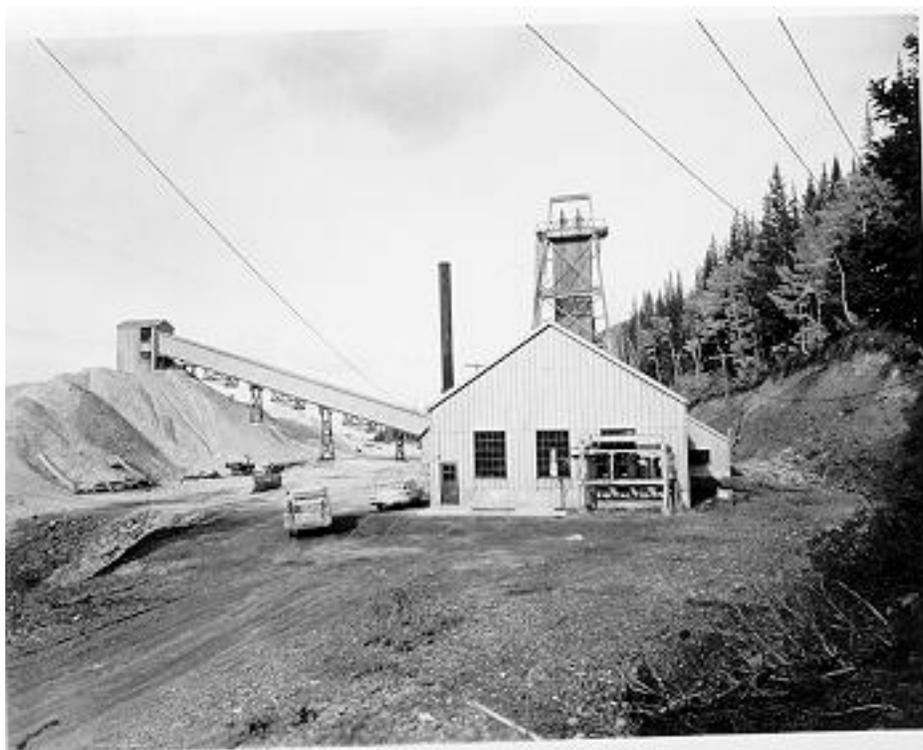
Thaynes Shaft Surface Plant - Silver King Coalition Mines Company. [c.1970?] *Leon Stanley Collection.* Hal Compton Research Library. Park City Historical Society & Museum. 10 Oct. 2009. Photo #1990.5.27. Electronic.
