# 1333 Park Avenue

## Historic Preservation Package

1333 Park Avenue  
Park City, UT 84060

# PHYSICAL CONDITIONS REPORT

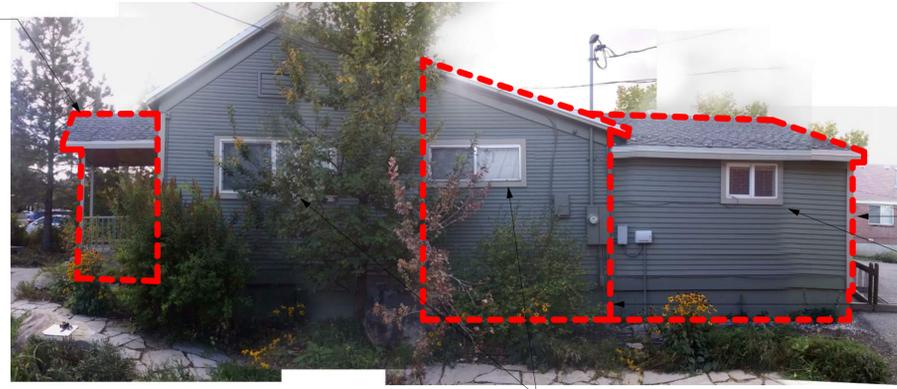
2 North Elevation  
0' 2' 4' 8' 16'  
1" = 1'-0"

Entry Porch Addition w/  
Gable Roof to Remain  
the same

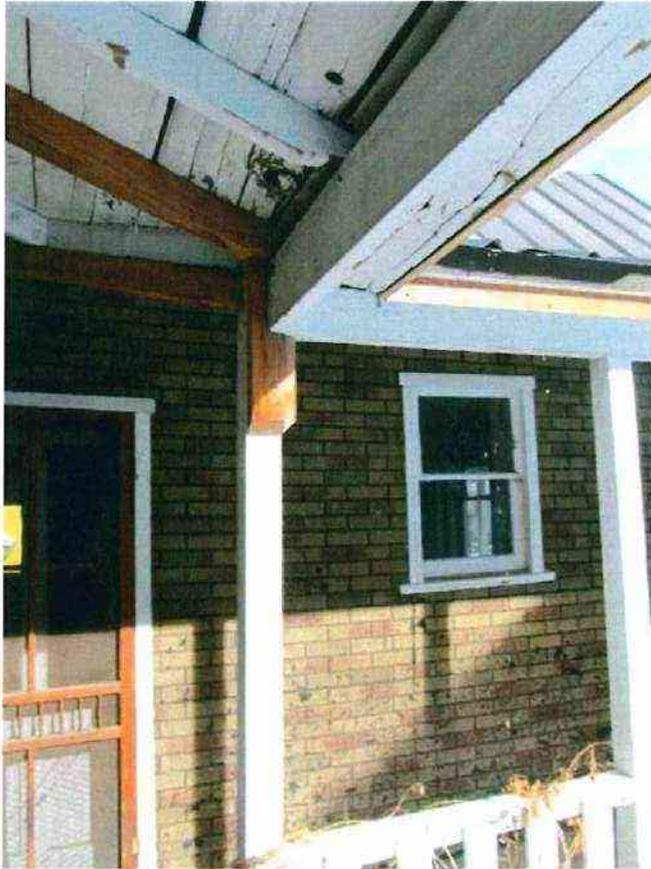
**Photo #2: East Elevation Porch Ceiling and Support Structure Detail**

Several of the wood porch posts and horizontal members have been replaced. The new wood porch posts and horizontal members are unpainted. The remaining historic wood railings and balustrades, porch posts, porch ceiling, roof structure, and horizontal members are missing paint. The fascia board at the connection between the east facade gable and porch roof is rotted and damaged. Wires are hanging/detached near the east facade gable and porch roof connection on the east facade. The flashing between the main roof and the porch roof is showing signs of rust.

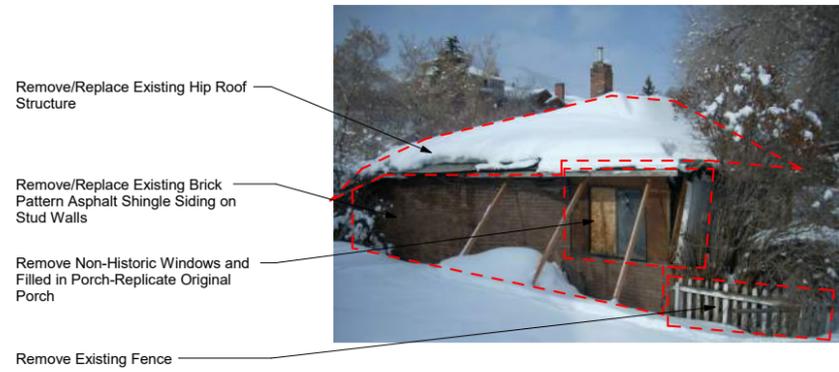
**5 Existing Looking North**  
SCALE:N.T.S.

- Remove/Replace Existing Hip Roof Structure
- Remove/Replace Existing Brick Pattern Asphalt Shingle Siding on Stud Walls
- Remove Non-Historic Windows and Filled in Porch-Replicate Original Porch
- Remove Existing Fence

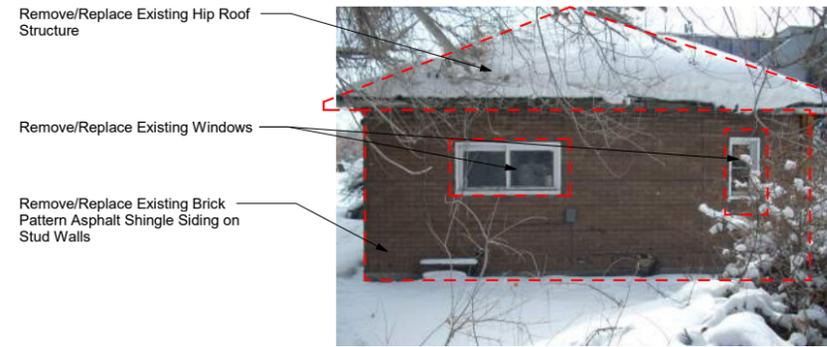
**3 Existing Looking South**  
SCALE:N.T.S.

- Remove/Replace Existing Hip Roof Structure
- Remove/Replace Existing Windows
- Remove/Replace Existing Brick Pattern Asphalt Shingle Siding on Stud Walls

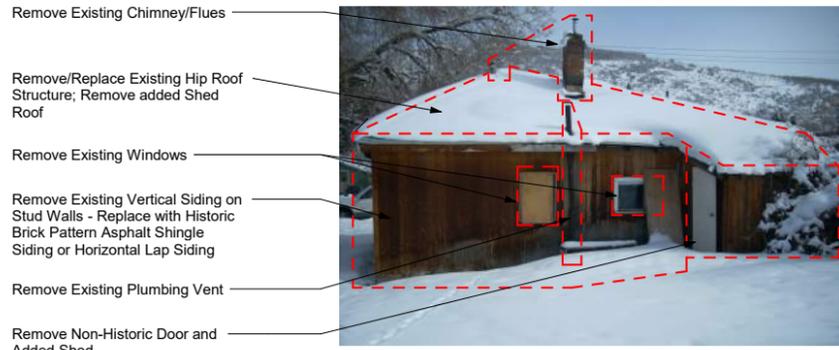
**4 Existing Looking East**  
SCALE:N.T.S.

- Remove Existing Chimney/Flues
- Remove/Replace Existing Hip Roof Structure; Remove added Shed Roof
- Remove Existing Windows
- Remove Existing Vertical Siding on Stud Walls - Replace with Historic Brick Pattern Asphalt Shingle Siding or Horizontal Lap Siding
- Remove Existing Plumbing Vent
- Remove Non-Historic Door and Added Shed

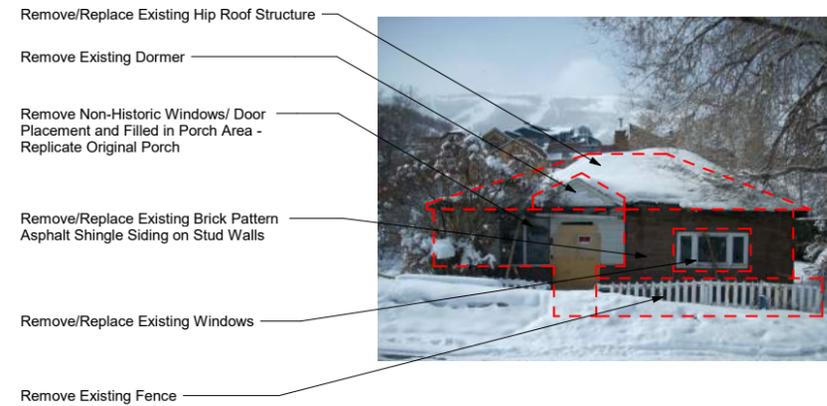
**2 Existing Looking West**  
SCALE:N.T.S.

- Remove/Replace Existing Hip Roof Structure
- Remove Existing Dormer
- Remove Non-Historic Windows/ Door Placement and Filled in Porch Area - Replicate Original Porch
- Remove/Replace Existing Brick Pattern Asphalt Shingle Siding on Stud Walls
- Remove/Replace Existing Windows
- Remove Existing Fence

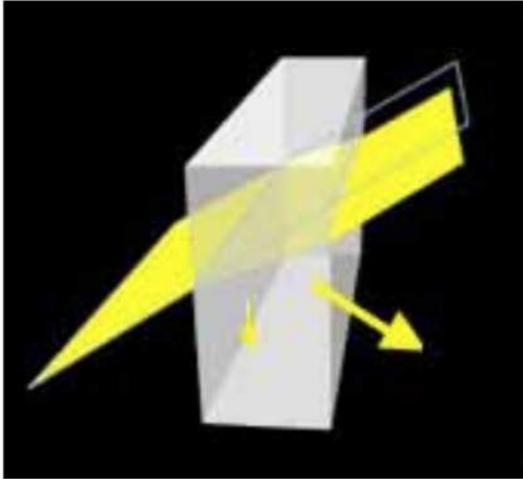
When a beam of light falls on a piece of glass, some of the light is reflected from the glass surface, some of the light passes through the glass (transmitted), and some (very little) is absorbed by the glass. Since solar panels are designed to absorb as much light as possible, the reflection values are significantly lower than typical glazing.

Depiction of resultant percentages from incident components

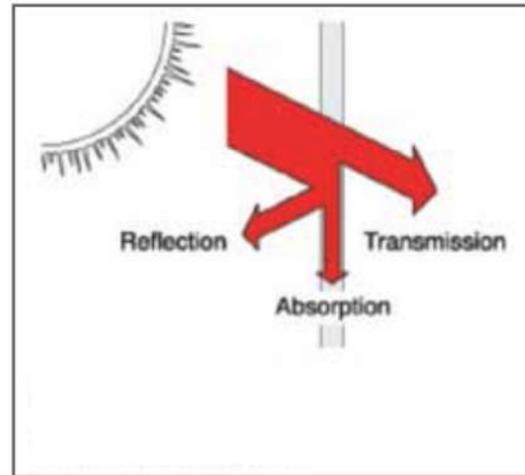
Solar radiation through a glazing material is either reflected, transmitted, or absorbed
