SPIRO MINE ENTRY CONCEPT

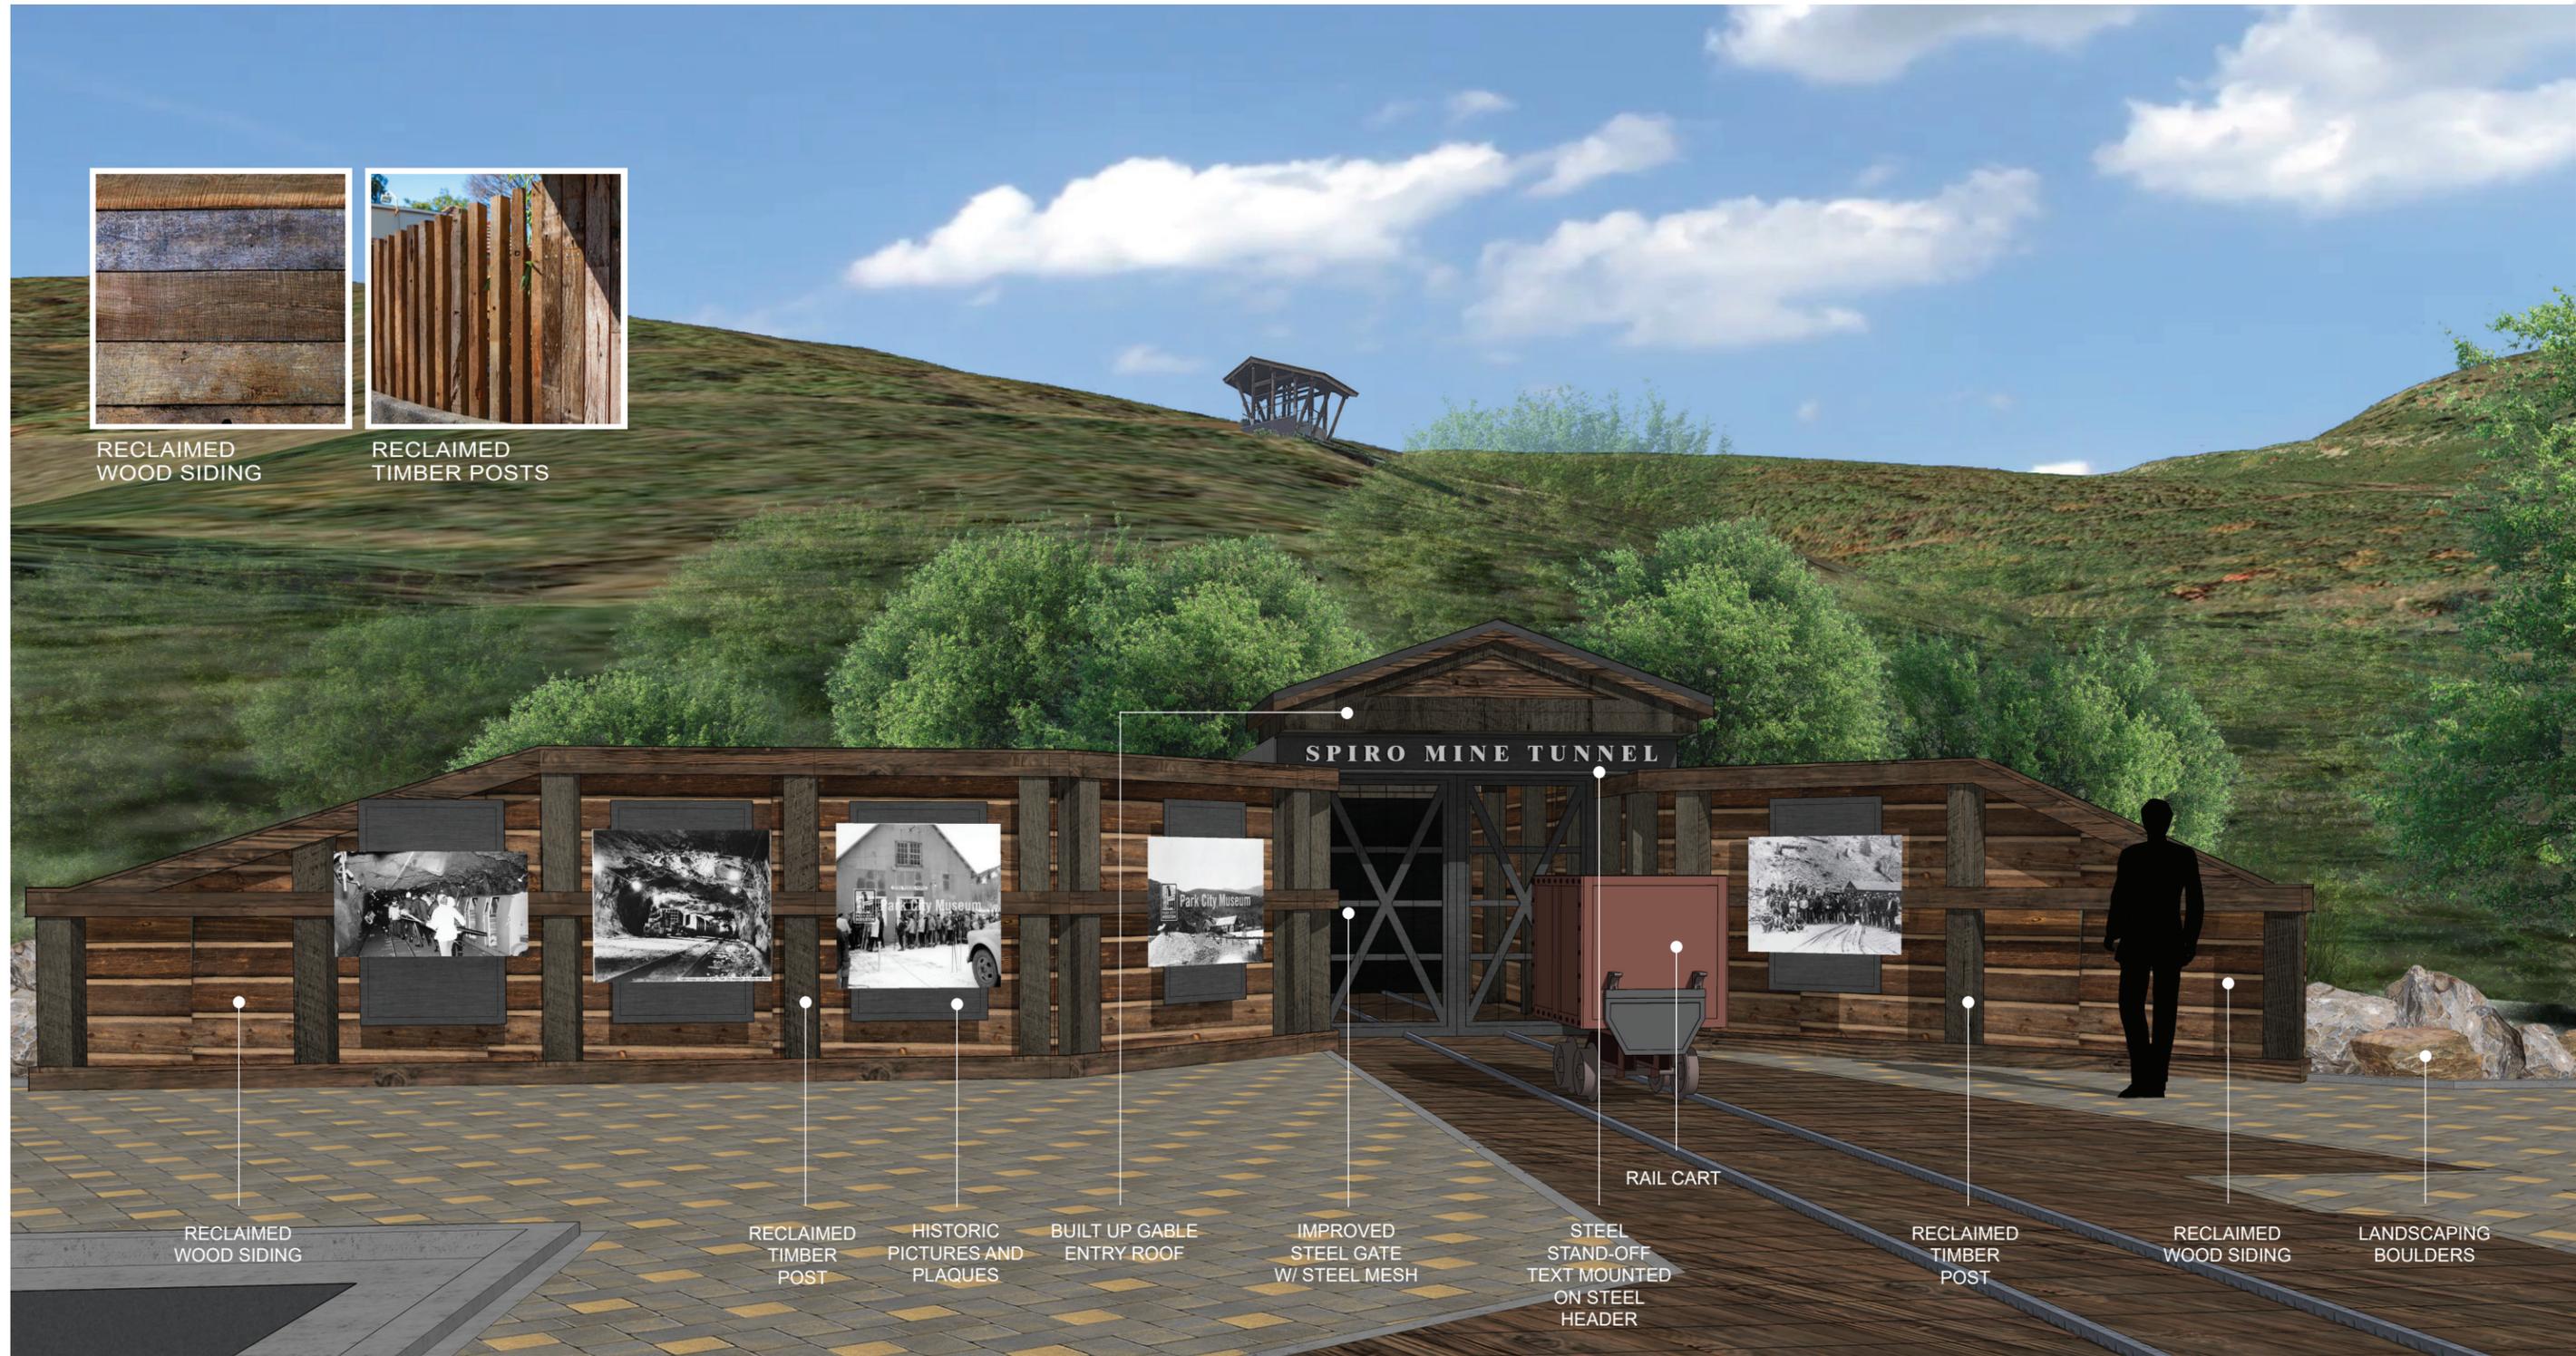
RECLAIMED WOOD SIDING

RECLAIMED TIMBER POSTS

RECLAIMED TIMBER POST

HISTORIC PICTURES AND PLAQUES

BUILT UP GABLE ENTRY ROOF

IMPROVED STEEL GATE W/ STEEL MESH

STEEL STAND-OFF TEXT MOUNTED ON STEEL HEADER

RAIL CART

LANDSCAPING BOULDERS
