HISTORIC SITES INVENTORY
HISTORIC SITE FORM
PARK CITY MUNICIPAL CORPORATION

Property Name (if any): George Murray House

Address: 44 ONTARIO CANYON STREET

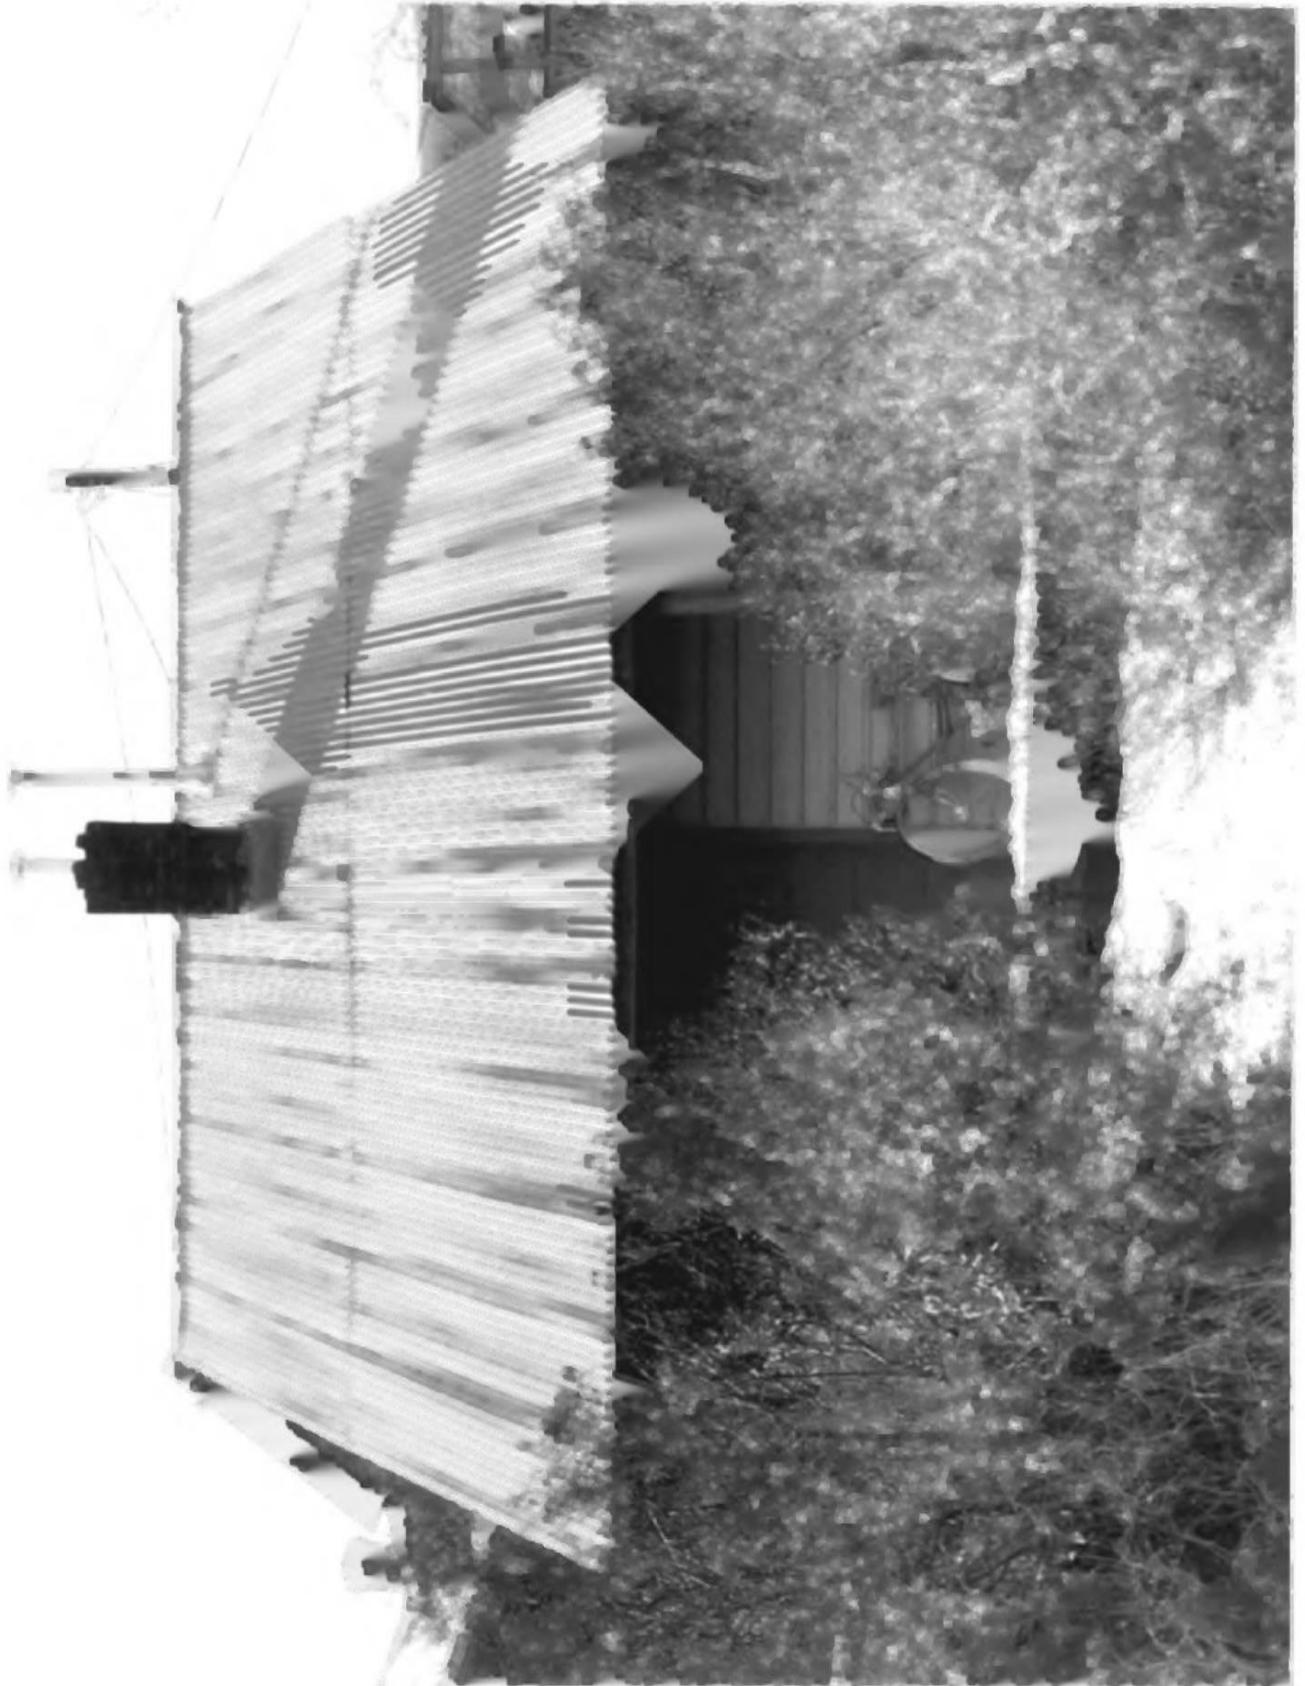
East facade

George Murray House
44 Chambers
Park City, Utah

Photo by Debbie Temme, October 1983
Negative: Utah State Historical Society
