**HISTORIC SITES INVENTORY**  
**HISTORIC SITE FORM**  
 PARK CITY MUNICIPAL CORPORATION

Property Name (if any): Edwin Kimball House

Address: 811 Park Avenue

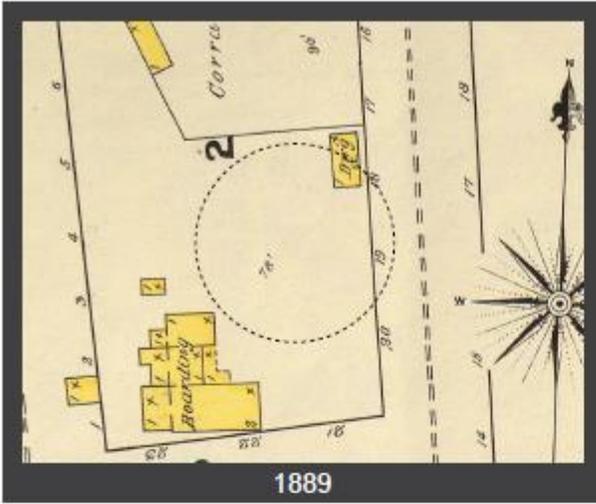
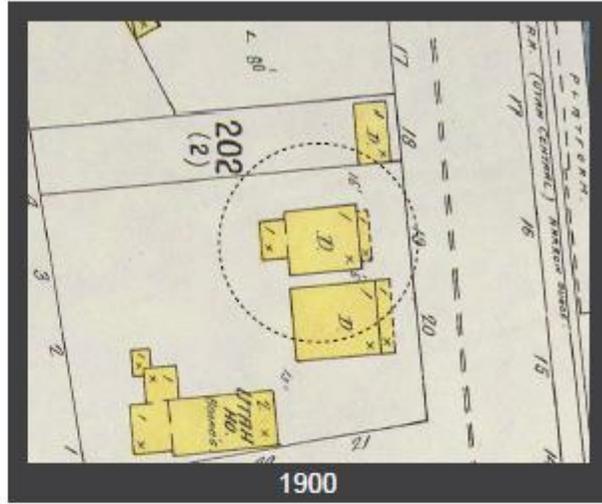
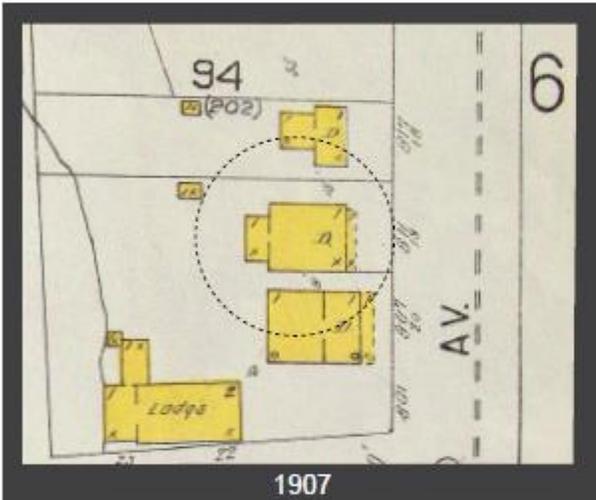
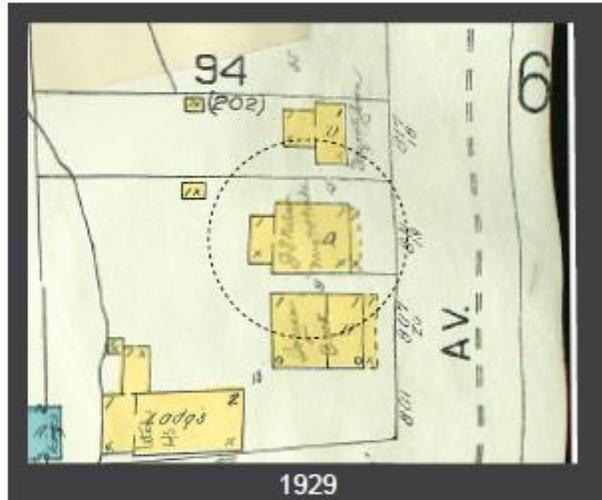
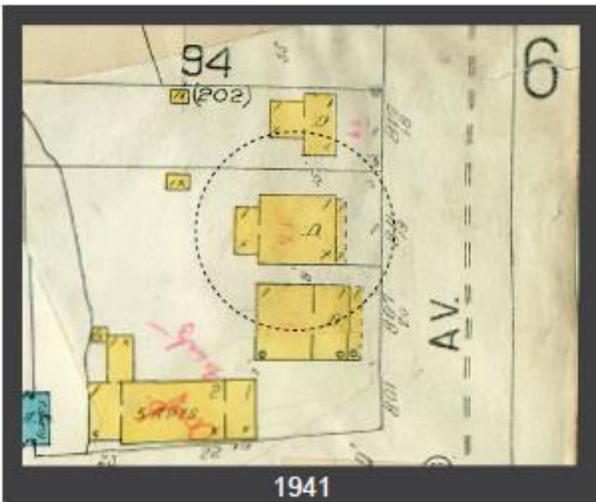
811 Park Avenue, Park City, Summit County, Utah  
Intensive Level Survey—Sanborn Map history

This house was built between 1889 and 1900, judging from the Sanborn Insurance maps from those years. It is likely that the house was built while the property was under the ownership of Edwin Kimball, a stagecoach entrepreneur. He gave it to his sons, who had formed the Kimball Investment Company, in 1918. They owned several properties in town, including their livery stable, which was located where the Kimball Arts Center is now.
