HISTORIC SITES INVENTORY
HISTORIC SITE FORM
 PARK CITY MUNICIPAL CORPORATION

Property Name (if any): Norman Smith House

Address: 1323 Park Avenue

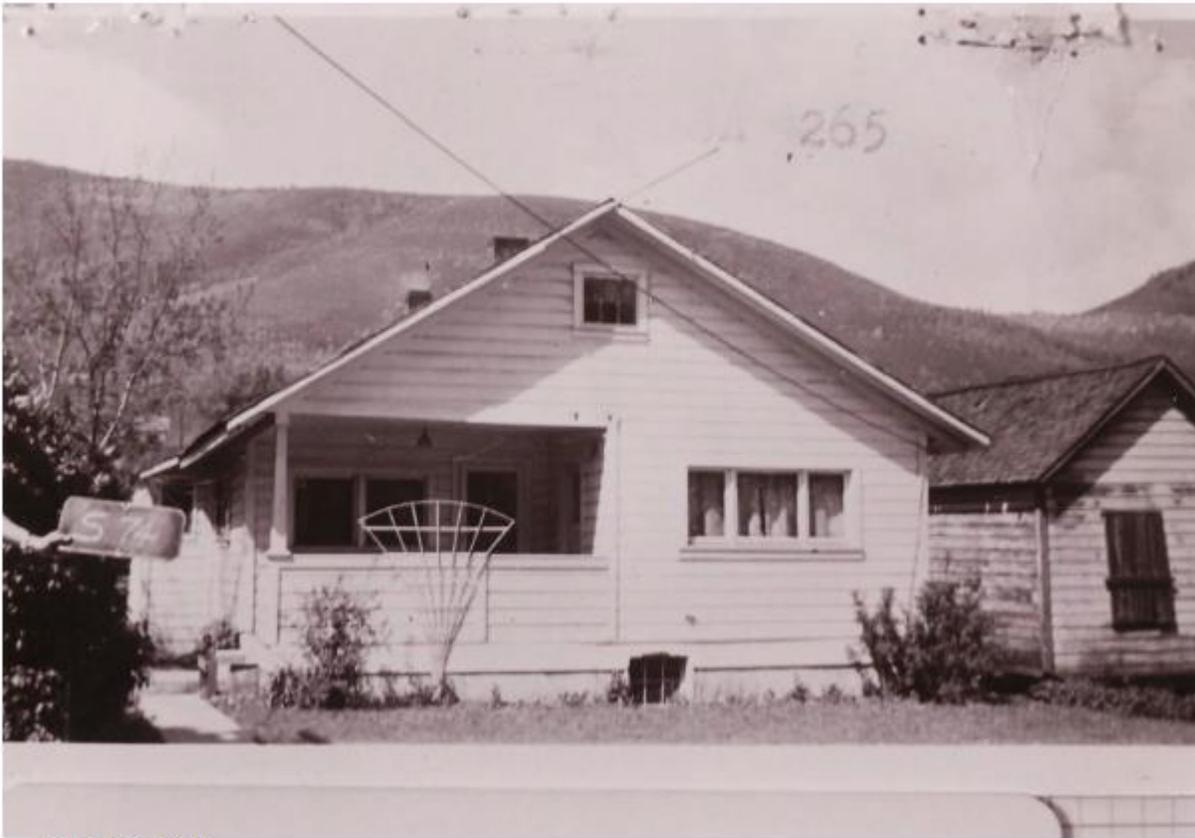
Tax photo c. 1940

side of the façade, currently a large fixed pane window, used to be a central pane window flanked by two narrower panes. What appears to be a sliding window in the porch area in the c. 1940 tax photo has been replaced with two one-over-one double hung sash windows. The door on the wall facing the street has been removed, with the door facing to the side becoming the main entry for the home. The porch area has also been altered significantly; the half wall surrounding the porch was replaced by a wood railing and the columns supporting the roof has been modified to be much larger and have a stone veneer similar to the foundation of the house. The site is largely the same, except for a planter box clad with the same stone veneer as the foundation. The cumulative formal and material changes have diminished its historic value.

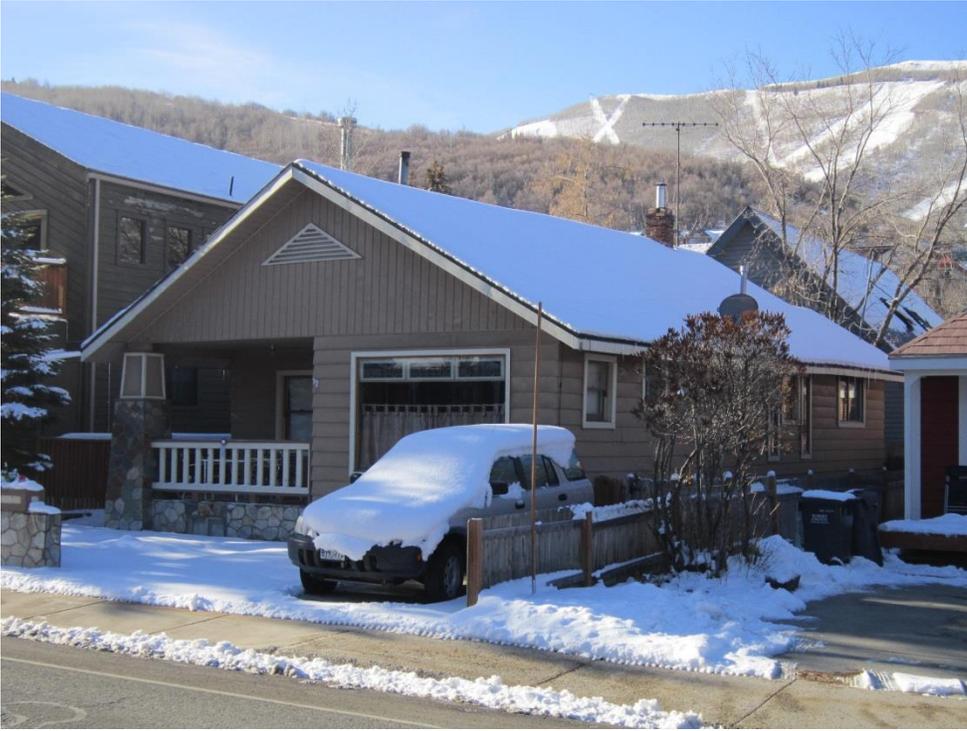
1323 Park Avenue. Northeast oblique. November 2013.

1323 Park is a bungalow type house that has not had any major modifications, but has undergone quite a few material alterations. While the bungalow was not one of the three main house types built during the historic Park City mining era, it was still common to that time period. The gable roof is sheathed with composition shingles. The walls are clad with horizontal aluminum siding, with vertical siding in the gable. Stone veneer covers the foundation area. The windows and doors have undergone the most alteration. Starting at the top, in the c. 1940 tax photo, a six pane window was present in the gable but has been replaced with a large gable vent. The window on the right

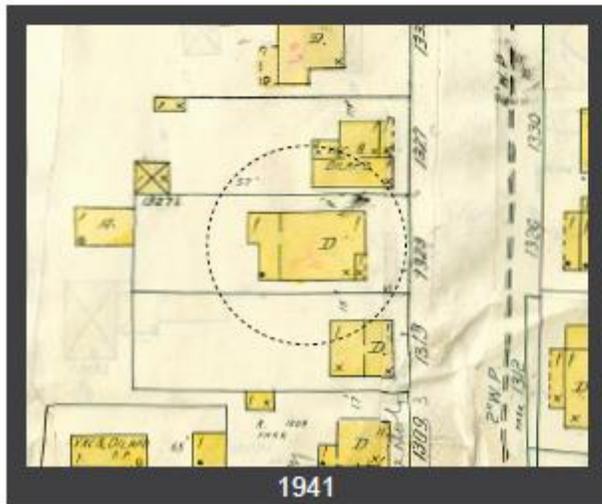
1323 Park Avenue, Park City, Summit County, Utah
Intensive Level Survey—Sanborn Map history

Though a structure appears on this lot on the 1907 Sanborn Insurance map, it appears that it was demolished to make room for the current house, which differs in size, shape, and location on the lot. Information from a previous Historic Site Form indicates that it was built around 1914, but this is not confirmed. The lot was owned by the Ontario Silver Mining Company initially, and the title history states that it was not sold to an individual until 1935. The census records disagree, and show owners of the house as early as 1930. It was a common practice in early Park City for lots to be sold off the books and recorded at a later date; this is probably the case in this situation.
