November 25, 2014  
Kleinfelder Project No.: 20150092.001A

SUBJECT: Phase I Environmental Site Assessment  
Clark Ranch Property  
Summit County Parcel #PP-26, PP-26-A-1, SS-121, and SS-91  
Park City, Utah

**PHASE I ENVIRONMENTAL  
SITE ASSESSMENT  
CLARK RANCH PROPERTY  
SUMMIT COUNTY PARCEL # PP-26, PP-26-A-1, SS-  
121, and SS-91  
PARK CITY, UTAH  
KLEINFELDER PROJECT NO: 20150092.001A**

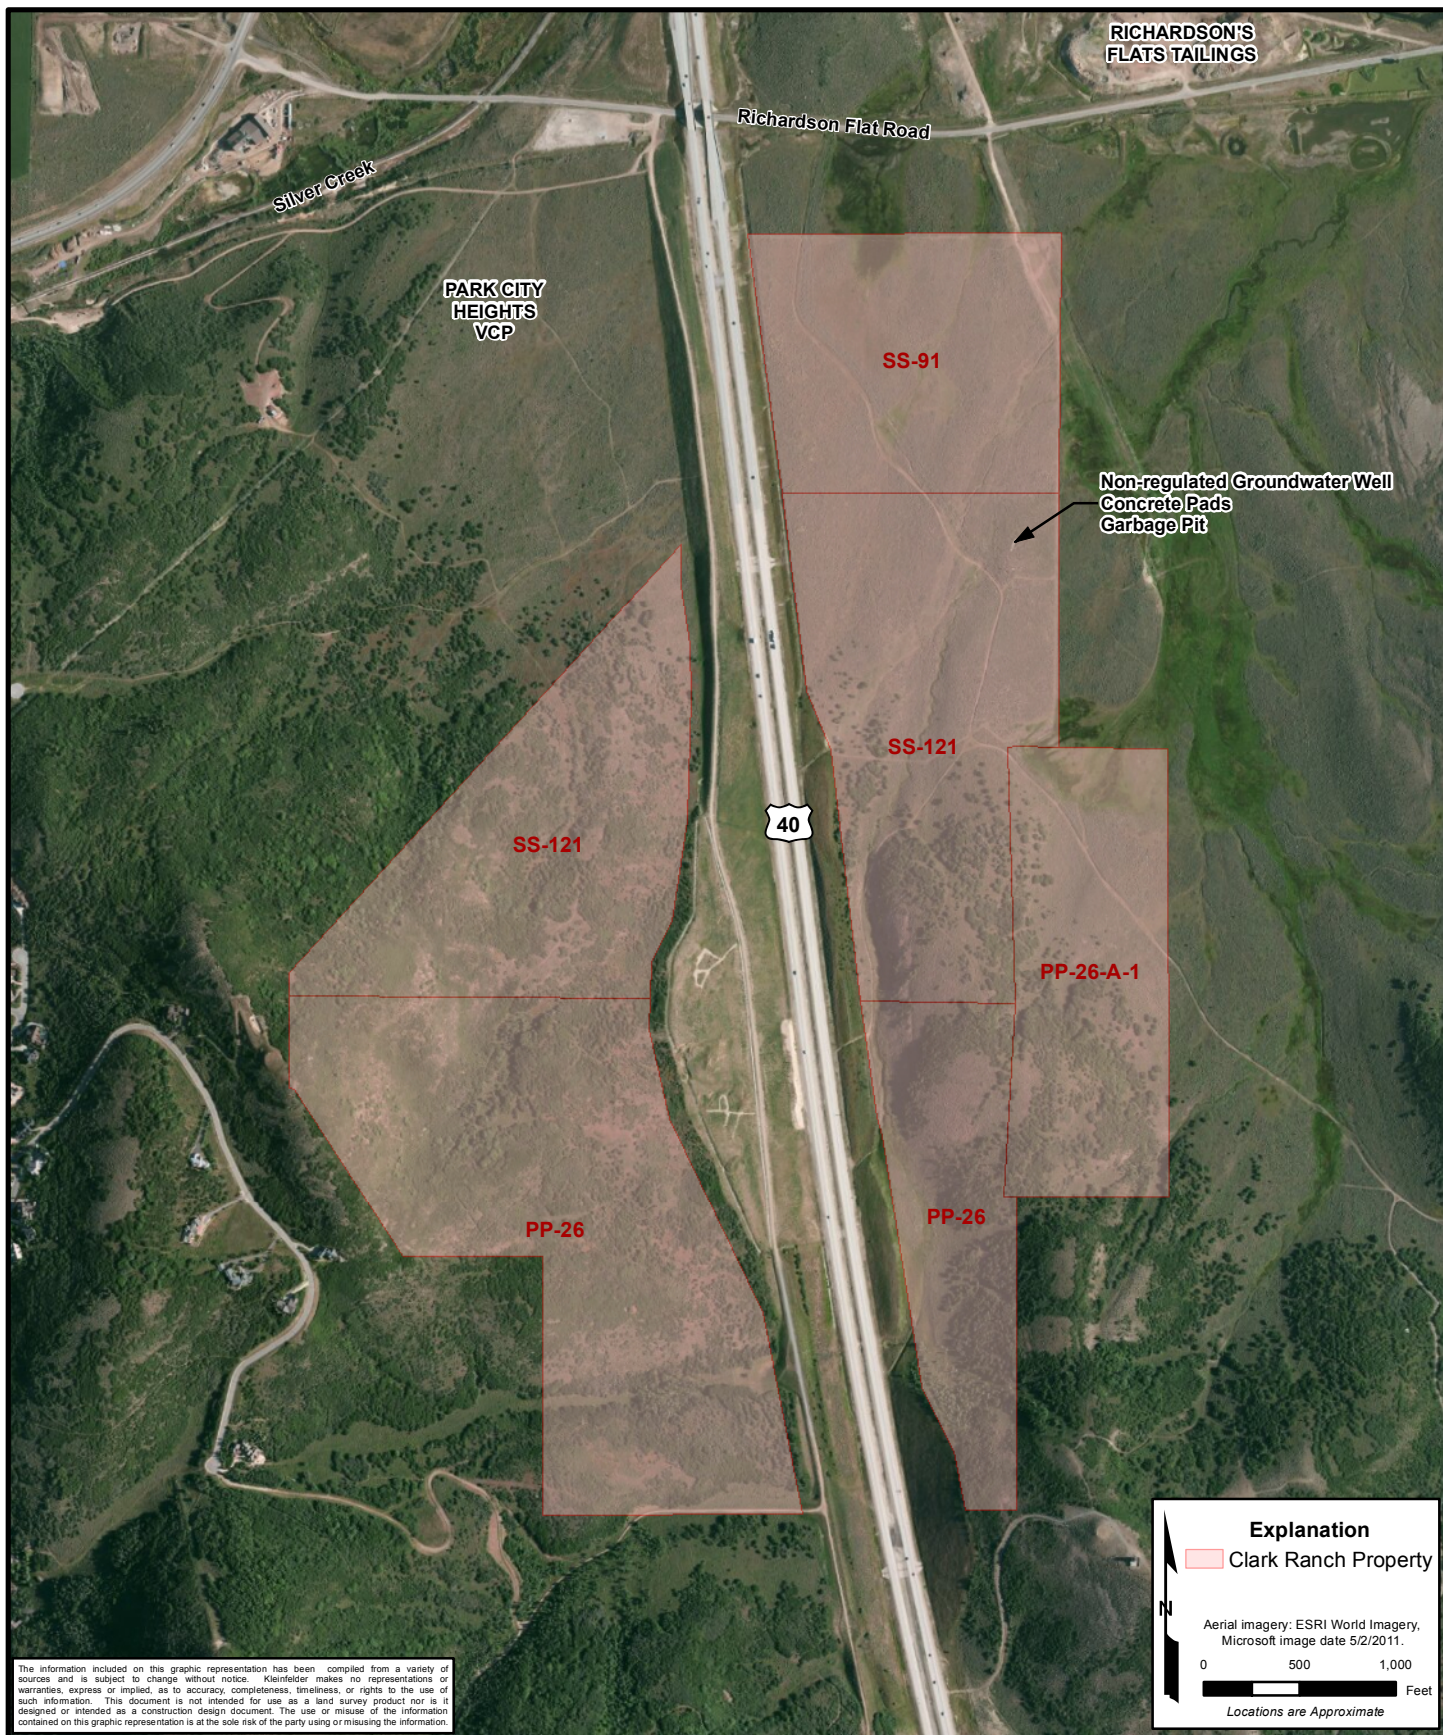
PROJECT NO.	20150092	<b>SITE VICINITY MAP</b>	<b>FIGURE</b>  <b>2</b>
	DRAWN:	11/17/2014		
	DRAWN BY:	KFH	Clark Ranch Property Phase I Environmental Site Assessment Highway 40 and Richardson Flat Road Park City, Summit County, Utah	
	CHECKED BY:	CAP		
	FILE NAME:	Figure2.mxd

Mr. Corey Park and Mr. Ryan Merkley of Kleinfelder, performed a Site reconnaissance during soil sampling activities on October 14, 15, and 31, 2014. The Kleinfelder representatives were accompanied by property representatives during the Site reconnaissance. The Site reconnaissance included a visual inspection of the Site to assist in identifying the presence or likely presence of hazardous substances or petroleum hydrocarbons under conditions that indicate an existing release, a past release, or threat of release into structures, soil, groundwater, or surface water at the Site (i.e., RECs). Observations of readily-apparent environmental conditions are summarized in Table 6-1, and color photographs of the Site on Figures 4 through 6. The approximate Site boundaries are shown on Figure 2, "Site Vicinity Map".

Two concrete pads were located in the approximate center of the east portion of the Site as shown on Figure 2. The concrete pads are located adjacent to the observed garbage pit and unregistered well. According to information provided by Park City representatives gathered from
