**Historic Preservation Board
Staff Report**

Subject: 1063 Norfolk Avenue
Author: Christy Alexander, Planner
Date: September 18, 2013
Type of Item: Historic District Grant
Project Number: PL-13-02051

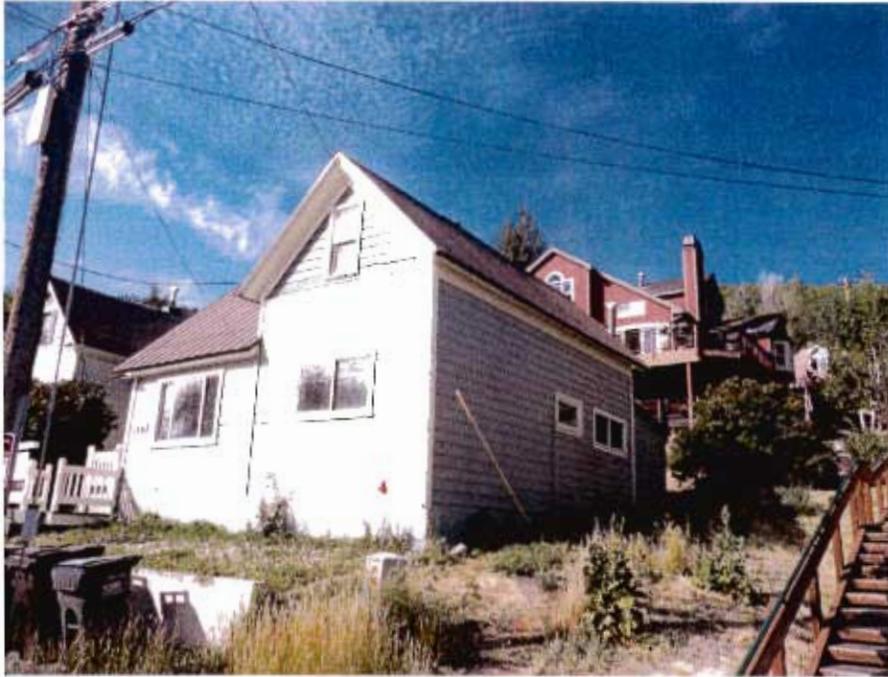
TOPOGRAPHY. Front and side view.

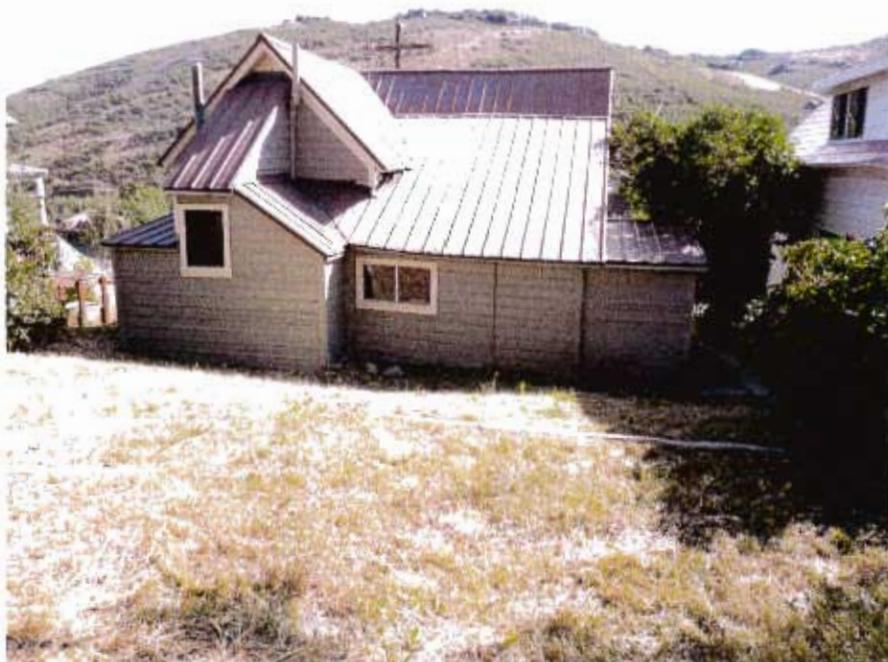
TOPOGRAPHY. Rear view.

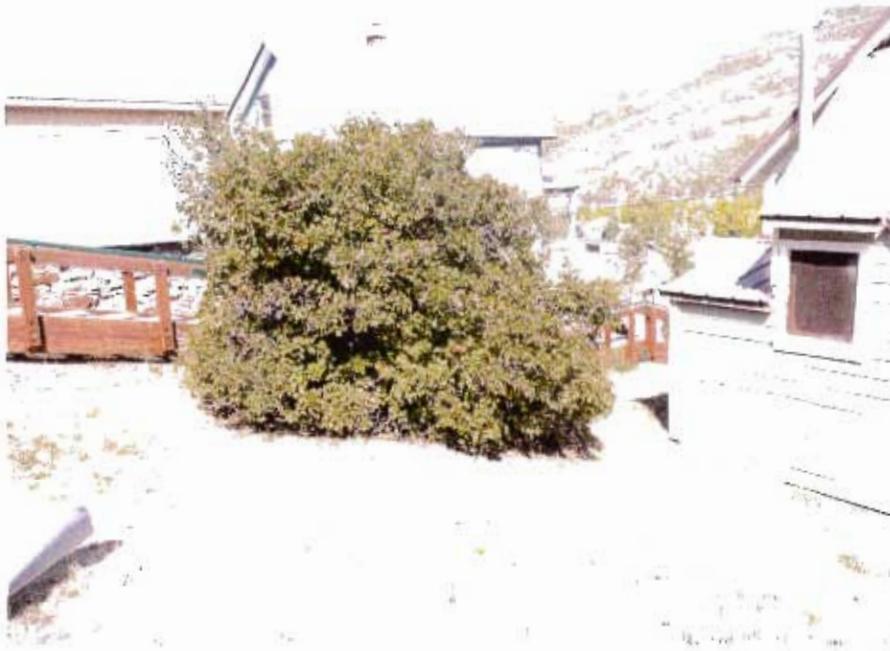
LANDSCAPING. Existing Lilac Bush.

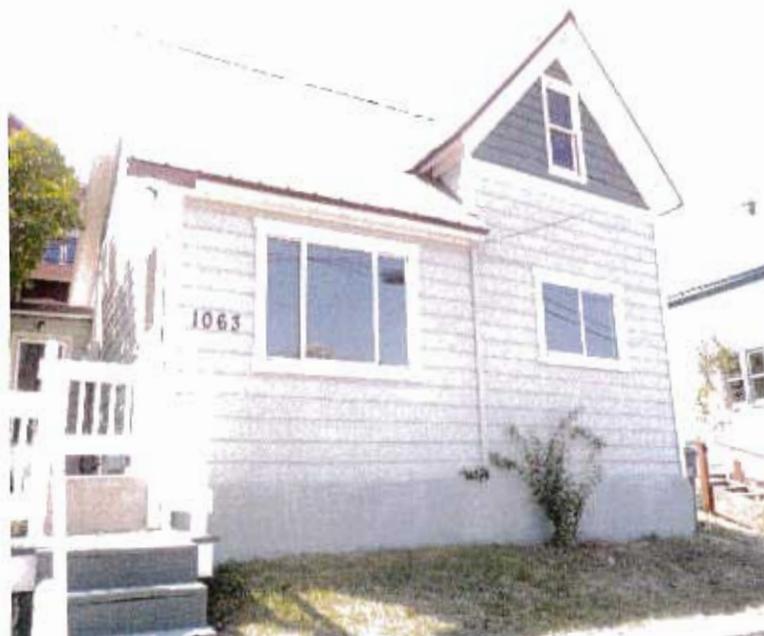
LANDSCAPING. Existing Rose Bush.

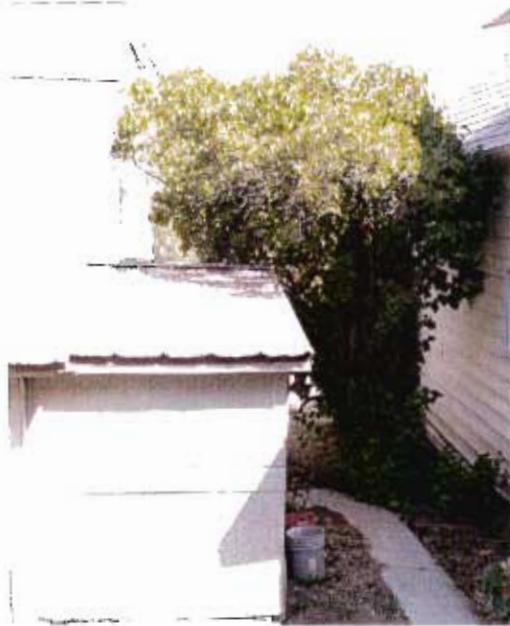
LANDSCAPING. Existing lilac bush and concrete path on South side of house.

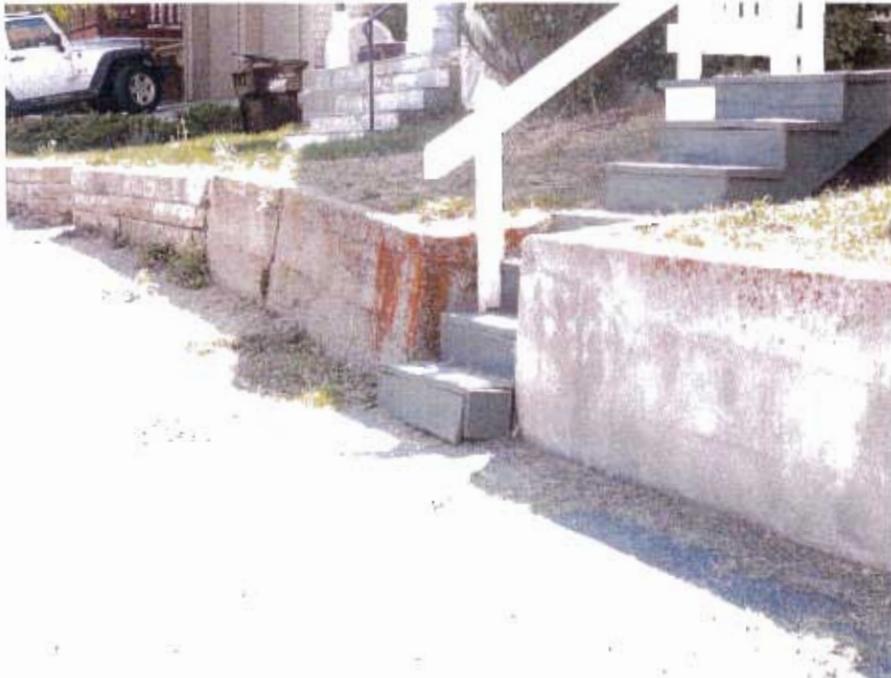
RETAINING WALLS. Existing retaining walls viewed from front of house.

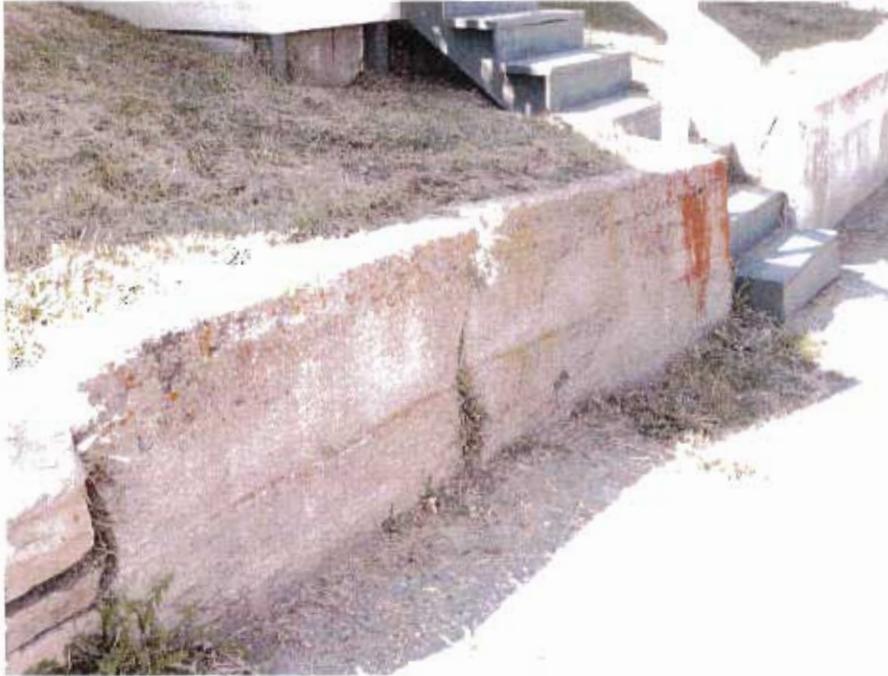
RETAINING WALLS. Existing retaining walls viewed from front of house.

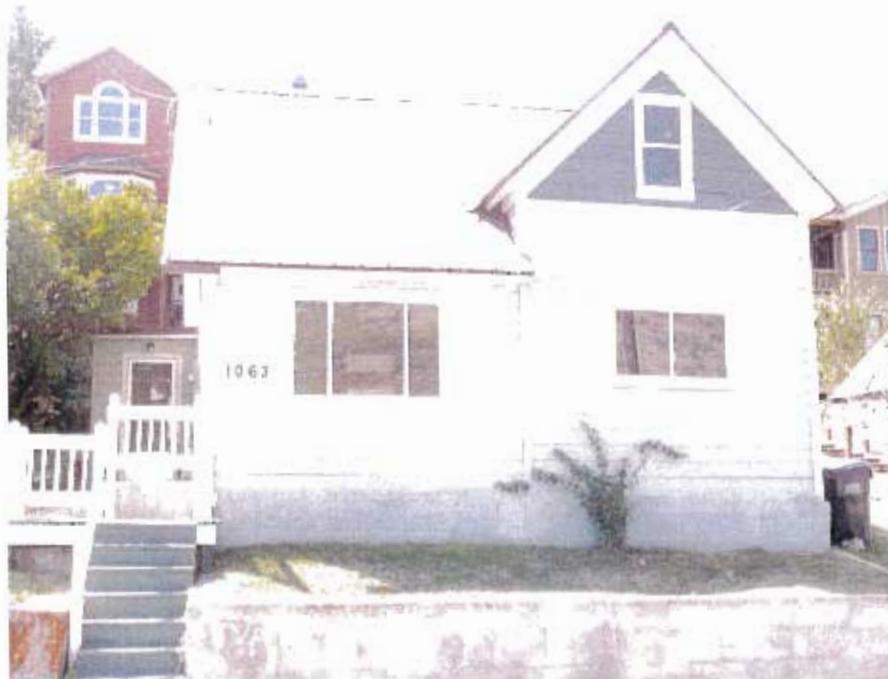
One staircase exists on the southeast corner (left) side of the property. It measures three feet in width and runs ten feet towards the rear, providing access to the front door and rear side entrance. The staircase appears to have been rebuilt within the previous fifteen years and is in fair condition for its age.

EXTERIOR STEPS. Exterior steps on south side viewed from front of house.

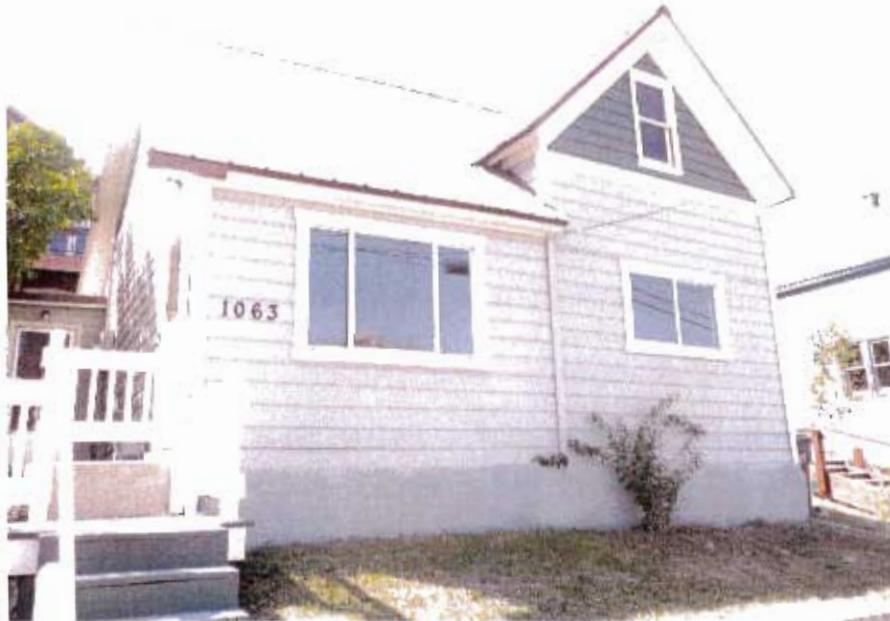
The front façade of the subject property faces Norfolk Ave. towards the Northeast. The façade is comprised of seven-inch horizontal cedar siding with a painted finish. It measures twenty-four feet five inches in width by ten feet in height except where the attic rises to 20.5 feet over the Northeast side of the house. The existing siding appears to have been installed over the original siding at an unknown time. Overall condition of the façade is fair to poor.

EXTERIOR WALL – PRIMARY FAÇADE. Front (East Side) of house.

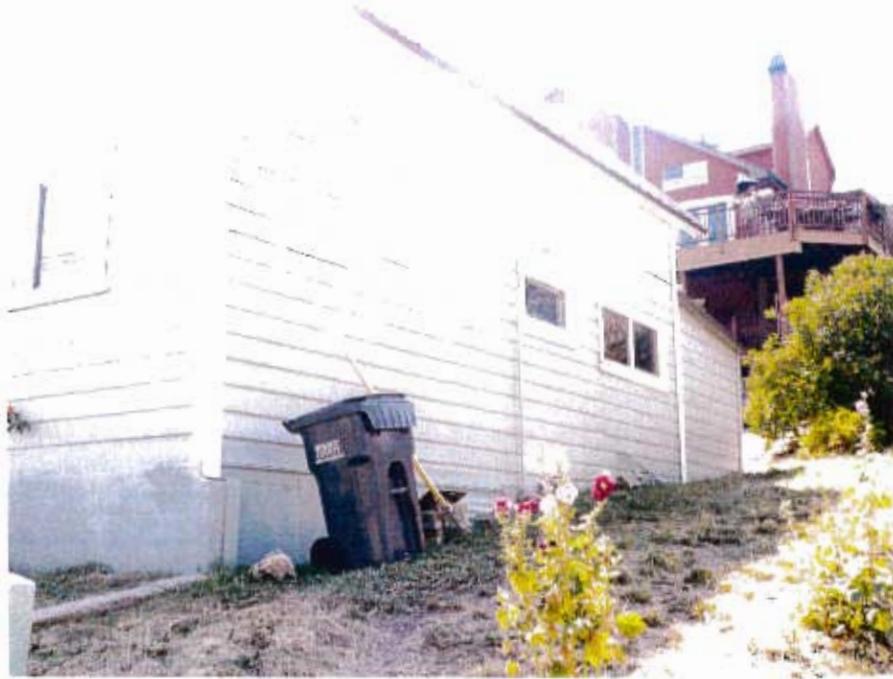
The northern (right) side of the house is comprised of seven-inch horizontal cedar siding with a painted finish. The dimensions are twenty-nine feet in depth by 6.5 to 14.5 feet in height. Several areas have been patched where windows used to be. Existing siding appears to have been installed over the original at an unknown date. Overall condition of the northern façade is fair to poor.

EXTERIOR WALL – SECONDARY FAÇADE 1. North side of house.

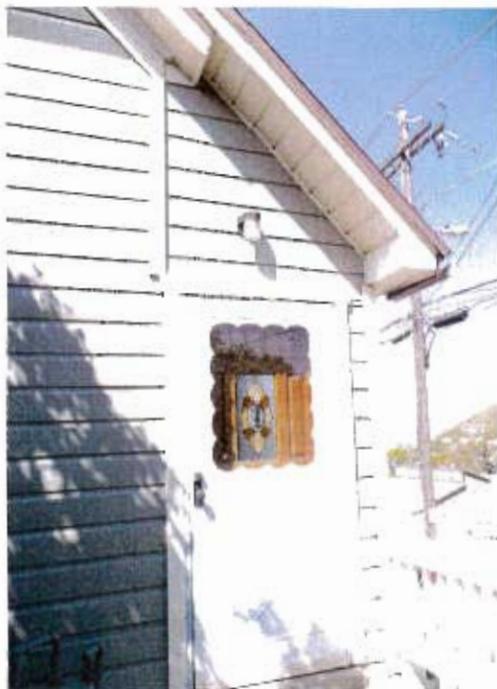
foot by nine-foot entry vestibule is appended to the rear of the southern façade and serves as a back door mud area. Its siding matches that of the rest of the house in type and finish if not age. The siding appears to have been installed over the original at an unknown date. Overall condition of the southern façade is fair to poor.

EXTERIOR WALL – SECONDARY FAÇADE 2. South side of house
- existing front porch fill-in.

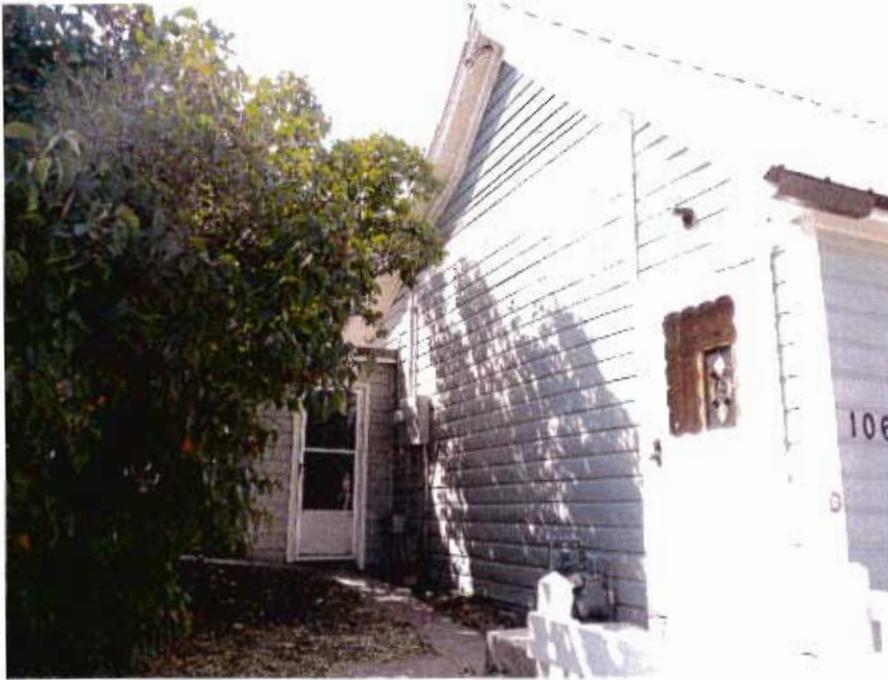
EXTERIOR WALL – SECONDARY FAÇADE 2. South side of house
– rear side addition entry.

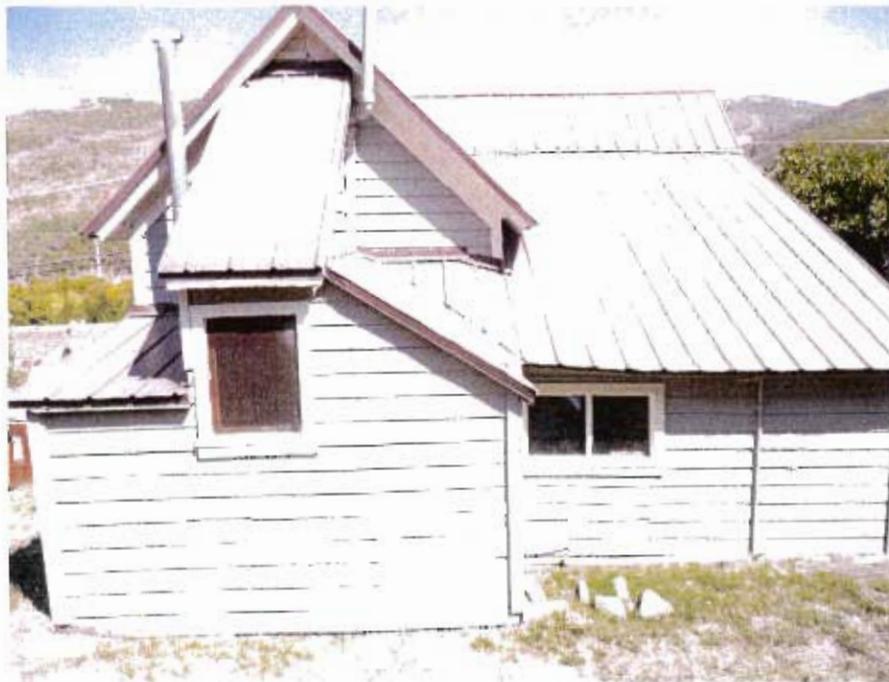
The western (rear) façade is comprised of seven-inch horizontal cedar siding with a painted finish. The rear façade measures twenty-four feet in width by 6.5 to 20.5 feet in height at the vertical axis of the roof apex. The rear of the house is a hodgepodge of two additions to the original T/L-shape structure. The additions to the rear façade both date to the late 1930's or 1940's, and are stick built construction with wood sills lying directly on bare earth. Both additions are failing structurally as evidenced by the sloping of both rooflines and flooring settlement. The siding is in keeping with the other three sides of the dwelling. Overall condition of the entire façade is poor.

EXTERIOR WALL – REAR FAÇADE. West side of house.

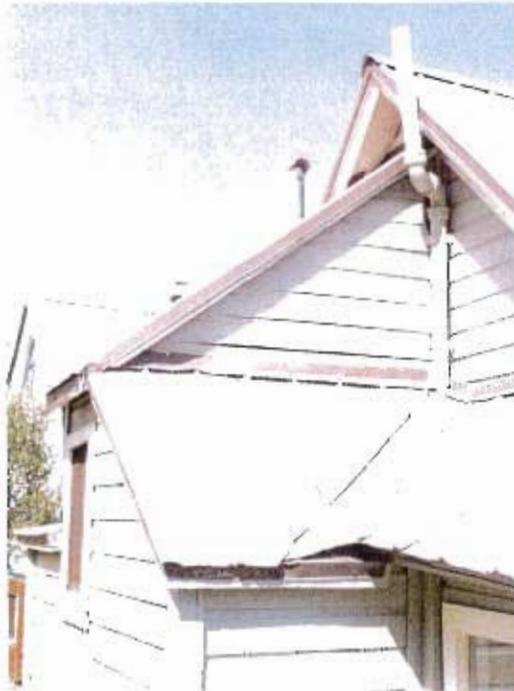
poor condition. The dormer addition measures 7.5 feet by twelve-feet and is clad in matching seven-inch horizontal cedar siding with a painted finish.

DORMER(S)/BAY(S). Dormer at rear of house with stairs to attic.

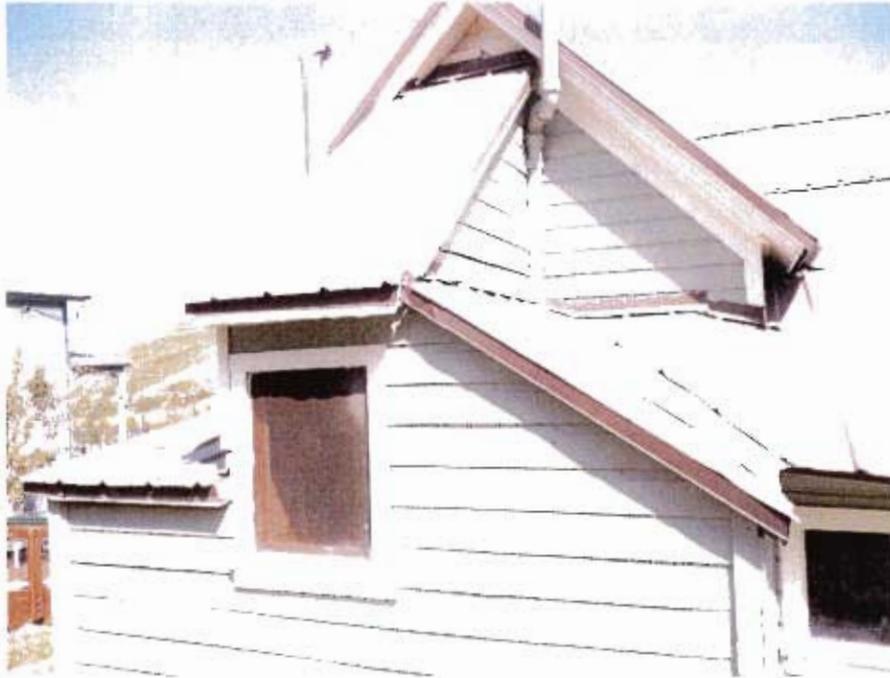
DORMER(S)/BAY(S). Dormer at rear of house with stairs to attic.

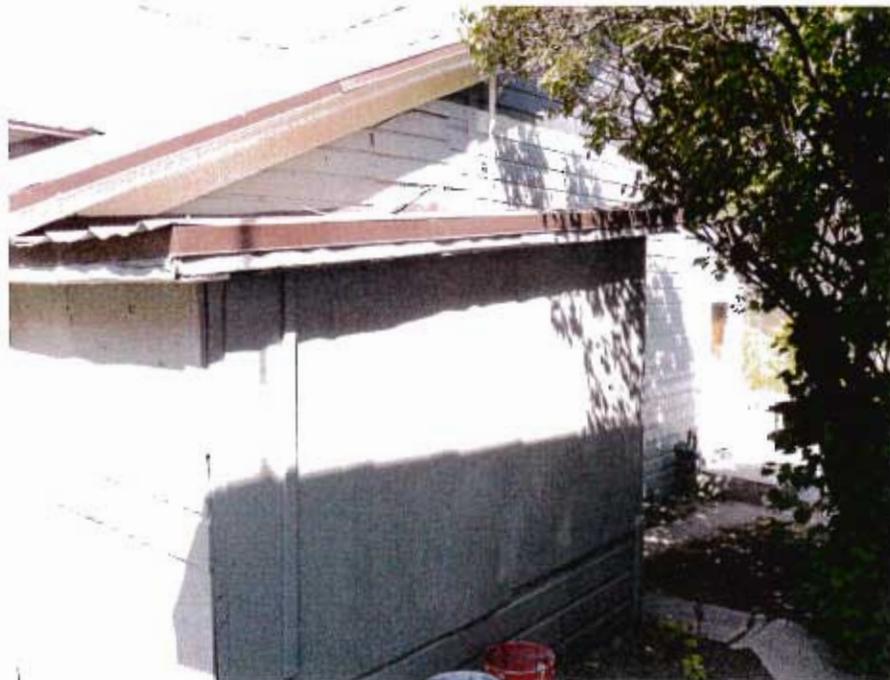
Along with the previously mentioned dormer, two other additions to the subject property are noted. The first, on the western (rear) façade, is made up of a shed style roof extension to the original cottage bringing the back wall out a further twelve feet. This extension made way for a "modern" style kitchen sometime during the 1930's to 1940's. The addition, like the original structure, has no masonry foundation and is suffering from significant settlement issues and rot. The kitchen addition measures twelve by twelve feet with a rear wall height of seven feet. The condition of this addition is extremely poor. The second addition of note exists along the southern (left) side of the façade. This addition measures six by nine feet and was built for the purpose of providing an exterior mudroom to the kitchen addition. This appendage may or may not have been built when the kitchen was erected. The construction techniques match that of the rest of the house and similar issues are evident, from rotting of the sills to settlement of the walls and floor.

ADDITION(S). Rear side entry on south side of house.

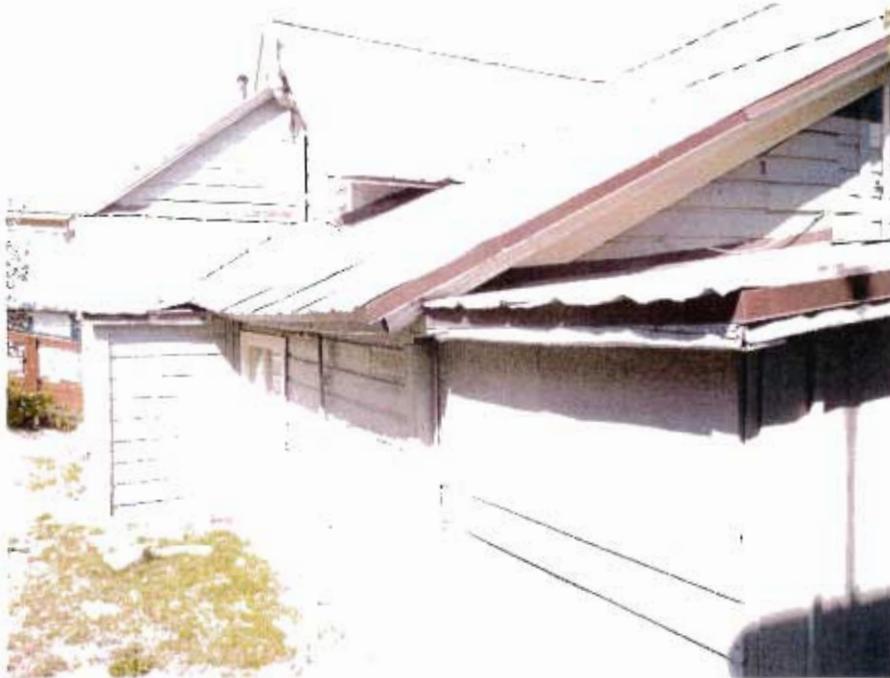
ADDITION(S). Rear kitchen addition on west side of house.

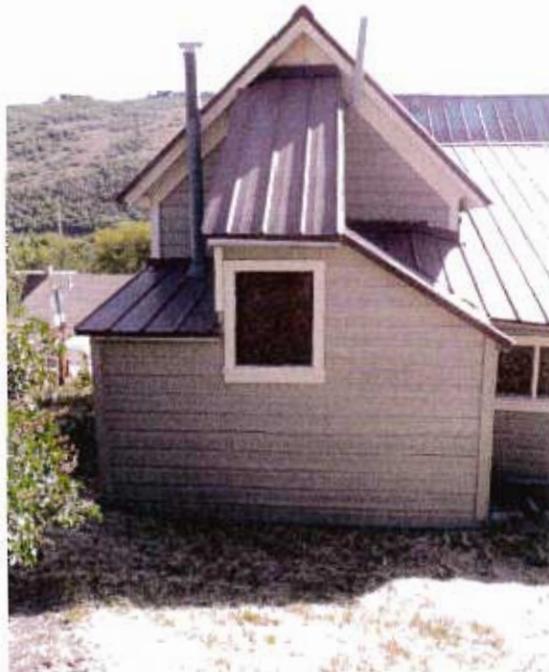
ADDITION(S). Stairwell/dormer addition in rear of house (west side).

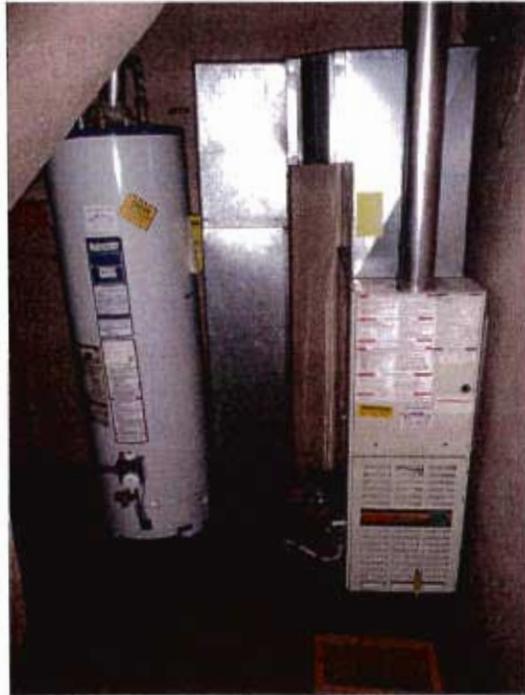
Subject property has a standard natural gas powered forced air furnace HVAC system. The system appears to have been a recent addition and appears to be in serviceable condition. This HVAC system was a more recent addition to the house. There appears to be evidence of an existing oil burning heat source.

MECHANICAL SYSTEM. Mechanical room inside house – hot water heater and furnace.

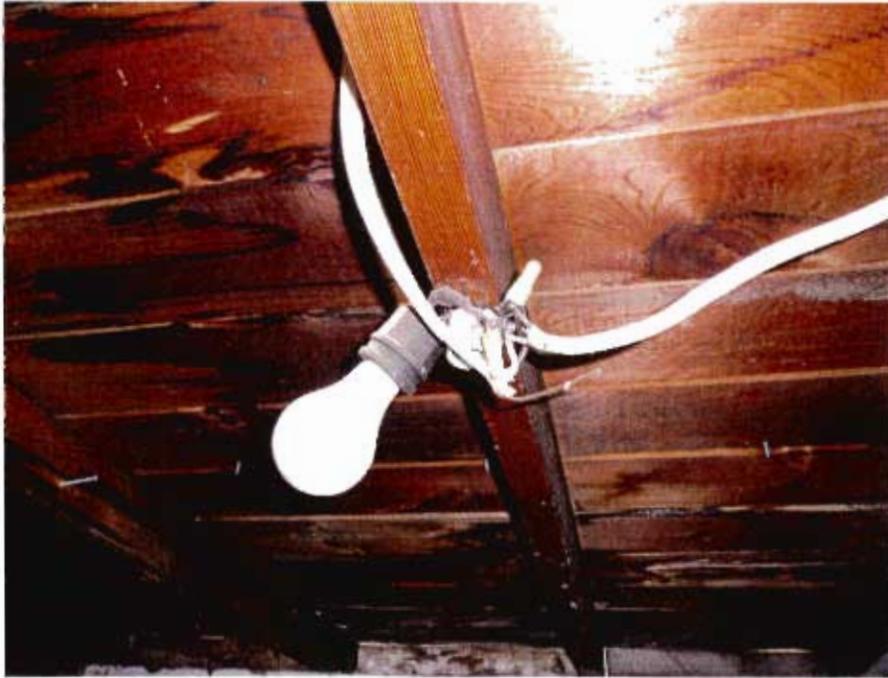
Subject property has a fairly new 100 amp service panel. This panel is connected to a mix of interior and exterior wiring. There are areas in attic where the original knob and tube wiring appears to be spliced with modern 14 gauge romex cable. Existing wiring is in poor condition and does not meet current electrical codes, due to the lack of GFCI's in wet areas and exposed electrical boxes and cables in living areas.

ELECTRICAL SYSTEM. Wiring in rear side entry.

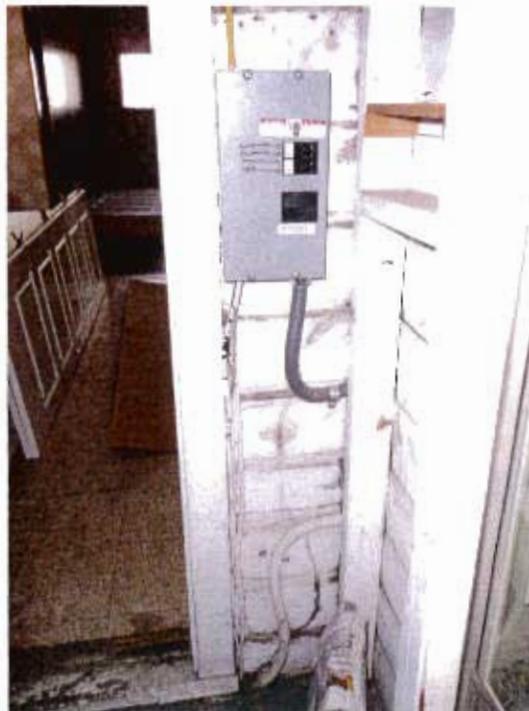
ELECTRICAL SYSTEM. Electrical panel by kitchen entry door.

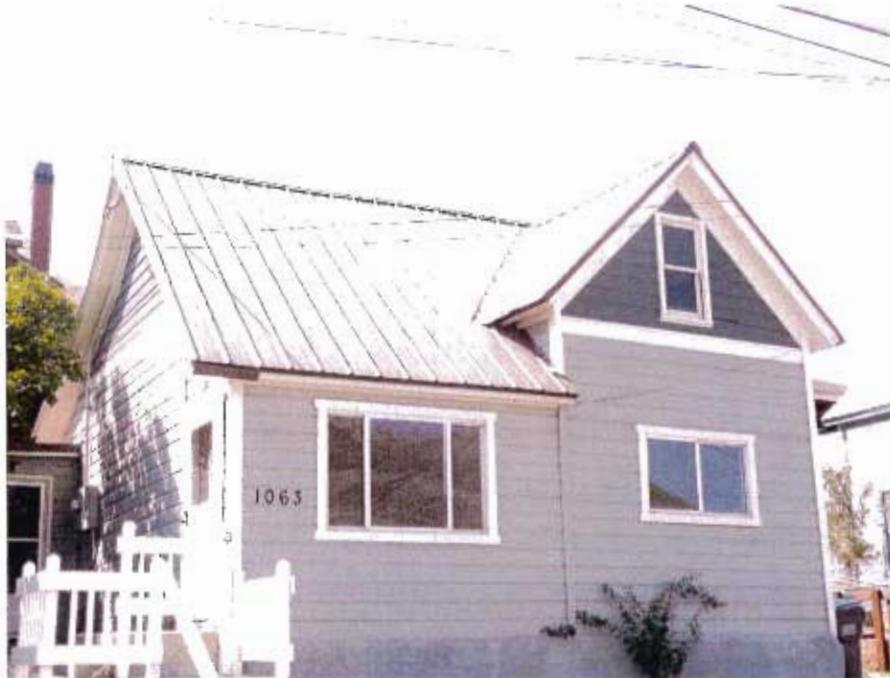
Subject property has eight windows in its current state. Only one of the windows appears to be original (Attic -- street facing east façade), the other seven are a mix of sizes and styles from 1960's era metal replacement windows (street facing east façade main windows and north façade dining window), and single pane wood windows added to the structure when the rear additions were built circa 1930's. None of the windows are in keeping with any sort of theme nor do they match what would have been installed in the original dwelling. All the windows are in poor condition, with several being unserviceable.

WINDOWS. Front of house showing old attic window and replacement metal framed windows.

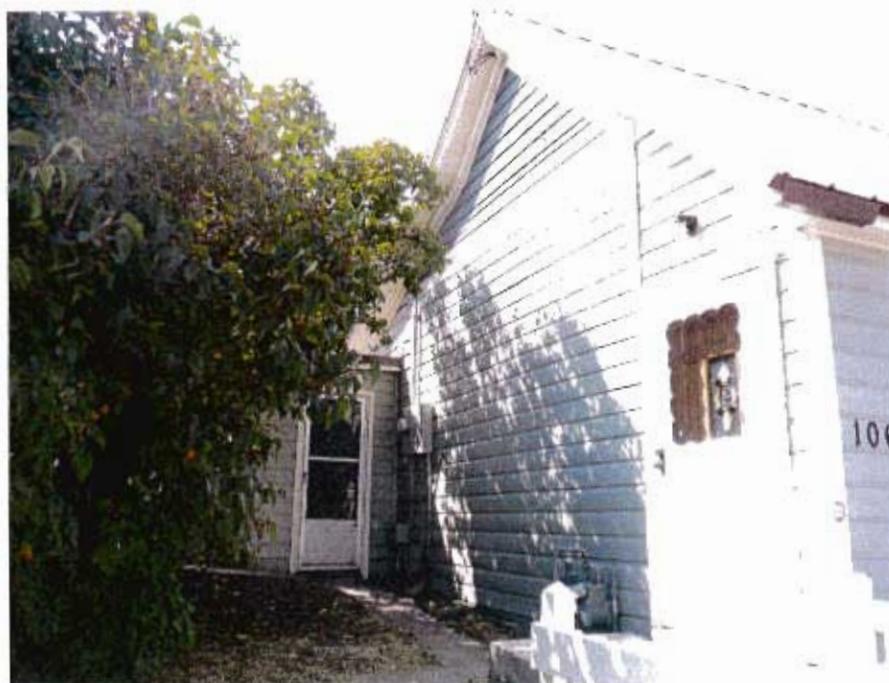
DOORS. South-east side of house showing entry/storm doors.

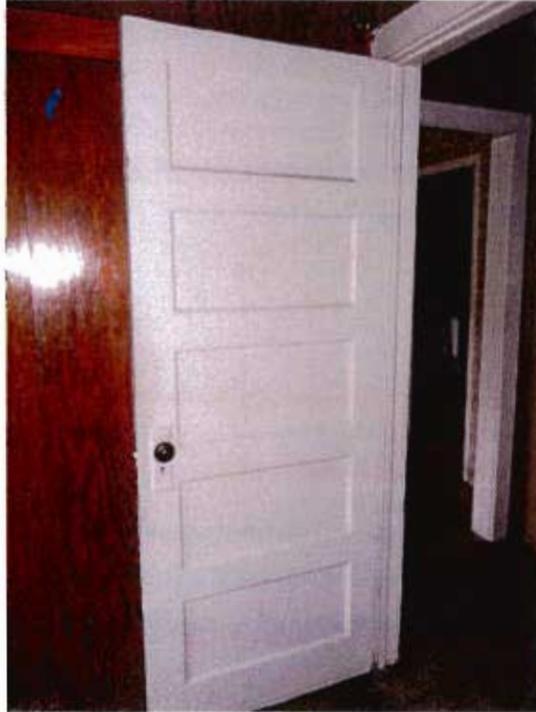
DOORS. Original interior paneled bedroom door.

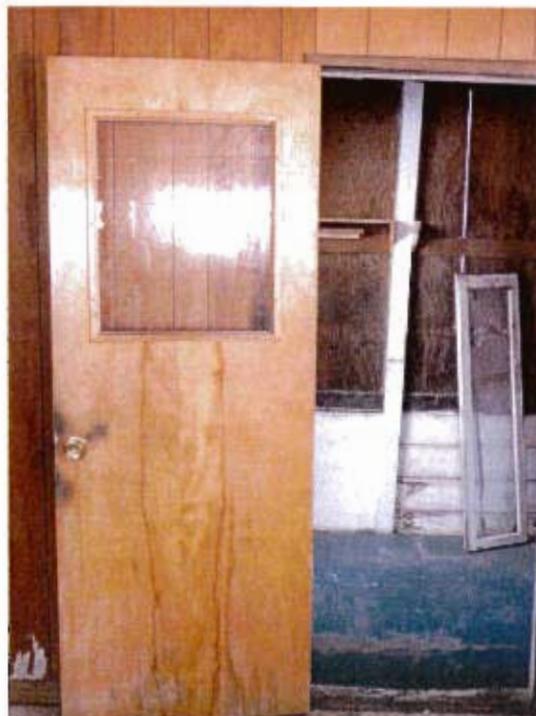
DOORS. Hollow core interior door.

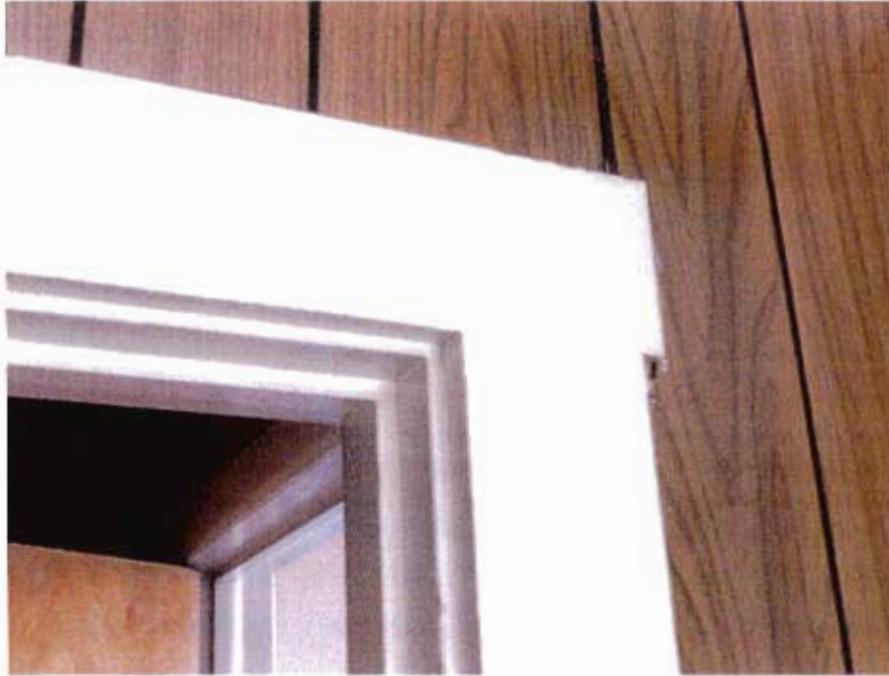
The existing trim on the interior of the property is all replacement 1960's vintage slim line rectilinear moldings. The one notable exception is the trim found around the original door leading into the main bedroom. This trim is more in keeping with a miner's type dwelling and is simple 1x4 fir. Existing exterior trim is all simple rectilinear style casement with some fluted crown moldings found under the eaves of the original structure. The property is devoid of any excess adornment.

TRIM. Original interior 1x4 door trim.

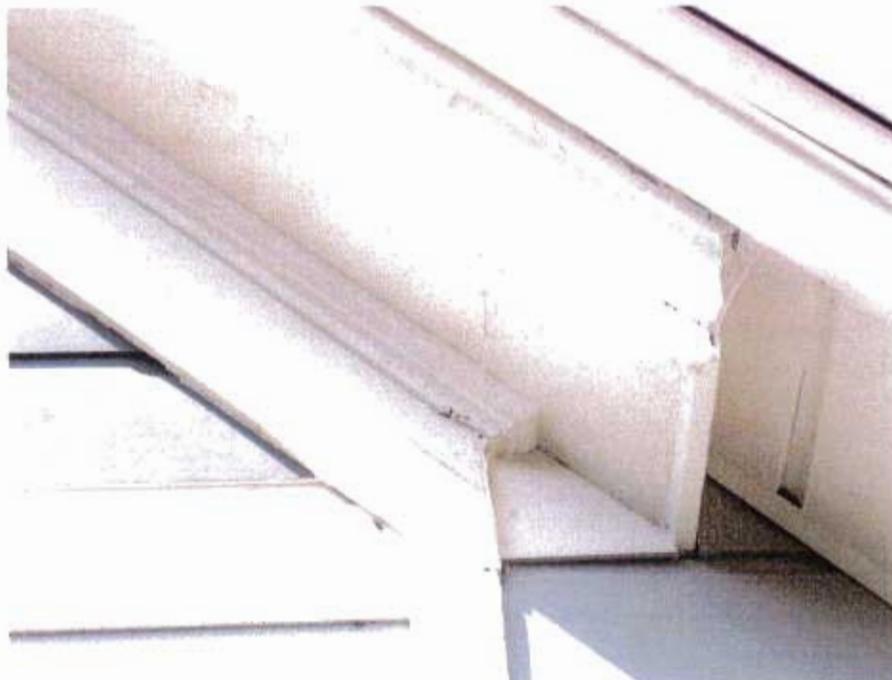
TRIM/ARCHITECTURAL ORNAMENTATION. Original exterior trim on front and sides of house.

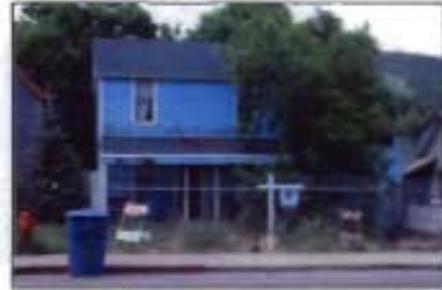
1119 Park Avenue, primary façade.

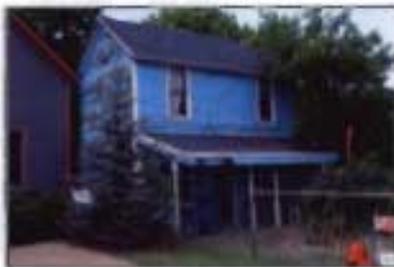
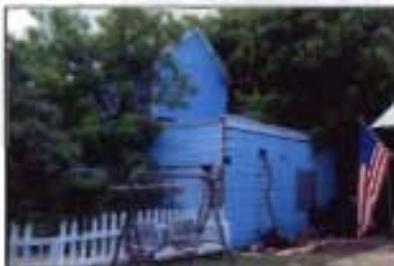
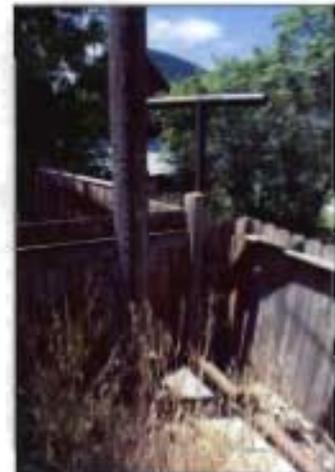
For safety purposes, the city has placed a temporary chain link fence around the front and side yards to limit access to the site and structure; the fence is padlocked. In addition to the temporary chain link, a 3' high picket fence separates the front yard from the neighbor to the north. There is a wooden slat fence and a chain link fence along the remainder of the north property line. The wood fence turns the corner and runs along the rear (west) of the property and stops at the rear of an outbuilding on the abutting west property. A wood slat fence continues south of the neighboring outbuilding, turns the corner (southwest) and meets the chain link on the south property line in the rear yard. There is a power pole in the NW corner of the lot.

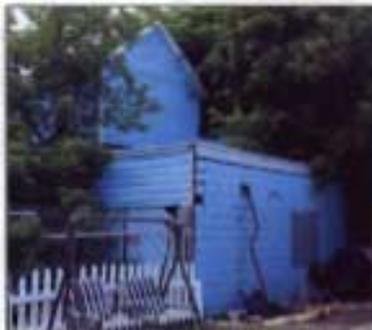
Garage addition: A flat roof with undetermined roofing materials. This roof was inaccessible due to the condition of the structure and the site. The garage roof structure, visible from the interior, is 2"x8" rafters attached to a ledger board using undersized joist hangers.

The ledger board may or may not be secured directly to the

north wall of the original hall-parlor house; two 4"x4" posts placed along the 12' span may be the primary support. The decking material is plywood.

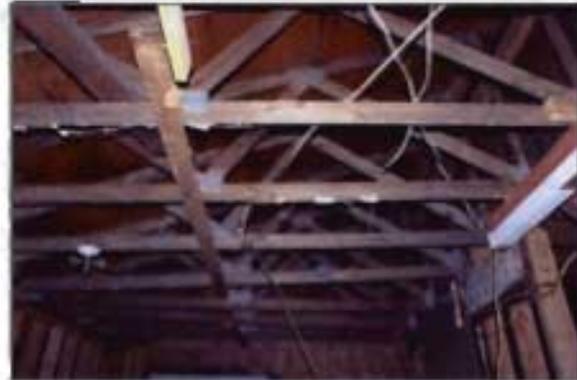
Addition 1: A 3 or 4/12 pitch shed roof projects from the west wall of the original hall-parlor house. It is clad in a black 3-tab asphalt shingle of undetermined age. The roof is supported by wood 2"x4" mono-pitch trusses and include nail plates and hangers that likely date from the 1970s or 1980s. Only a few of the bottom chords are girder or wall supported and several top chords have been extended to reach the stud frame of the west wall.

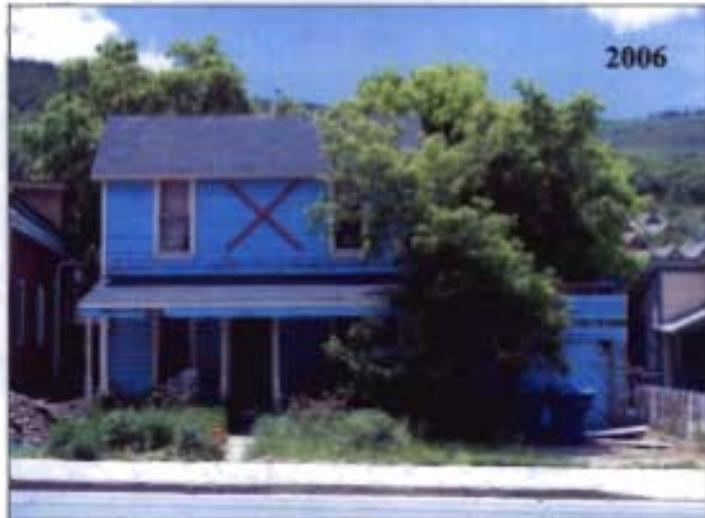
The 2-story primary façade is original and was constructed in two parts during the historic period (1869-1929). The first floor is believed to have been constructed c. 1900 with the second story added c. 1905. The primary façade, approximately 22' wide, is near symmetrical with a flush central entry door flanked by narrow, vertically oriented one-over-one double-hung windows, typical of the hall-parlor house type. The upper story has two symmetrically placed narrow, vertically oriented double-hung windows.

The horizontal drop-novelty siding on the first story is approximately a 6 1/4" exposure. The second story also has a horizontal siding with a 6 1/4" exposure but it is a tongue and groove type. Both are original but are severely weathered and checked; some boards are cracked their full length. The 1" x 4"

corner boards are original as well as the windows and the window trim. The blue paint appears to have been applied in the 1990's and is failing.

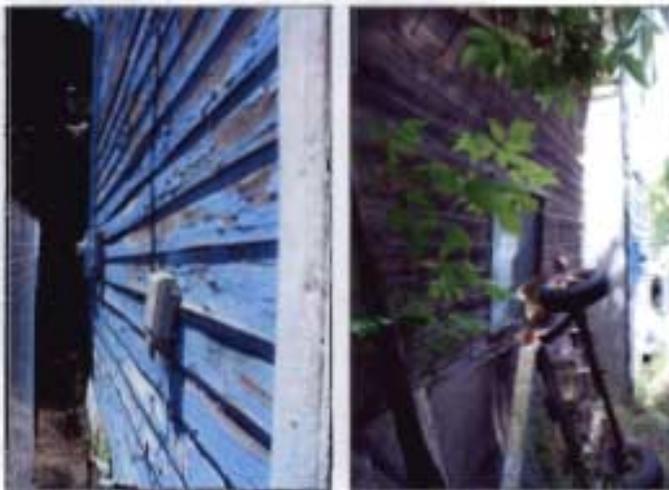
The south façade of the hall-parlor house is original siding similar to the primary façade; the first story is a drop-novelty siding and the upper story is clad in a tongue and groove type. There are not windows on the original house. The gas meter is on this facade. The meter base and mast are also on this facade.

Addition 1: Wall height at the point the addition abuts the original hall-parlor is approximately 12'. At the west end, the wall height is approximately 8' from finished grade (finished grade is obscured by piles of debris and building

materials). The wall is clad in horizontal wood tongue and groove siding with approximately 6" exposure. The siding is weathered and shows signs of checking and cracking. This wall includes one aluminum horizontal window.

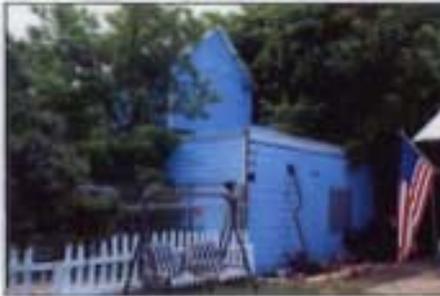
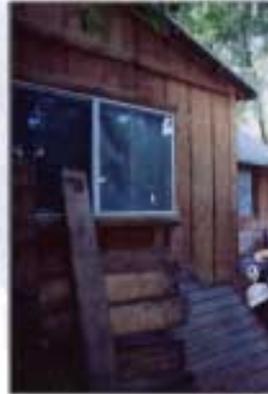
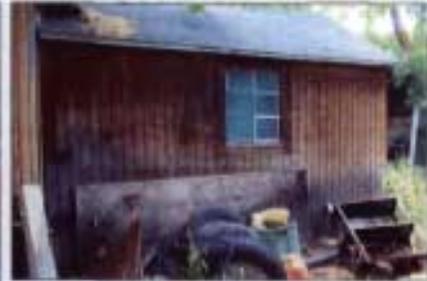
A one-story cinder block garage addition obscures the first floor of the original hall-parlor house. It should be noted, however, that the original drop-novelty wood siding serves as the interior wall finish of the south wall of the garage.

Addition 1: Wall height at the point the addition abuts the original hall-parlor is approximately 12' to 13'. At the west end, the wall height is approximately 8' from finished grade (finished grade is obscured by piles of debris and building materials). The wall is clad in T1-11 with approximately 12" wide exposure between approximately 1" vertical channels. This wall includes one vinyl horizontal slide window.

Addition 2: Wall height is approximately 6'-8" from the finished grade. The wall is clad in T1-11 with a narrow exposure between vertical channels. There is one multi-light wood window on this façade. The window (likely salvaged) appears to be fixed. The window was badly built, is in terrible disrepair, and has no salvage value.

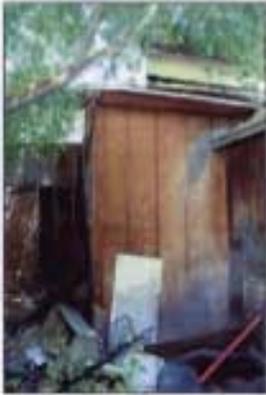
Addition 1: On the north side, the addition is clad in T1-11 with approximately 12" wide exposure between approximately 1" vertical channels. On the south side, the wall is clad in the same T1-11 siding but includes a multi-light double French door. The doors are non-original steel with plastic muntins for the divided lights.

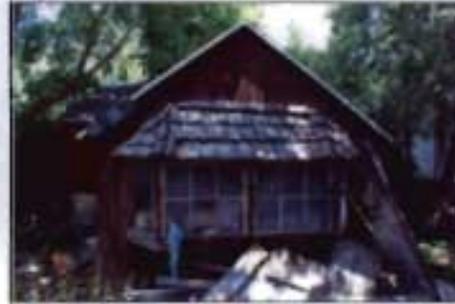
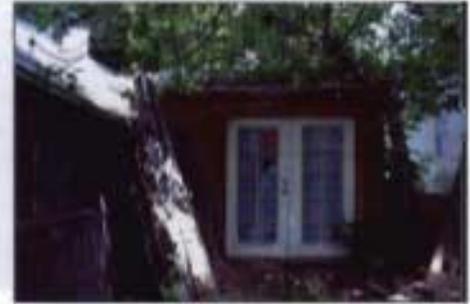
Addition 2: The wall is clad in T1-11 with a narrow exposure between vertical channels. Centered in the rear façade is a two-angle bay window with fixed sidelights and paired central three-over-three awning type windows. The window was badly built, is in terrible disrepair, and has no salvage value.

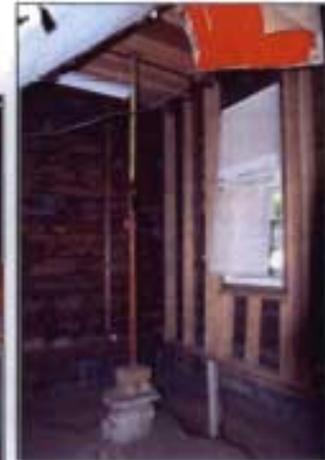
The original hall-parlor house has no foundation. County tax assessor building cards suggest that the structure had wooden sills on dirt or rubble foundation as late as 1968, but all material that once supported the perimeter walls has been removed. All that exists is the trenched perimeter

where the original footing and/or foundation material was removed. The front and south sides of the building are suspended above the bottom of the trench by a series of 4 to 5 pipe jacks located haphazardly on the interior dirt where the floor joists and decking have been removed.

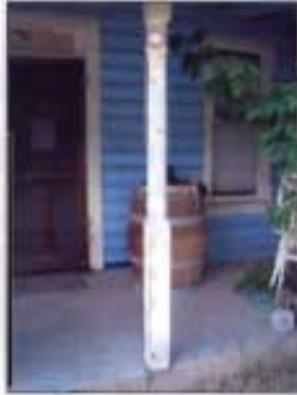
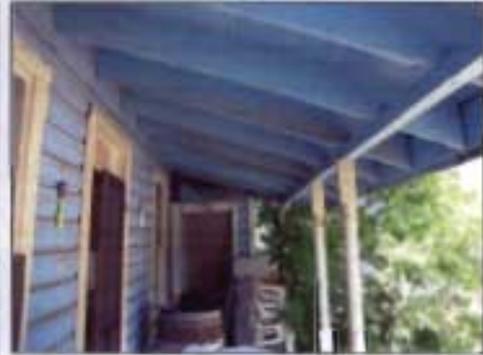
The front porch is the only extant porch. The concrete deck of the porch and the roof structure appear to be added sometime after 1948. Historic photographs show narrower structure with a shallow hip roof with brackets at the top of the slender posts. Paint line shadows on the primary façade show the locations of the original porch posts.

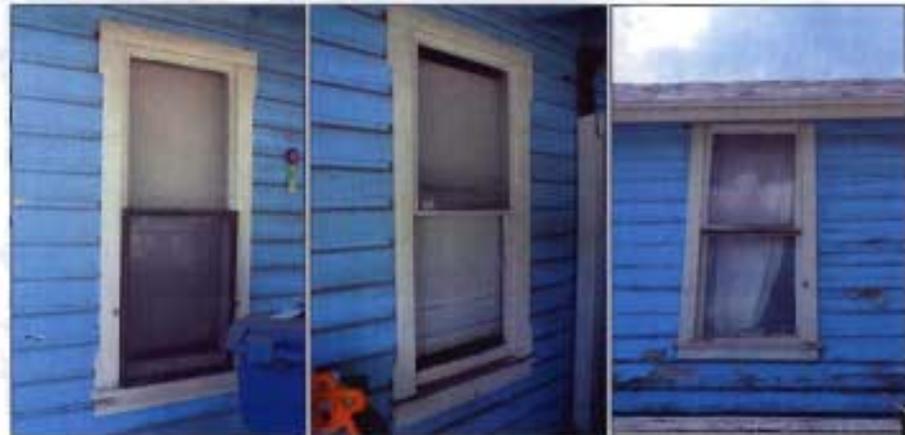
There are four original wood windows, all located on the primary façade. They are double hung, single pane. Some of the glass is missing and the sashes are painted closed. The sills are badly checked and the checkrails are damaged on the second story.

The remaining windows include the aluminum horizontal slide unit on the south elevation of addition 1 and the vinyl horizontal slide unit on the north side of addition 1. In addition, various salvaged wood windows are used

on all three facades of addition 2. There is no evidence to suggest these windows were once part of the original house and could not be reused because they are in severely deteriorated condition.
