MCPOLIN BARN – STRUCTURAL STUDY

PROJECT #14359

July 1, 2014

PREPARED BY: BHB Consulting Engineers, PC

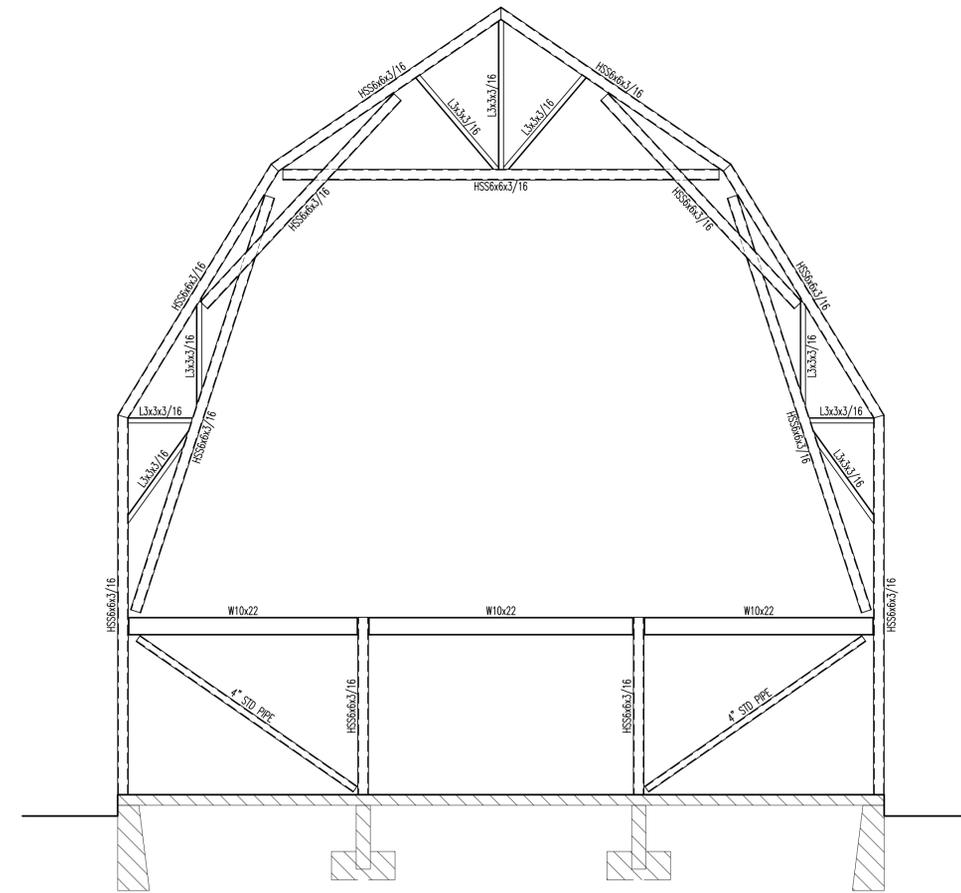
B BARN/TRUSS SECTION BRACE FRAME RETROFIT
SCALE: 1/4"=1'-0"
0 4 8 16'

The barn does not have a dedicated system to resist earthquakes or wind loads. Instead the wood frames have performed both functions of resisting the lateral and gravity loads. The exterior wood planks have also helped stiffen the structure. This system is woefully inadequate. Consequently, diagonal steel cables were added in the 90's to resist lateral loads.

The existing structure is currently inadequate to resist snow loads, wind loads and high seismic loads required by local building codes. We recommend that the building be retrofitted with new braced frames to resist the required lateral loads. These frames could be shaped in a way to minimize the impact on the barn and historic nature of the building. Refer to B/S-301 Appendix. We also recommend that portions of the east and west walls be sheathed to create shear walls.

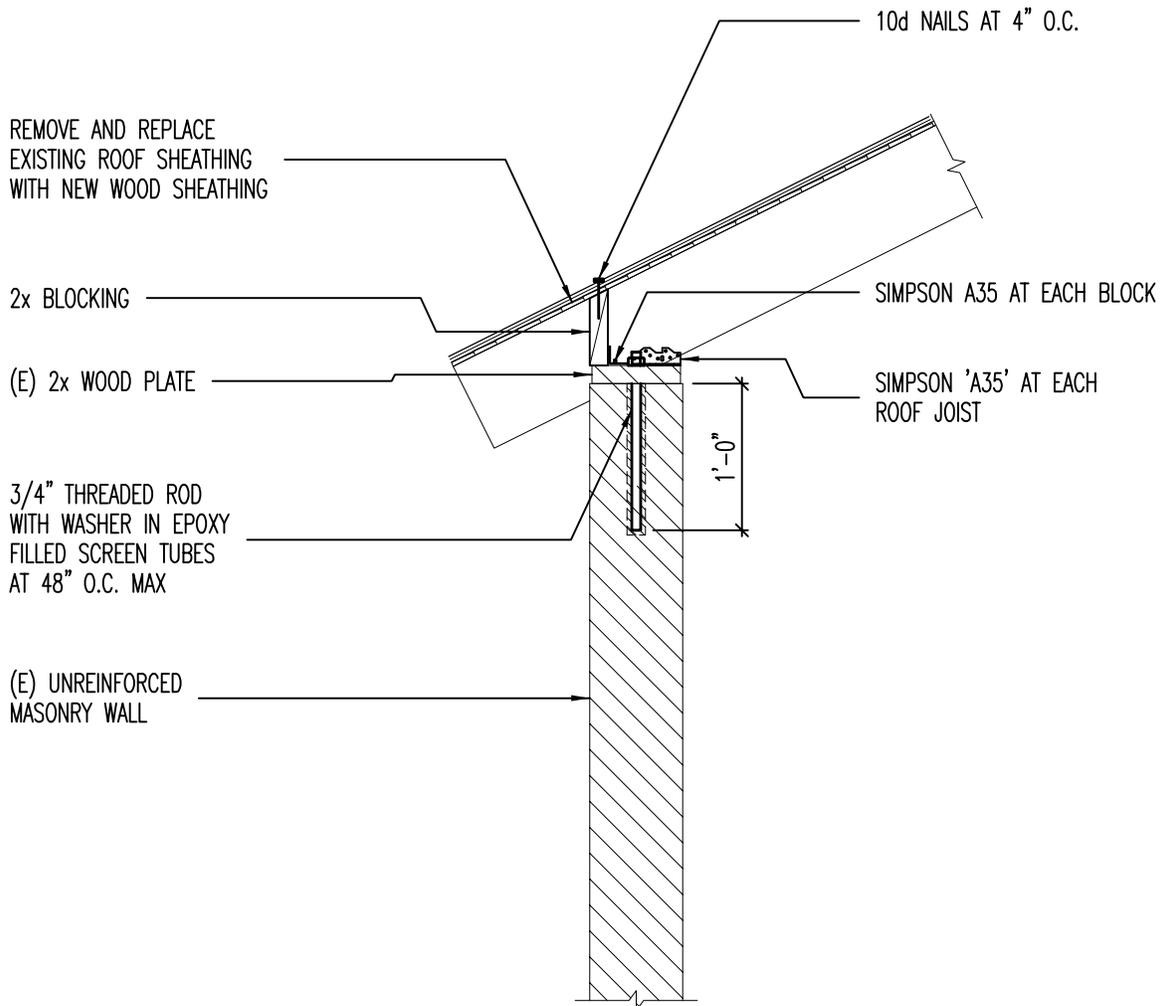
TYPICAL URM WALL BRACING AT ROOF (DEFICIENCY 4a)

The additions to the original building are framed with unreinforced masonry walls (URM). These walls present a hazard in an earthquake due to their relatively high weight and potential to tear away from the roof in an earthquake. The connections between these walls and the roof trusses should be retrofitted.

At the newer additions, unreinforced masonry walls (URM) walls provide stiffness. However, the stiffness provided by the URM walls can be a hazard under cyclic earthquake forces. This is due to the fact that the URM walls are not very ductile and are susceptible to cracking. Additionally, the high weight of the walls increases the seismic forces experienced by the structure. The biggest threat is the potential for the wall to pull away from the roof, resulting in a total collapse.
