# HISTORIC SITE FORM -- HISTORIC SITE INVENTORY

Name of Property: Judge Mine Site - Assay Office and Change Room Building

Name of Property: Judge Mine - Shed Structure

Name of Property: Judge Mine Explosives Bunker Portal

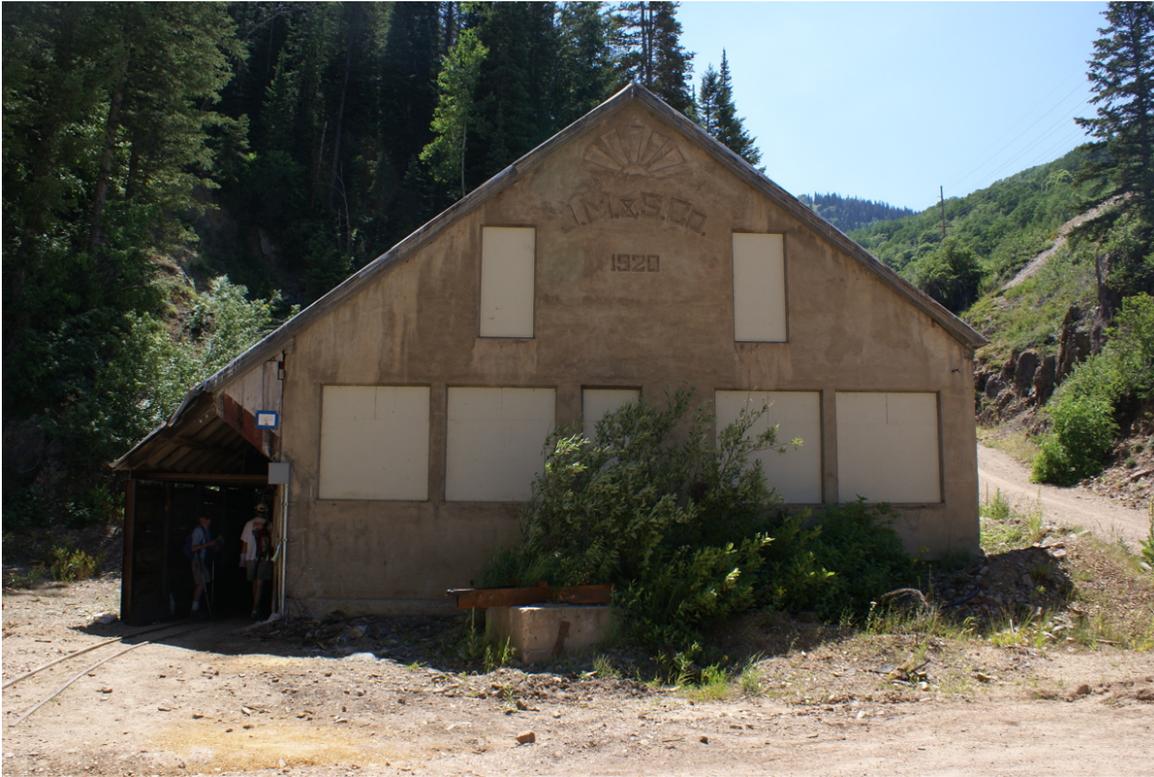
**Photo No. 1:** Northeast elevation (primary façade). Camera facing southwest, 2009.

Fair (Some problems are apparent. Describe the problems.): General deterioration - windows boarded, roof damage.

Judge Mine Assay Office and Change Room Building, 2009

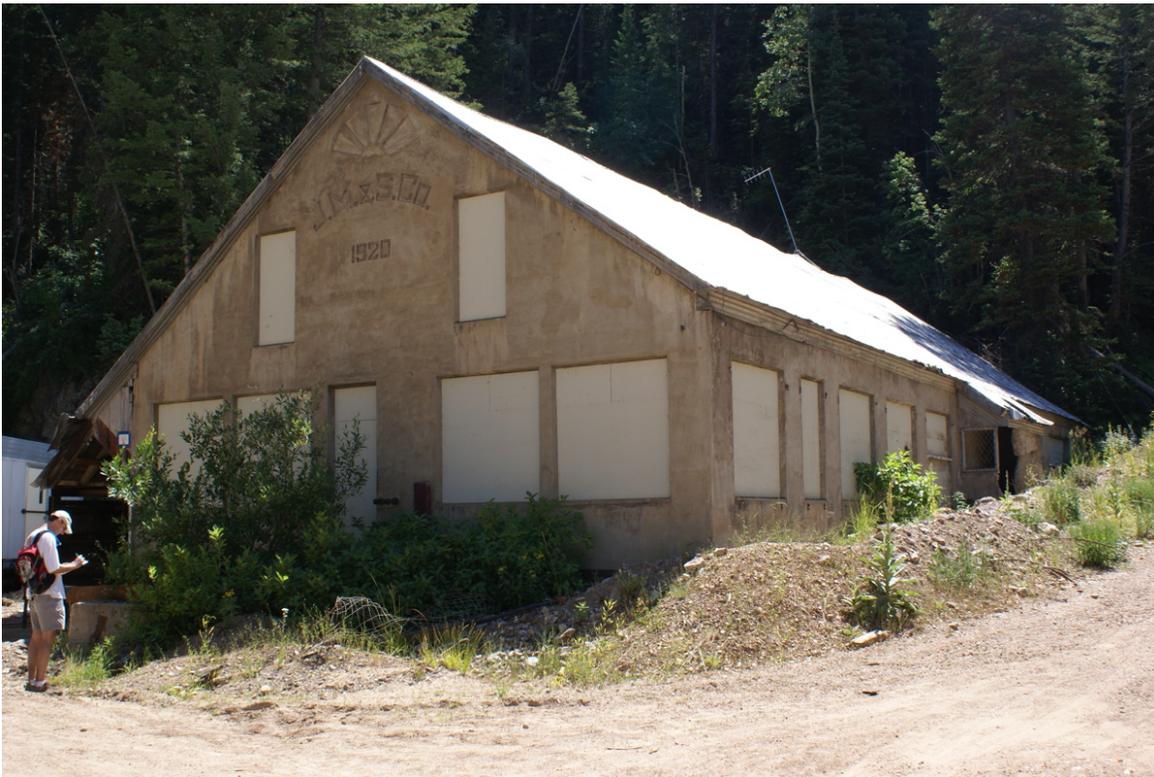
**Photo No. 2:** Northeast elevation (primary façade). Camera facing southwest, 2009.

Judge Mine Assay Office and Change Room Building, 2009

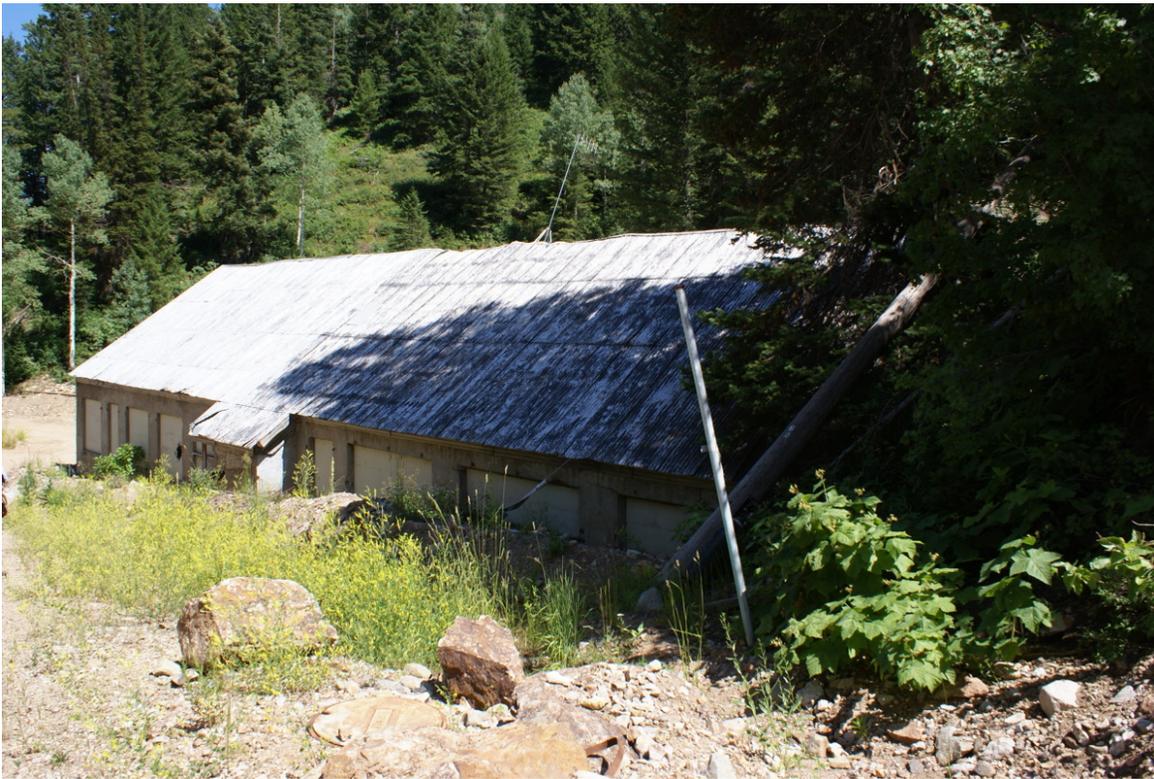
**Photo No. 3:** North oblique. Camera facing south, 2009.

Judge Mine Assay Office and Change Room Building, 2009

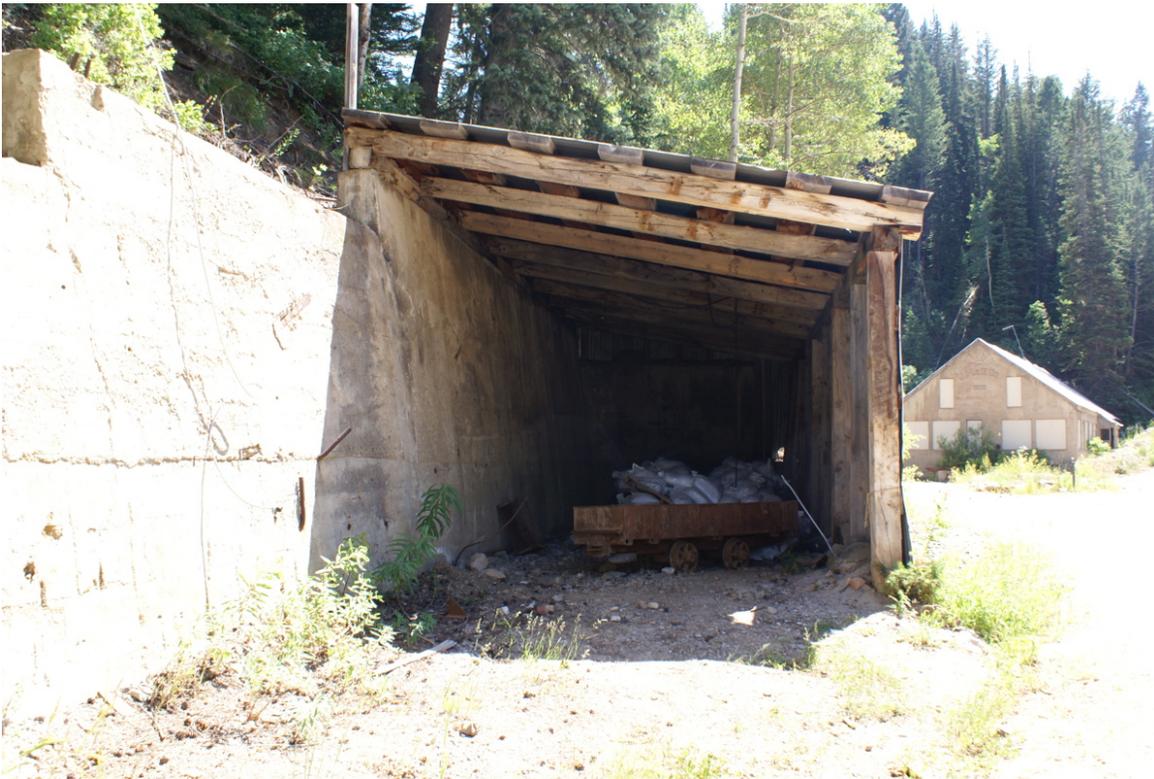
**Photo No. 1:** West elevation. Camera facing east, 2009.

Fair (Some problems are apparent. Describe the problems.): General deterioration.

Judge Mine Shed Structure, 2009

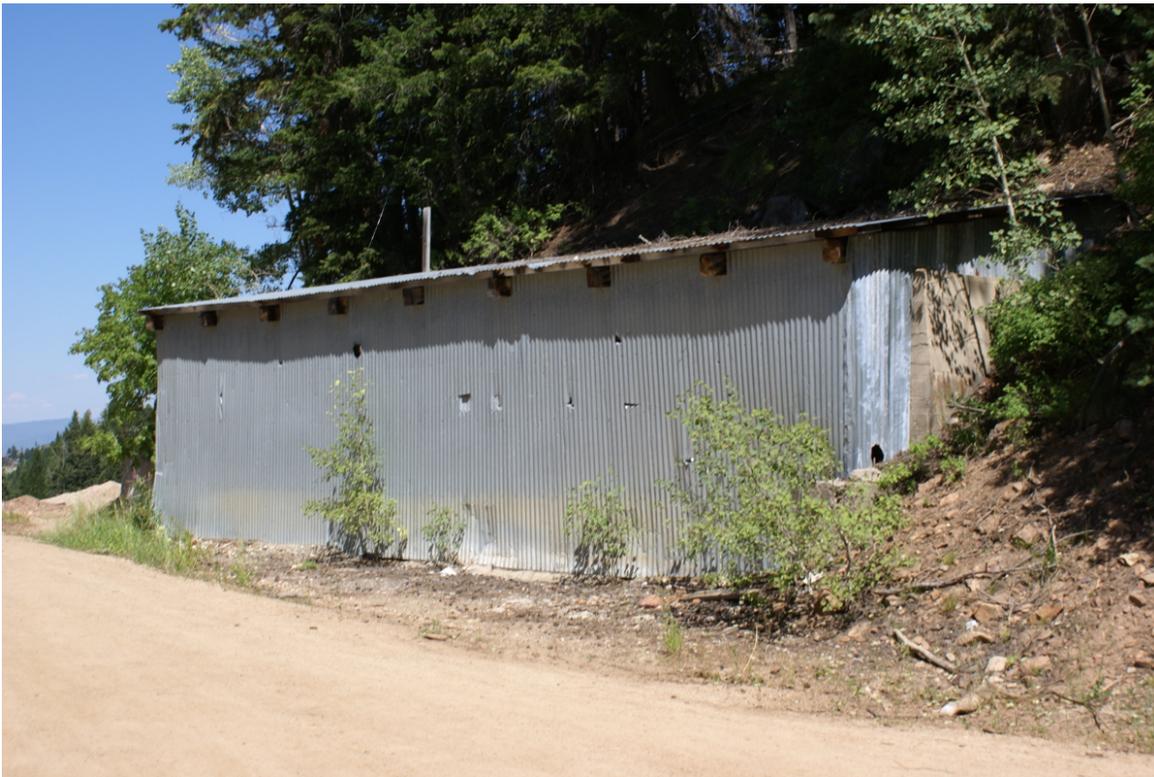
**Photo No. 2:** Southwest oblique. Camera facing northeast, 2009.

Judge Mine Shed Structure, 2009

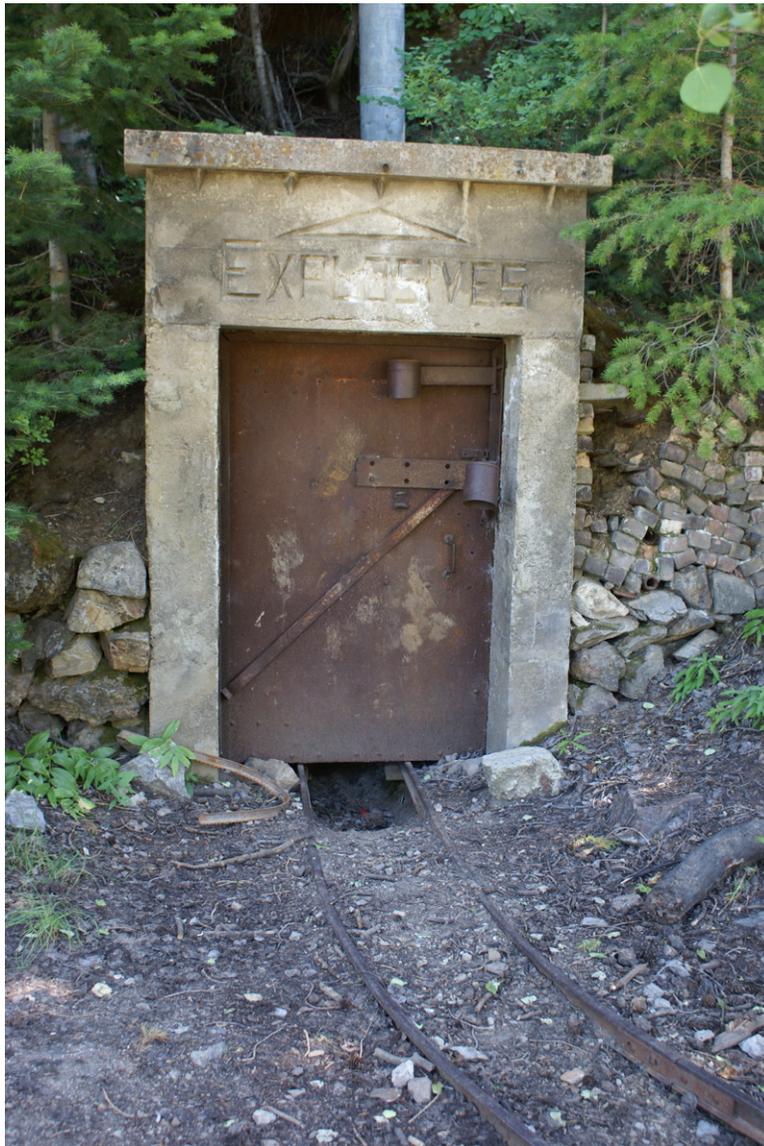
**Photo No. 2:** North elevation. Camera facing south, 2009.

- Good (Well maintained with no serious problems apparent.)
- Fair (Some problems are apparent. Describe the problems.): General deterioration.
- Poor (Major problems are apparent and constitute an imminent threat. Describe the problems.):
- Uninhabitable/Ruin

Judge Mine Explosives Bunker Structure, 2009
